NOVEMBER 1975

Servicing the **ITT** CVC5 CVC5/8 CVC7 CVC8 CVC9 Chassis

E. TRUNDLE

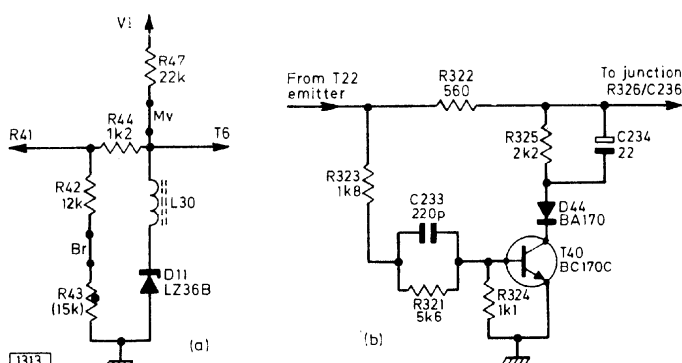
Fig. 5: Early versions of the CVC5 chassis used the tuning voltage stabiliser circuit shown at (a) and the noise gate shown at (b).

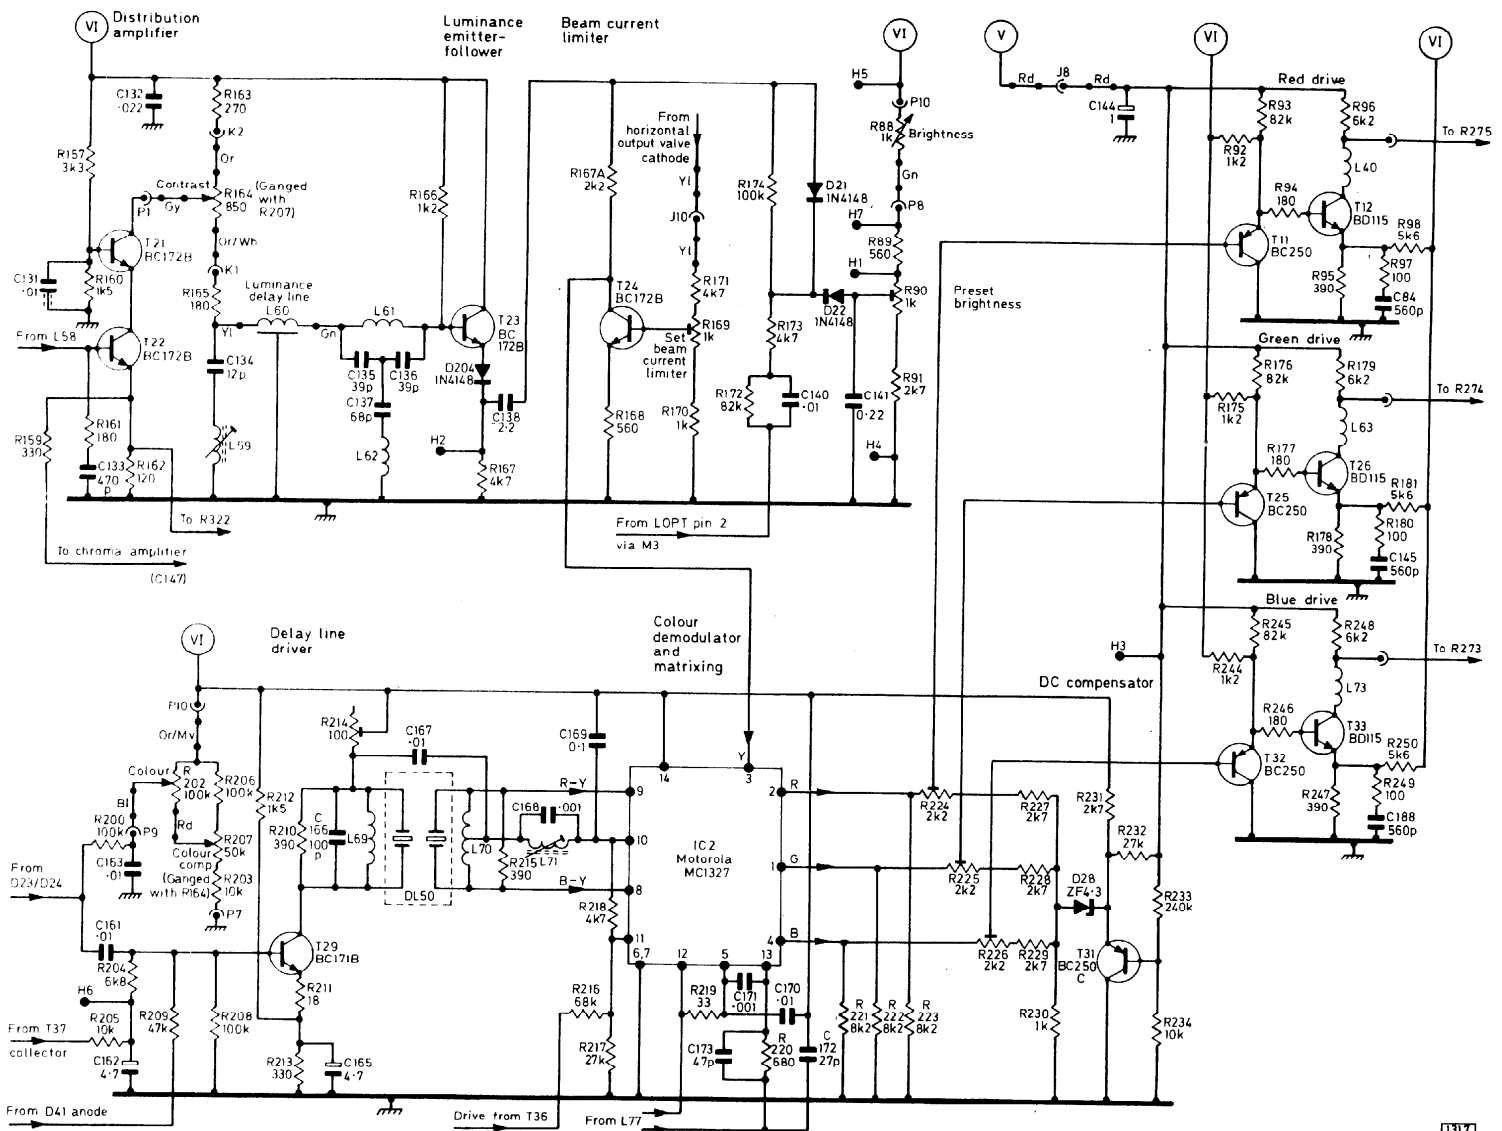
Fig. 6: Modified decoder and RGB circuitry employed when an MC1327P i.c. is used for colour demodulation and matrixing, and PAL switching. The subcarrier amplifier circuit is modified as follows: there is no tap on L77, and the feedback to the detector diodes D34/D35 is from a tap on L76 via C211 with C210 and R286 deleted.

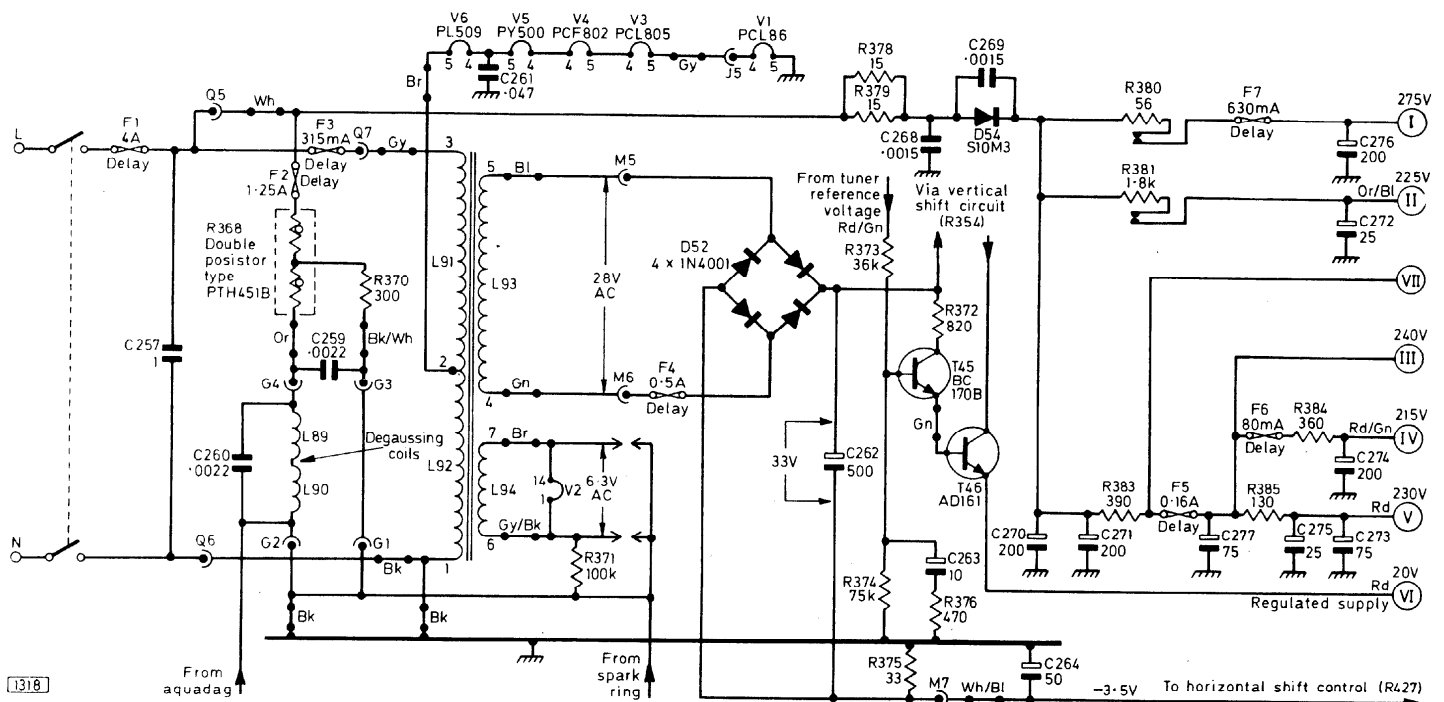
Fig. 7: Power supply and degaussing circuit used in the CVC8 chassis. In the CVC9 chassis F3 is replaced by a thermal cut-out and a pair of BY133 h.t. rectifiers may be used as in earlier sets with two BY103 h.t. rectifiers.
