## THE DECCA 10/30 CHASSIS PART 1

# 'BRADFORD' CHASSIS SERIES 10 & 30 PART 1. by R.W. THOMSON

PART 2. by R.W. THOMSON

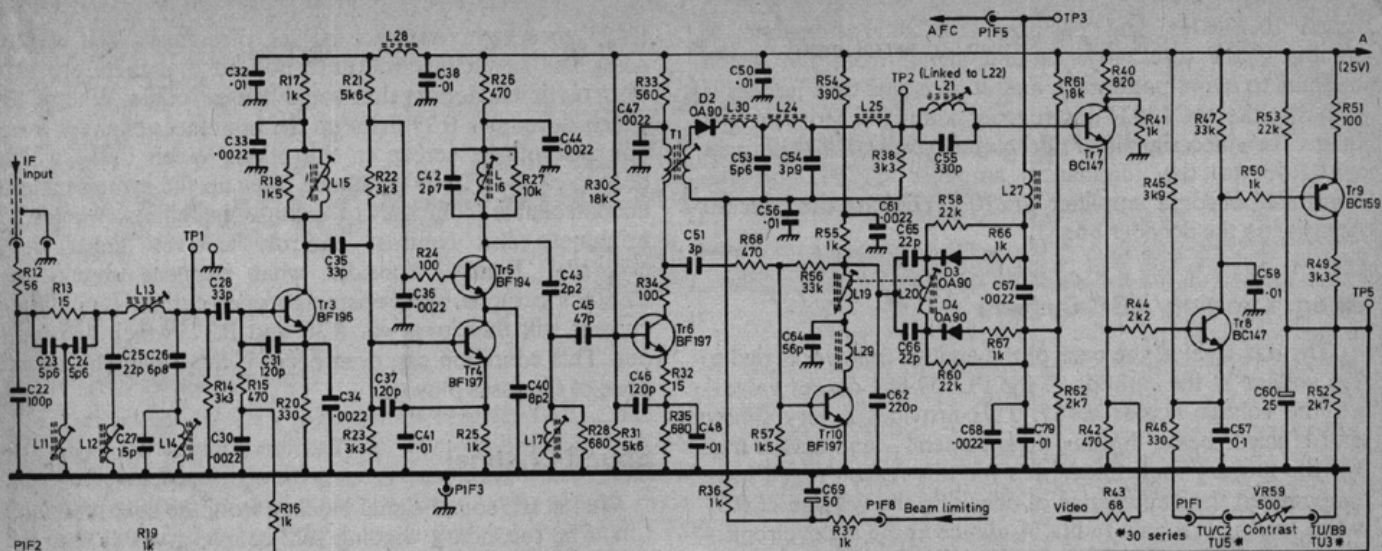
In the case of very low gain not attributable to the foregoing or to an obvious aerial or aerial socket fault, check the voltage appearing on R37 on the i.f. panel. If this exceeds 2.5V or so the fault lies elsewhere – we'll return to this later. If the voltage is approximately correct however the tuner's r.f. amplifier transistor is not operating normally, the transistor itself being the most likely culprit and fairly easy to check.

Fig. 4: Circuit of the i.f. strip. In the 30 series chassis R68 and C79 are omitted and a 41.5MHz trap is added in the detector circuit. With varicap tuners R58 and R60 are 100k $\Omega$ , R61, R62 and C68 are omitted and the junction of R60-C67 is connected to chassis.

It's for this reason that I recommend a check on the voltage at R37 before deciding for example that a grey, watery picture is due to a gain fault. Under normal test card conditions, with the contrast and brightness controls adjusted for a good, clean picture, the voltage at R37 should read 2.2V on the 10V scale of an Avo Model 8 or similar 20k $\Omega$ /V meter. Any notable increase in this voltage should lead to an investigation of the line timebase, a "notable increase" meaning one outside the normal 10% tolerance allowed on this type of equipment. Under no signal conditions a reading of 2.4V should be obtained at the positive end of C60, rising to approximately 5.5V when a good signal is being received, thus biasing Tr3 into a lower gain condition. It is vital then to check that the low-gain condition is not caused by a.g.c. action through excess line output stage current. The PL509's cathode voltage is the key, and the most convenient point to measure it is at R37 on the i.f. strip.

R453 goes high resistance is lack of contrast and brightness. The suspicious will have noticed that there are two electrolytic capacitors that could cause trouble. When C69 which decouples R37 dries up the brightness changes from one side of the screen to the other. When C434 which decouples the PL509's cathode dries up the symptoms are uncontrollable contrast, or picture instability when the brightness and contrast controls are set higher than normally. Finally, consider what happens should the PL509's cathode bias resistor go open-circuit. Its cathode current will then pass via R36 and R37, which will burn out. This condition can even occur if the tripler shorts and none of the fuses blow.

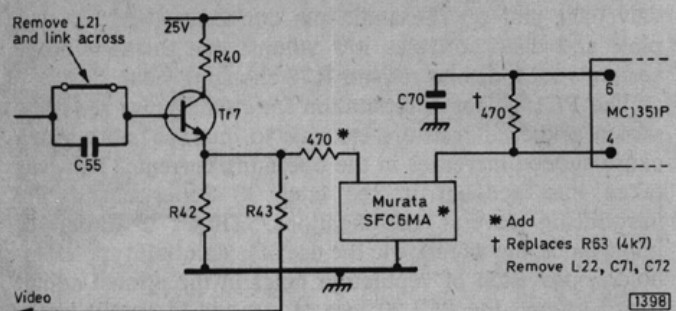
Fig. 6: Modification to remove caption buzz under difficult reception conditions. This should be tried only where normal adjustments fail to produce any improvement, and will not remove buzz due to signal overloading.

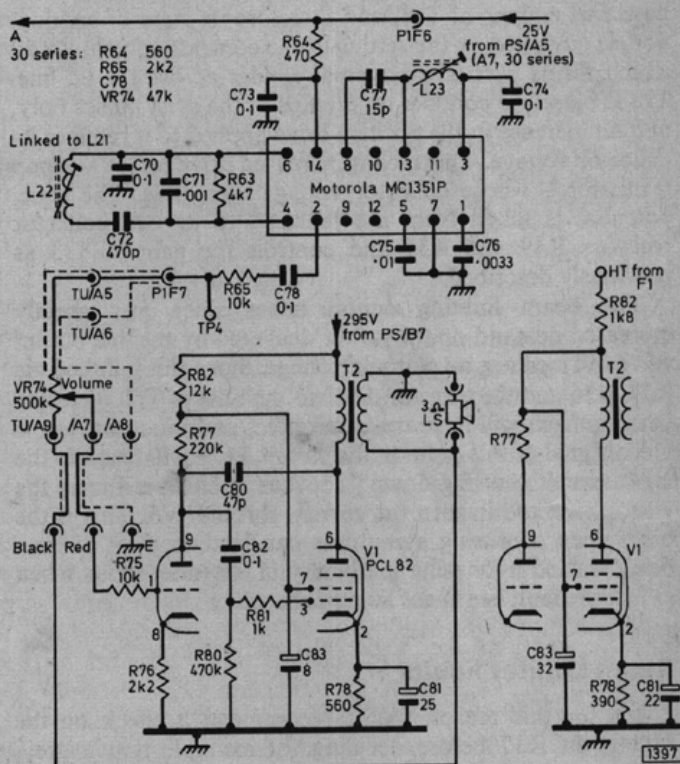
Fig. 7: The sound circuits. Modifications to the audio output stage in the 30 series chassis are shown on the right.

The PCL82 has a reputation for ruining bias resistors, screen grid feed resistors etc. due to internal faults which cause sudden increases in the operating currents. This was taken into account in the later 30 Series chassis by introducing several modifications. These, in order of importance, are as follows: the use of a stand-off type valveholder, provision of ventilation holes in the printed circuit board around the PCL82, use of a modified output transformer, and the uprating of some of the more vulnerable resistors in the circuit.

Intermittent sound on either panel can usually be traced to cracks in the print around the heavy and totally unsupported output transformer, particularly if the panel has been removed and replaced a few times. In cases of distortion try a new PCL82, check its pentode cathode components R78 and the decoupler C81 and also its screen grid feed resistor R82, and if necessary check the anode and cathode resistors R77 and R76 in the triode circuit – these also tend to change value.

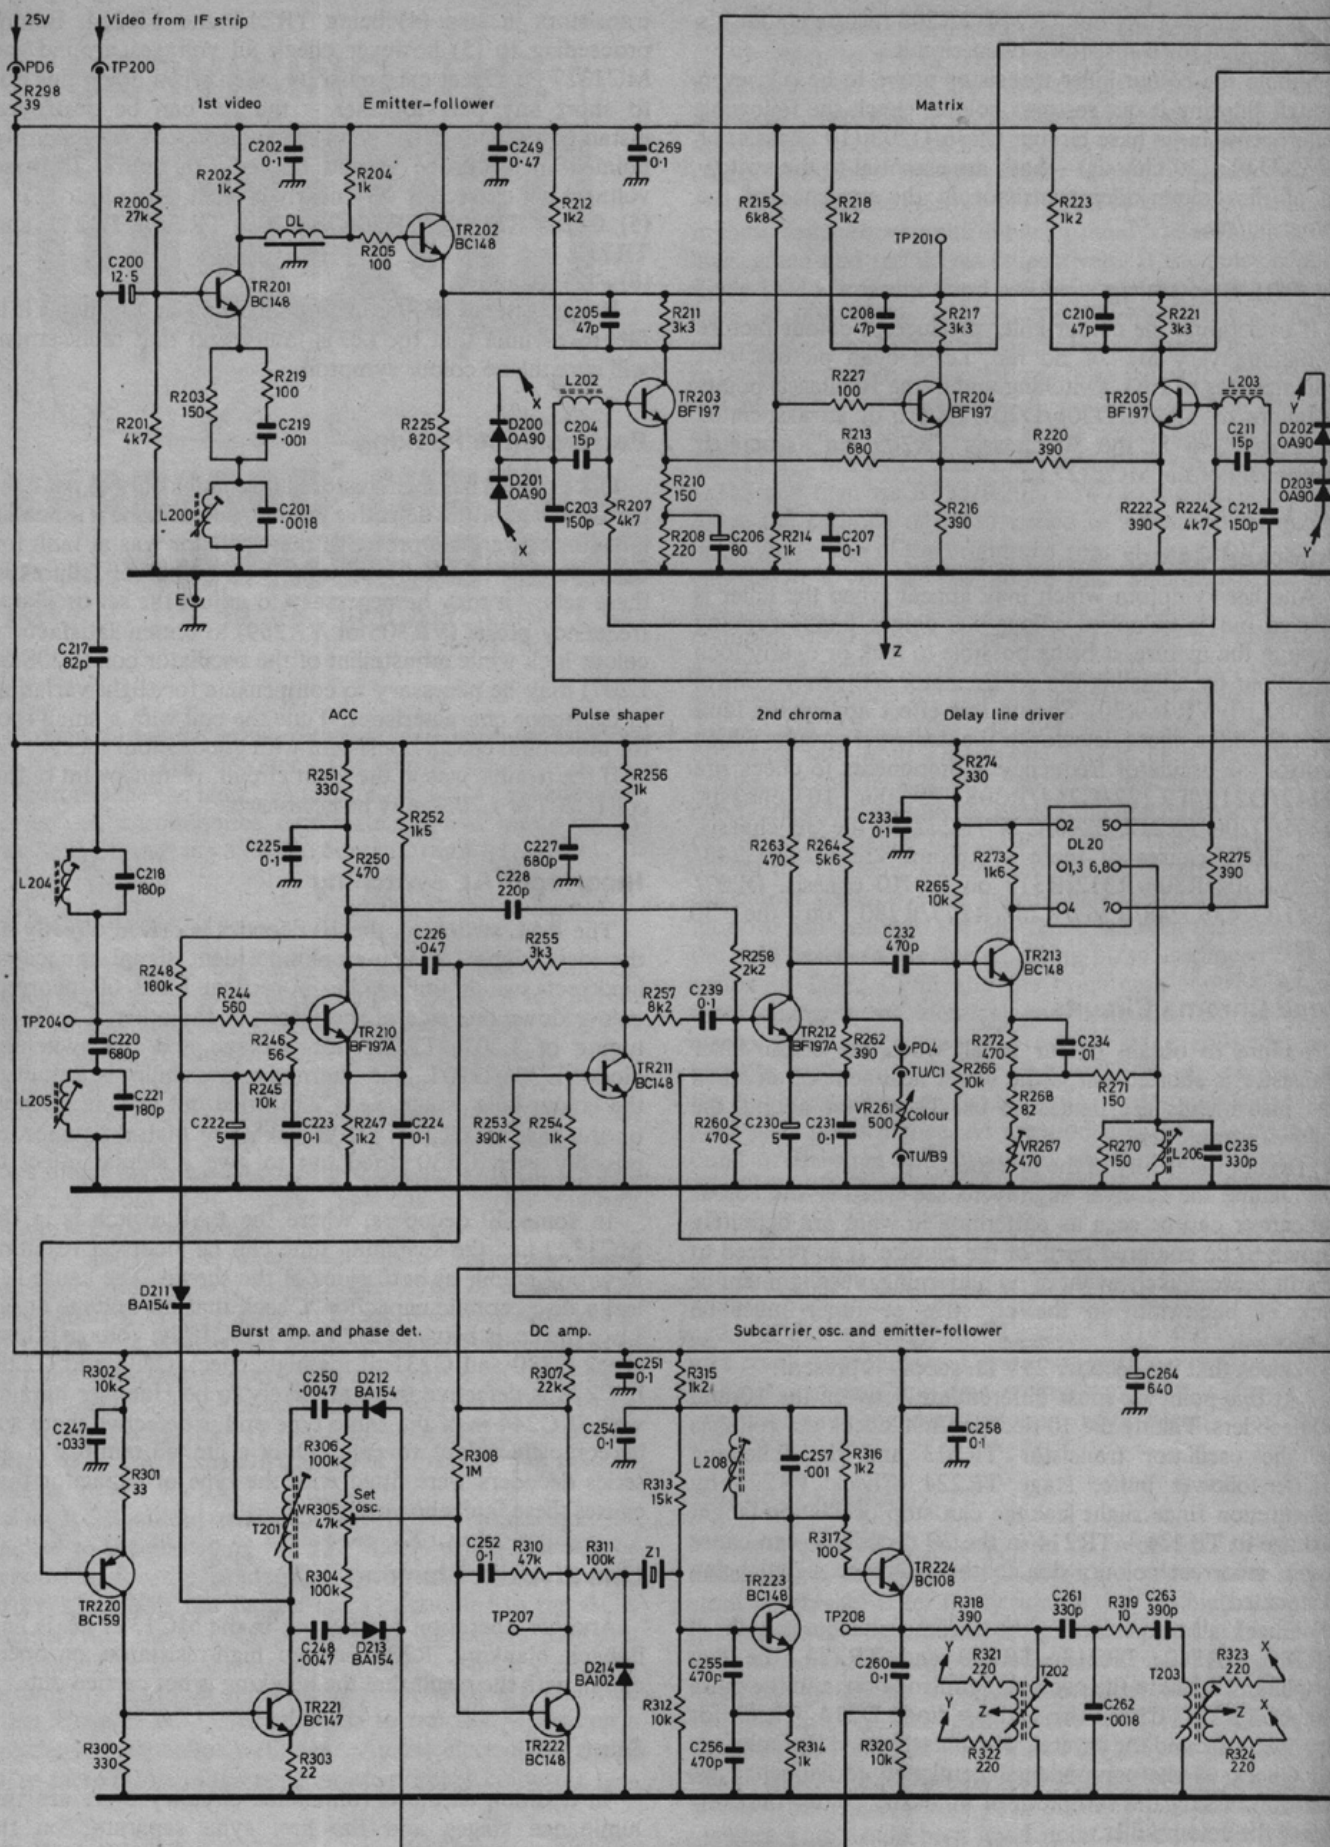
Both decoders are highly reliable. The most common colour faults occur in the RGB output stages. A bright red, green or blue picture usually indicates a short-circuit BF337 (BF179 in the 10 chassis) while a cyan, magenta or yellow picture is normally due to an open-circuit BF337/BF179. A less common cause of a bright blue/red/green picture is an open-circuit output stage collector load resistor. In all these cases diagnosis is easily confirmed by checking the voltage to chassis from each collector heatsink in turn – the odd voltage is the wrong 'un'!

The PAL switch on the 10 decoder is driven directly by the ident signal. A low-amplitude ident signal can cause incorrect switch timing, i.e. a vertical band of incorrect colour down one side of the screen or the other. Check the tuning of L207, TR215 for leakage and the switching diodes D206/D207. The alternative possibility is a fault in the colour-killer stage, i.e. C236 dried out leaving a ripple on the base of TR214, D208 leaking or high-resistance, or possibly even C230 dried out to give a similar effect to C236.

Fig. 8: Decoder circuit used in the 10 version. The circuit used in the later

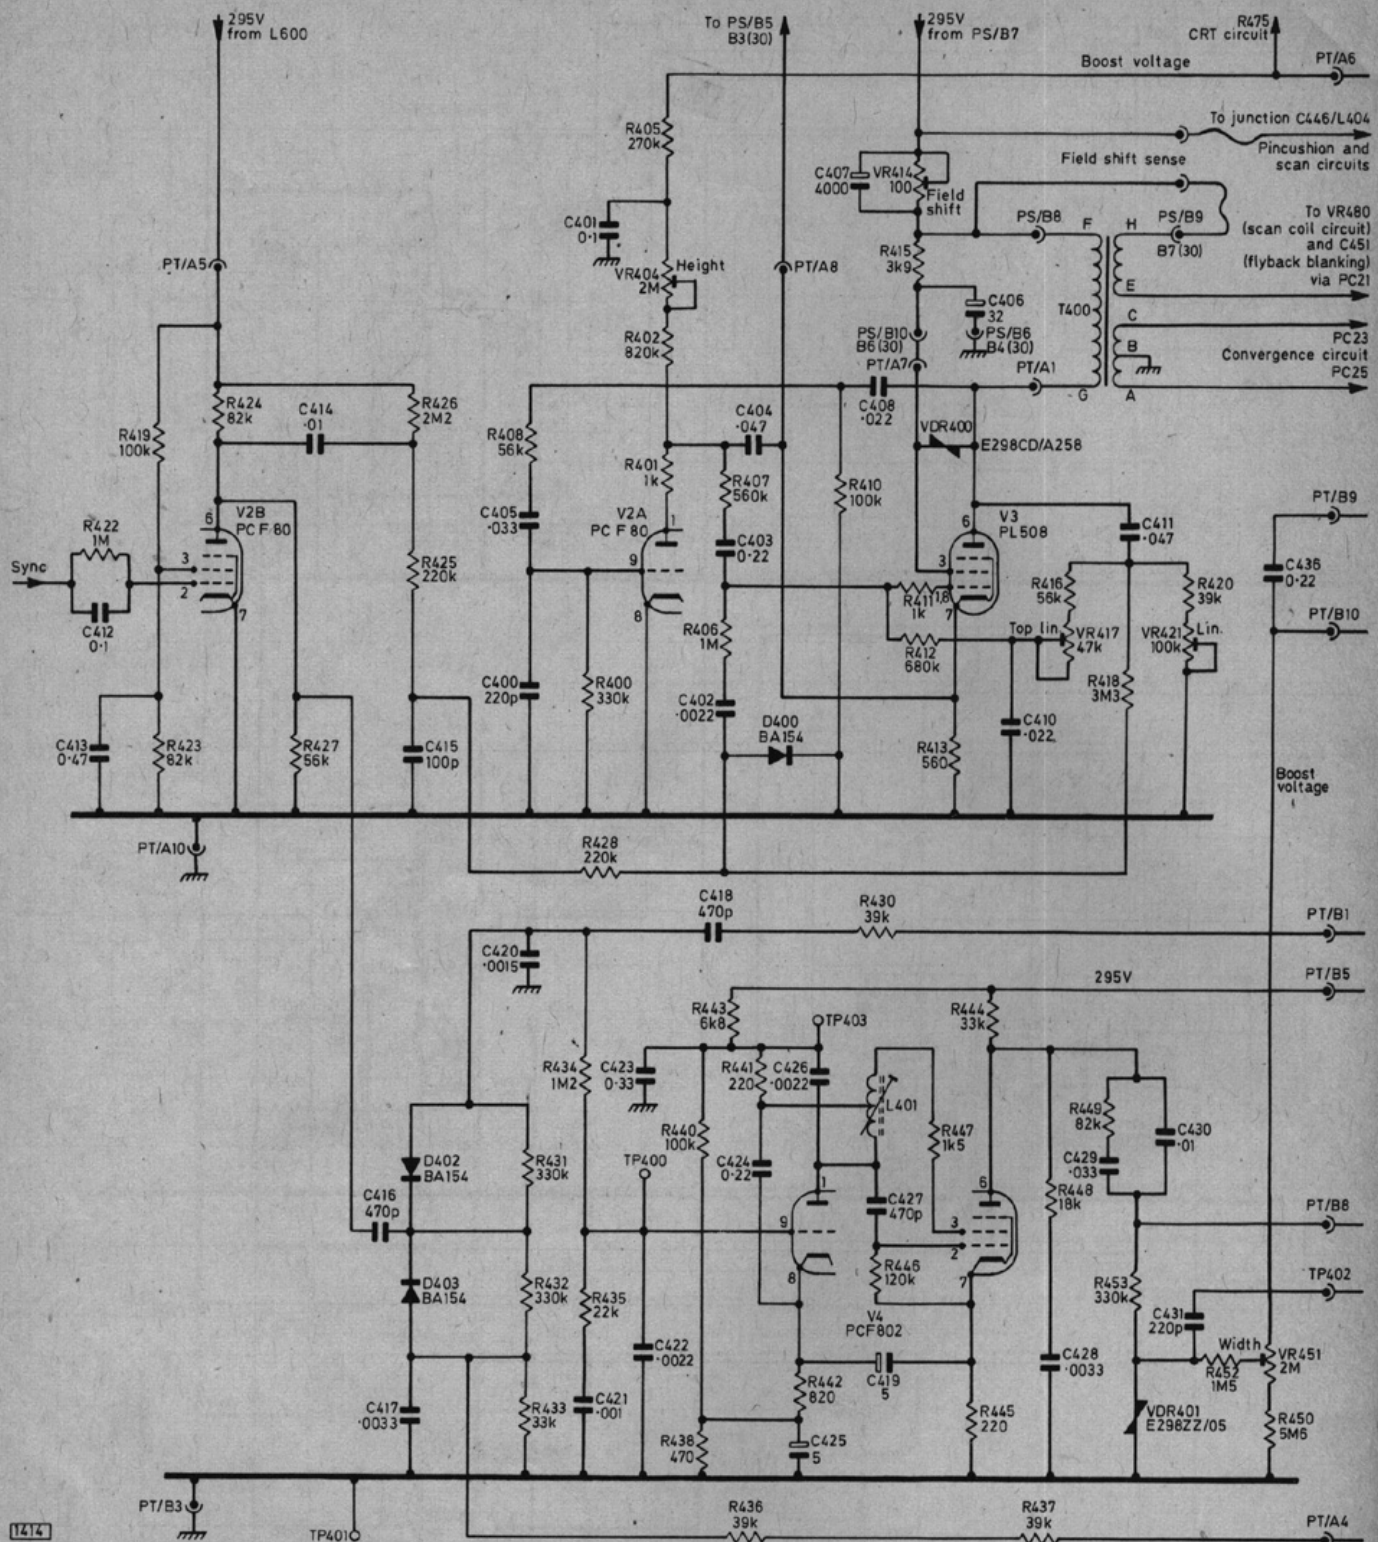
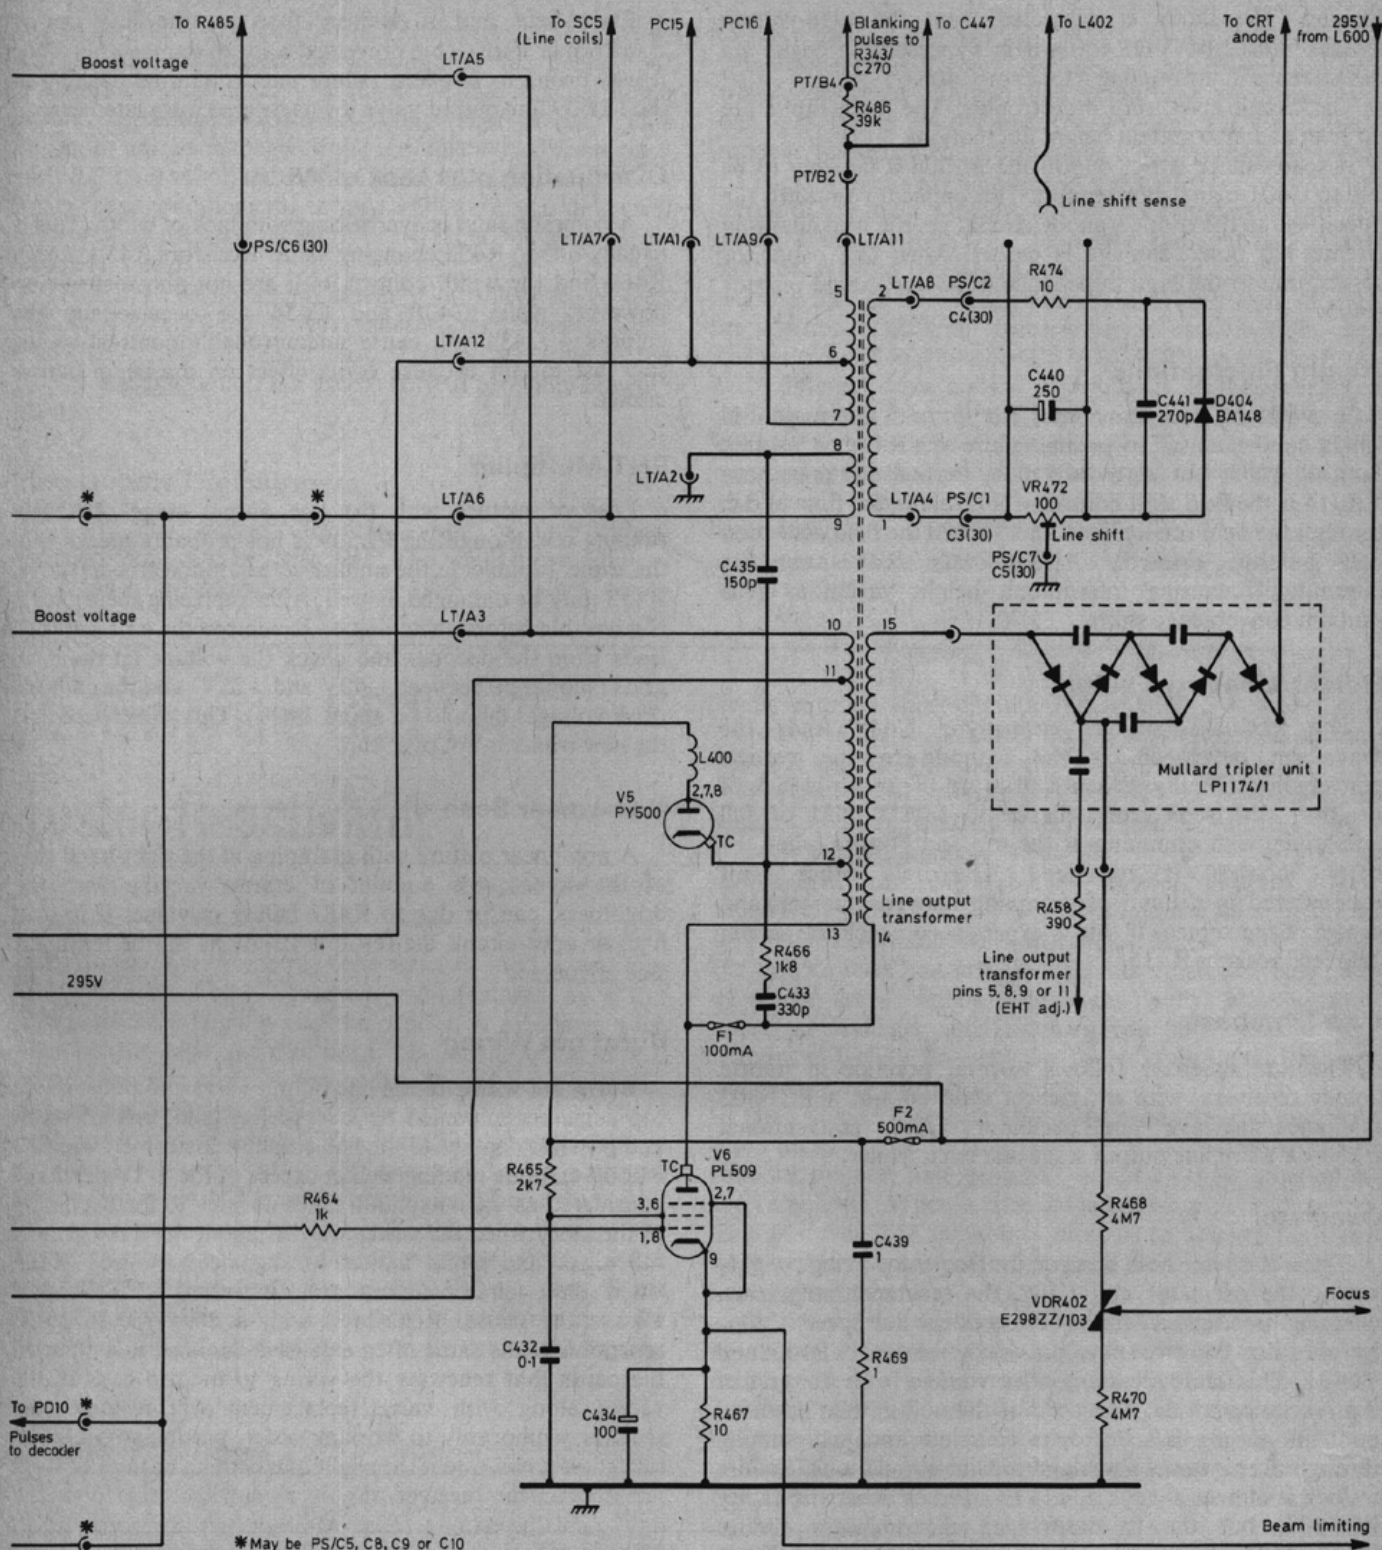
Fig. 9: Circuit diagram of the field and line timebases, 10 chassis. Small-screen (20kV) models differ in using an e.h.t. doubler instead of a tripler, with no e.h.t. adjustment (R458 not present). There are several modifications which should be noted in the later 30 chassis. These are as follows. The 500mA h.t. fuse is coded F1 and supplies V2, V3, V4 and V1 plus PC6 (c.r.t. first anode circuit) in addition to the line output stage, the 100mA fuse on the line output transformer being replaced by a link. C449 (0.001µF) is added to link the earth sections of the field and line parts of the printed panel. In the line generator circuit D402 and D403 are type 1N914, C423 is 8µF and R452 consists of two 820kΩ resistors in series. TP403 is marked TP402 on some

panels, while the TP402 marking (next to C431) may be omitted. Great care should be taken not to confuse these points: the white lead from the line output transformer must be connected to the pin adjacent to C431. In the line output stage R467 may be 6-8Ω, C435 maybe 220pF, C440 is 220μF and C439 is 0.22μF with R469 omitted. There is no "LT" plug and socket. R486 is omitted, the line flyback blanking pulses for pin 6 of the MC1327 i.e. being taken from pin 9 of the line output transformer via PD10. In the field timebase D400 is type 1N914 and C407 is 4,700μF. The field linearity circuit is modified as follows: C411 is 0.1μF, R420 22kΩ, R416 33kΩ and R412 820kΩ.

A common fault is overheating with lack of width. This is usually due to R453 changing value. Resistors R450, R452, R467 and the width control itself are not above suspicion however, while C430 and C434 are occasionally the culprits – C434 will cause uncontrollable contrast as we saw last month because of its effect on the beam limiter circuit.

Loss of picture with the line output stage obviously running o.k. though the PL509 is hot probably means that the tripler (doubler in the smaller-screen models) is defective. R458 may be damaged as well. After replacing the tripler it is advisable before switching on to remove the c.r.t. cathode leads from the decoder and check the voltage on the c.r.t. grids (should be between -40V and +25V) and the cathode drive voltages (should be about 140V). This will ensure that the new tripler is not over-run.

Burnt out wiring to the line output valve and boost diode top caps, accompanied by low receiver gain, lack of width and possible damage to the line output transformer, with the PL509 cathode reading well in excess of the 2.2V normally considered as the maximum, takes us back to the beginning of the story when the writer warned about the link between the a.g.c. and beam limiter arrangements. Check R453 when these circumstances are discovered – it's nearly always the cause. Replace it with a 2W type to avoid repetition of the same often extensive damage. It is quite on the cards that renewing the wiring to the top caps of the valves along with valve replacement will restore the receiver temporarily to working order, particularly in good reception areas, and if the slight overheating of the PL509 is not noticed the receiver may work satisfactorily for a few days until the damage once again occurs. So check R453 whenever there are line drive or receiver gain faults.

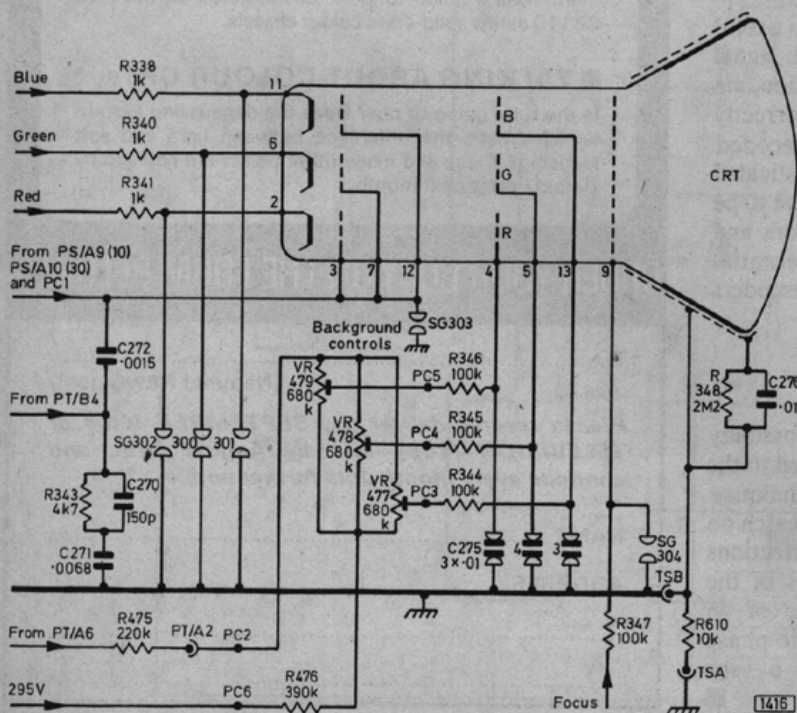
**No sound or raster, R603 open-circuit:** Check whether the h.t. rectifier D600 is short-circuit. The correct replacement resistor should be fitted since it offers a great deal of protection, fusing a lot faster than the thermal overload trip (10 chassis) or the anti-surge mains fuse (30 chassis).

**No sound or raster, heaters, R603, and fuse o.k., small screen models:** Check whether the h.t. smoothing resistor R606 (100Ω, replaces L600 fitted in the larger sets) or D600 is open-circuit.

**No sound or raster, heaters, R603 and fuse o.k., large-screen models:** Check D600 for being open-circuit.

Fig. 1 (left): C.R.T. circuit, 10 series chassis. In the 30 series chassis R610 is omitted, C276 is 0.004μF, VR477-9 are 1MΩ with C409 (0.01μF) shunting R476 and the background controls. C272/R343/C270/C271 are omitted (line flyback blanking is carried out in IC2), the c.r.t. grid bias from R600 and the field flyback blanking pulses from PC1 being fed to pins 3/7/12 via a 10kΩ resistor (R339).

Fig. 2 (right): The power supply circuit used in the 10 series chassis. The circuit used in the 30 chassis is similar, the main differences being as follows. The thermal cutout is replaced by a 2A anti-surge fuse (F3) in the live a.c. lead and a 500mA fuse (F2) from tag F on T600 to chassis; D601, D602 and D603 are type 1N4002, D601 and D602 being protected by parallel 0.01μF capacitors; C604 is 2,500μF and C605 22μF; R606 in the heater line is omitted; R611 is omitted and VR601 is connected directly between C604 and C605 (i.e. there is no R612); the plug and socket connections differ. In the 17 and 18in. models R606 (100Ω) replaces L600. C605 is 47μF in Model CS1830.
