Servicing the ITT CVC1 and CVC2 Chassis

E. Trundle

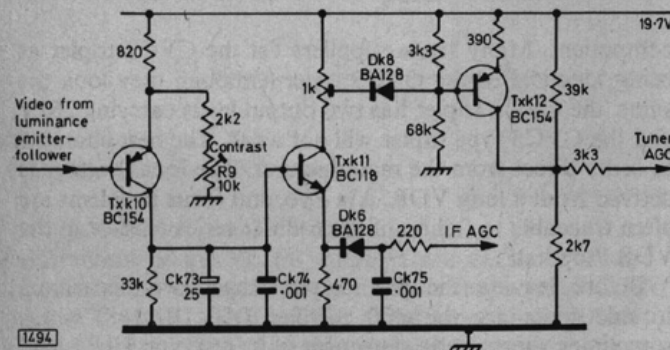
Fig. 1: The a.g.c. circuit.

The i.f. strip is often responsible for low-gain, instability and various intermittent problems. The a.g.c. department should be eliminated first, by overriding its potential (across Ck75, see Fig. 1) with a low-impedance bias box. The vast majority of i.f. problems stem from faulty transistors and poor jointing. Transistor failures are usually easily tracked down with a d.c. voltmeter.

Txk10 and Txk11 are suspect for a.g.c. faults, with Txk10 favourite. Txk12 is concerned only with the tuner a.g.c.

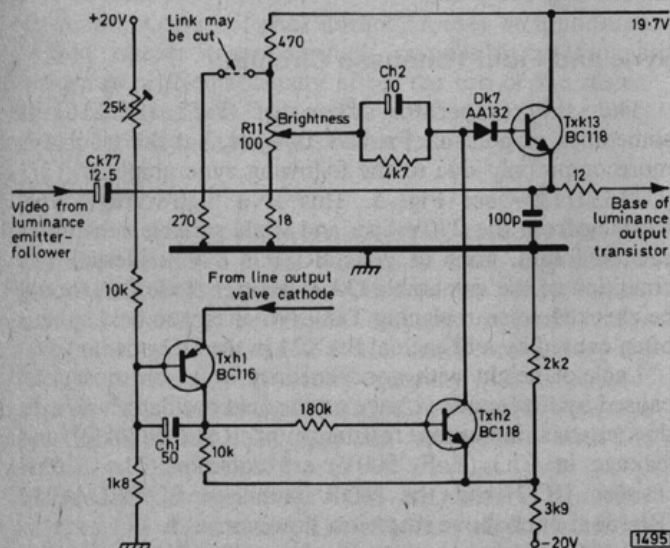
Fig. 2: The beam limiter and brightness/d.c. restorer circuit.

Brightness faults are not uncommon, and usually stem from the beam limiter transistors on the line timebase chassis. These are Txh1 (BC116) and Txh2 (BC118) – see Fig. 2. Varying brightness can often be traced to leakage in the 12.5µF luminance coupling capacitor Ck77 – uncontrollable brightness is the fault should it go short-circuit. Another cause of brightness troubles is the line output valve's cathode decoupling capacitor Ch29 (200µF) – the cathode voltage is used as the basis of the beam limiter action. A brightness fault that's difficult to diagnose is when R24 (470kΩ) which returns the c.r.t. first anode preset controls to chassis goes open-circuit or high resistance. The first anode voltages rise and the increased beam current brings the beam limiter circuit into operation.

The result is negative voltages around the beam limiter transistor Txh2, at the base and emitter of the d.c. restorer transistor Txk13 and at the base of the luminance output transistor Txf1. The potential divider network in the collector circuit of the luminance output transistor – from the 290V rail to chassis – prevents the collector voltage rising to the full h.t. potential but leaves a bright screen with flyback lines. A possibility in case of brightness variations is the two 50 μ F electrolytics Cp2 and Cp3 which smooth the –20V rail. A glance at Figs. 2 and 6 will show why.

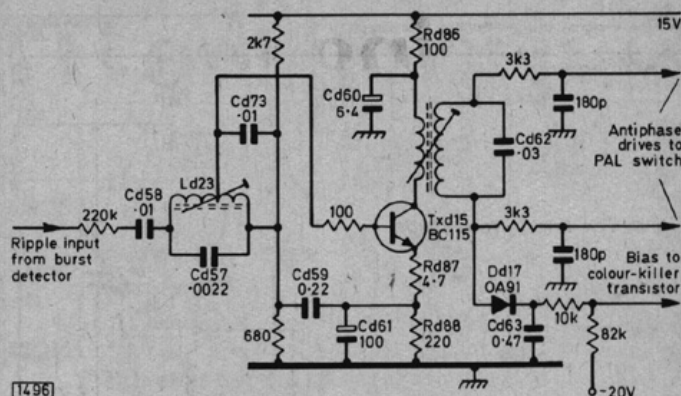
Fig. 3: The ident amplifier and colour-killer circuits.

colour-killer reservoir capacitor Cd63 (0.47 μ F) being particularly troublesome (see Fig. 3). In fact all polystyrene capacitors in the decoder should be treated with suspicion. Where the colour-killer is erratic due to low ident signal (at least 6V d.c. is necessary at the cathode of the colour-killer rectifier Dd17) Rd87 (4.7 Ω) may be bypassed. This modification, we hastily add, is quite unofficial.

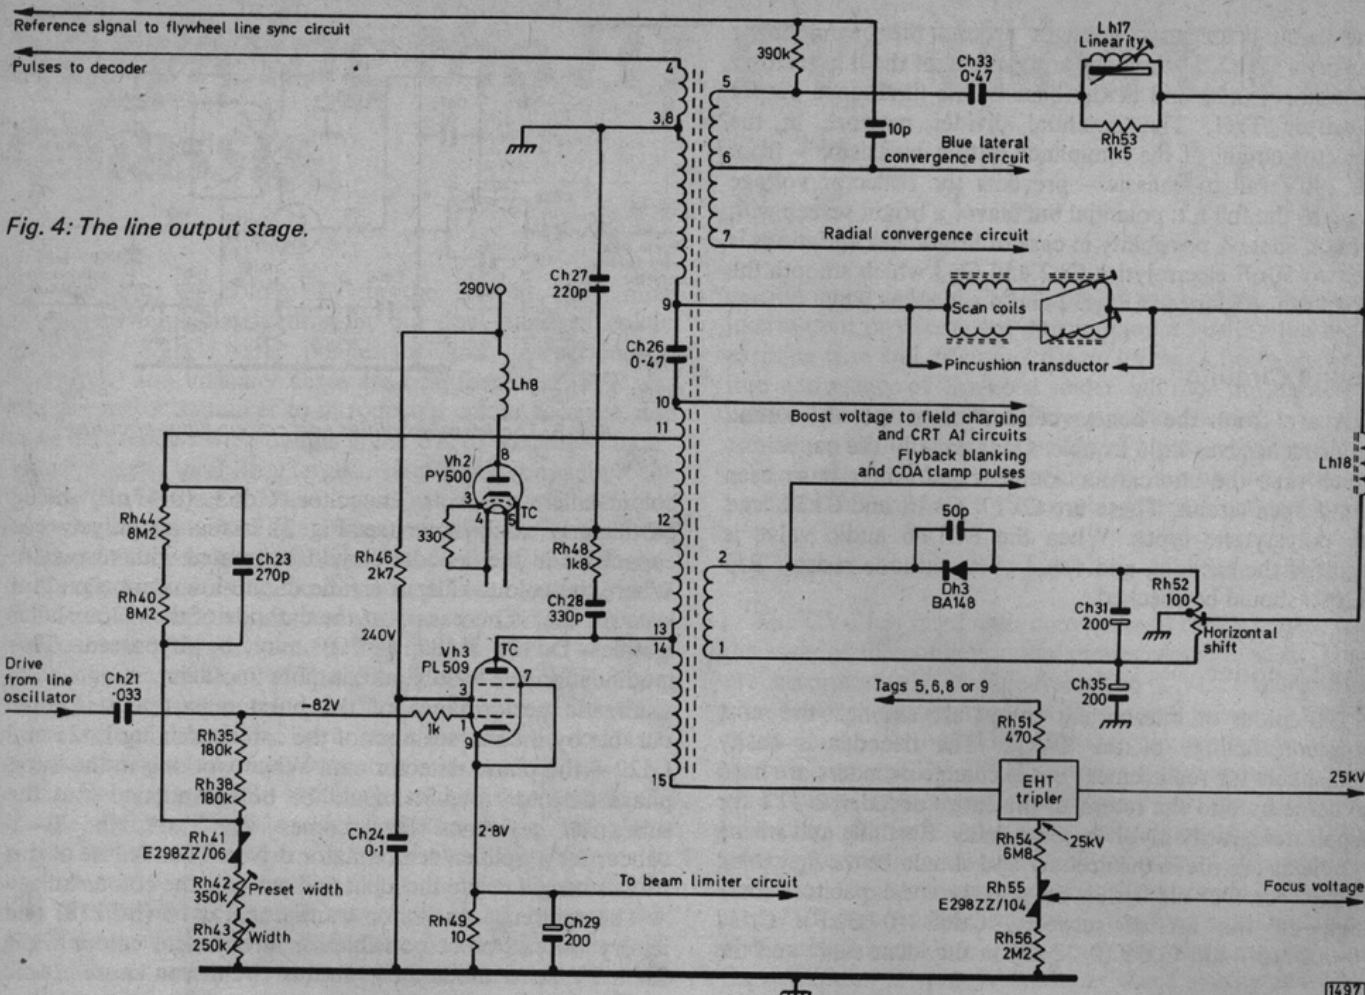
Fig. 4: The line output stage.

Having sorted out the line oscillator we can follow the line drive pulses to the line output stage (see Fig. 4). Several horrors await us here. The two 8.2MΩ resistors Rh40 and Rh44 in the width circuit predictably go high, resulting in low width. On the same panel is the 220pF ceramic capacitor Ch27 whose function is to tune the line output transformer and whose habit is to go dead short. The PY500 then glows until the 1.6A h.t. fuse Fp4 blows.

On the secondary side of the line output transformer the main offender is the 1.5kΩ line linearity coil damping resistor Rh53. This burns and goes open, resulting in heavy striations down the left of the picture. A 5W replacement is much better. The e.h.t. tripler is quite reliable, but when replacement is necessary it's important to obtain the correct

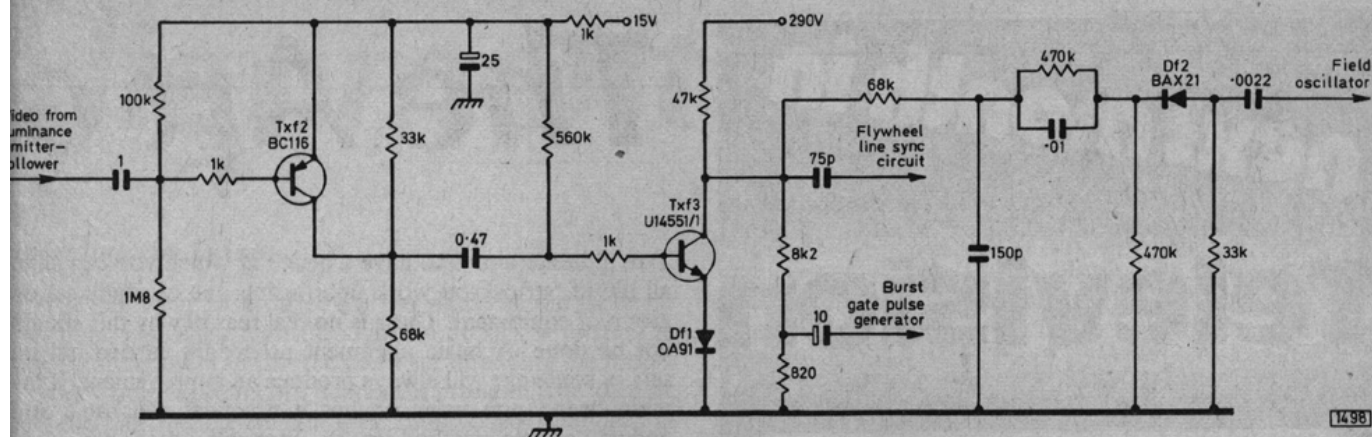
Fig. 5: The two-transistor sync separator circuit. Note that the burst gating pulses are derived from the sync pulses.

The sync separator transistor Txf2 (BC116) is sometimes responsible for lack of sync, but the trouble is more commonly due to the following sync amplifier Txf3 (U14551/1) — see Fig. 5. This is a high-voltage type, working from the 290V line, and while suitable substitutes can be found, none of your BC107s if you please! The condition of the vulnerable OA91 emitter diode Df1 should be checked when replacing Txf3. No or erratic field sync is often caused by a bronchial BAX21 in the Df2 position.

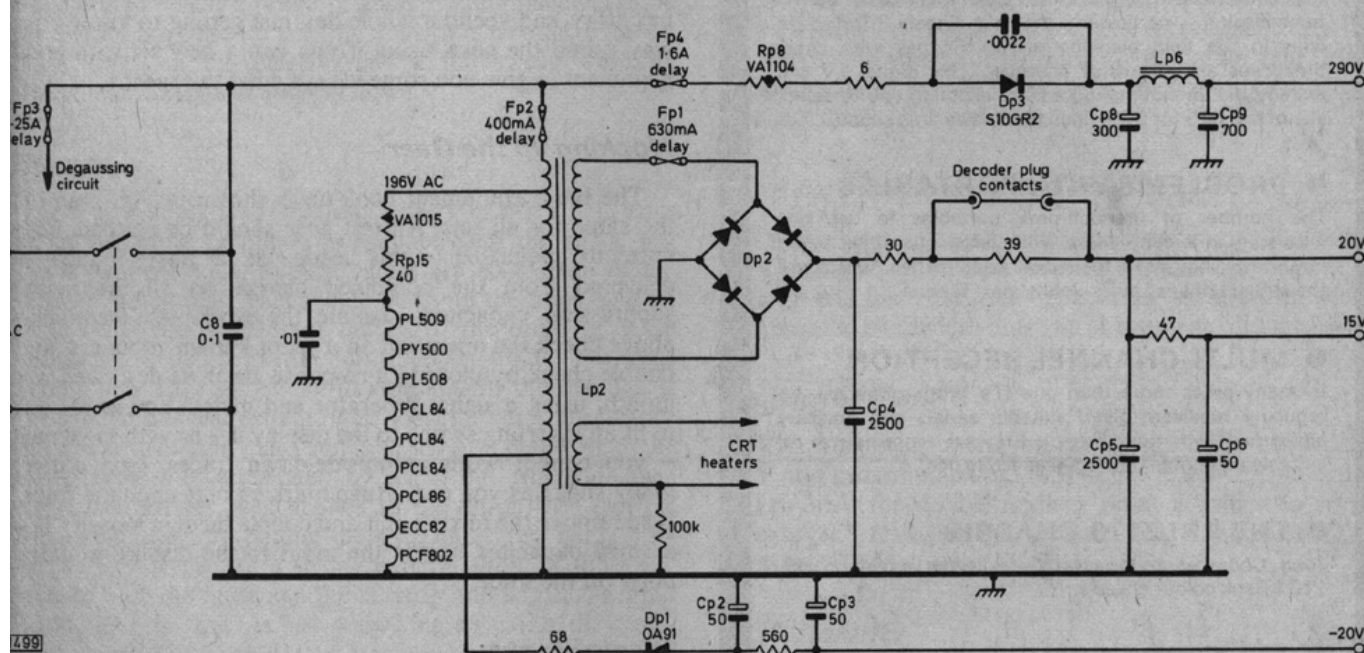
Fig. 6: The power supply circuitry.

The power supply is the last section to be dealt with but is certainly not least in the number of faults it produces! The mains filter capacitor C8 can go short-circuit, sometimes welding the switch contacts together before blowing the plug fuse. Lack of h.t. can be caused by the VA1104 thermistor Rp8 parting company with its lead-out wires. The h.t. rectifier Dp3 (S10GR2) commonly shorts to blow the 1.6A h.t. fuse, and can be replaced with the humbler-sounding BY127.

A strange situation arises when the reservoir capacitor Cp8 goes low capacitance. The efficiency of the following filter Lp6 and Cp9 results in complete absence of hum effects on the picture and sound, but because the average

voltage at the cathode of the h.t. rectifier is lower than the peak mains the h.t. voltage falls to give a low-width effect. A great deal of time can be spent in the line output department before the simple expedient of checking the h.t. voltage leads the harassed technician back to the power unit. The vast can containing the smoothing block is not commonly available, and has to be ordered from the makers.

The l.t. rectifier bridge Dp2 sometimes goes leaky, blowing the 630mA l.t. supply fuse. Dp2 can also go high resistance, with the result that the 15V and 20V l.t. lines drop and the receiver's performance is affected — there can be intermittent colour, brightness troubles and so on. Four 1N4001 diodes in a bridge configuration make a more reliable replacement.
