Hot Pyes

Les Lawry-Johns

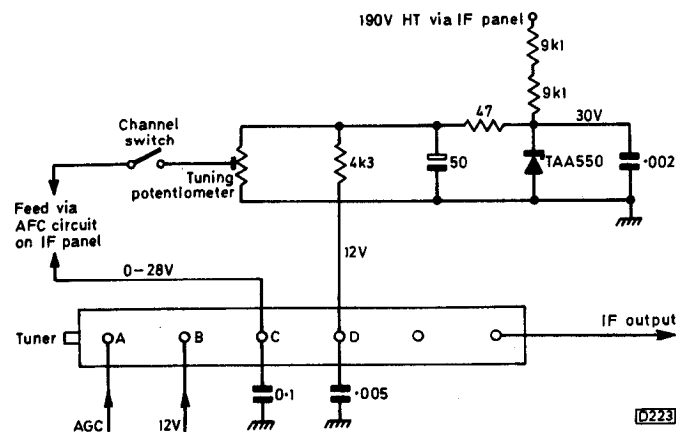
Carry on to next set not too far away. Ekco with the 697 chassis. Varicap tuner. Raster and noise on screen, just as if aerial is disconnected. Aerial is disconnected. Plug in aerial. No change. Check tuning. Suspect loss of h.t. to the two 9.1k Ω resistors on top of the tuning panel (Fig. 1). H.T. present, and just over 30V at the TAA550 zener. Now what?

Remove tuner panel and check voltages. A.G.C. o.k. at A. +12V at B, nothing at C. This is where the tuning voltage should be. Check again and hold tuner steady. Tuning voltage o.k. at around 10V and lots more noise. Reach round and tune in sound and vision. I.F. unit on one knee, tuner on other, very uncomfortable. Let go of tuner. No tuning voltage, no sound only hiss. Move legs. Sharp point on i.f. panel penetrates trousers. Has to be 200V h.t. Move more quickly and wish I were dog in van. Examine tuner more carefully. Intermittent short to earth from tuner

voltage point C when tuner is moved. Take off cover and find tiny piece of wire which had no right to be there.

Fig. 1: Varicap tuner supplies, Pye 693/697 chassis. There are six channel selector switches/tuning potentiometers.
