SERVICING television receivers

L. LAWRY-JOHNS

HYBRID PYE COLOUR CHASSIS

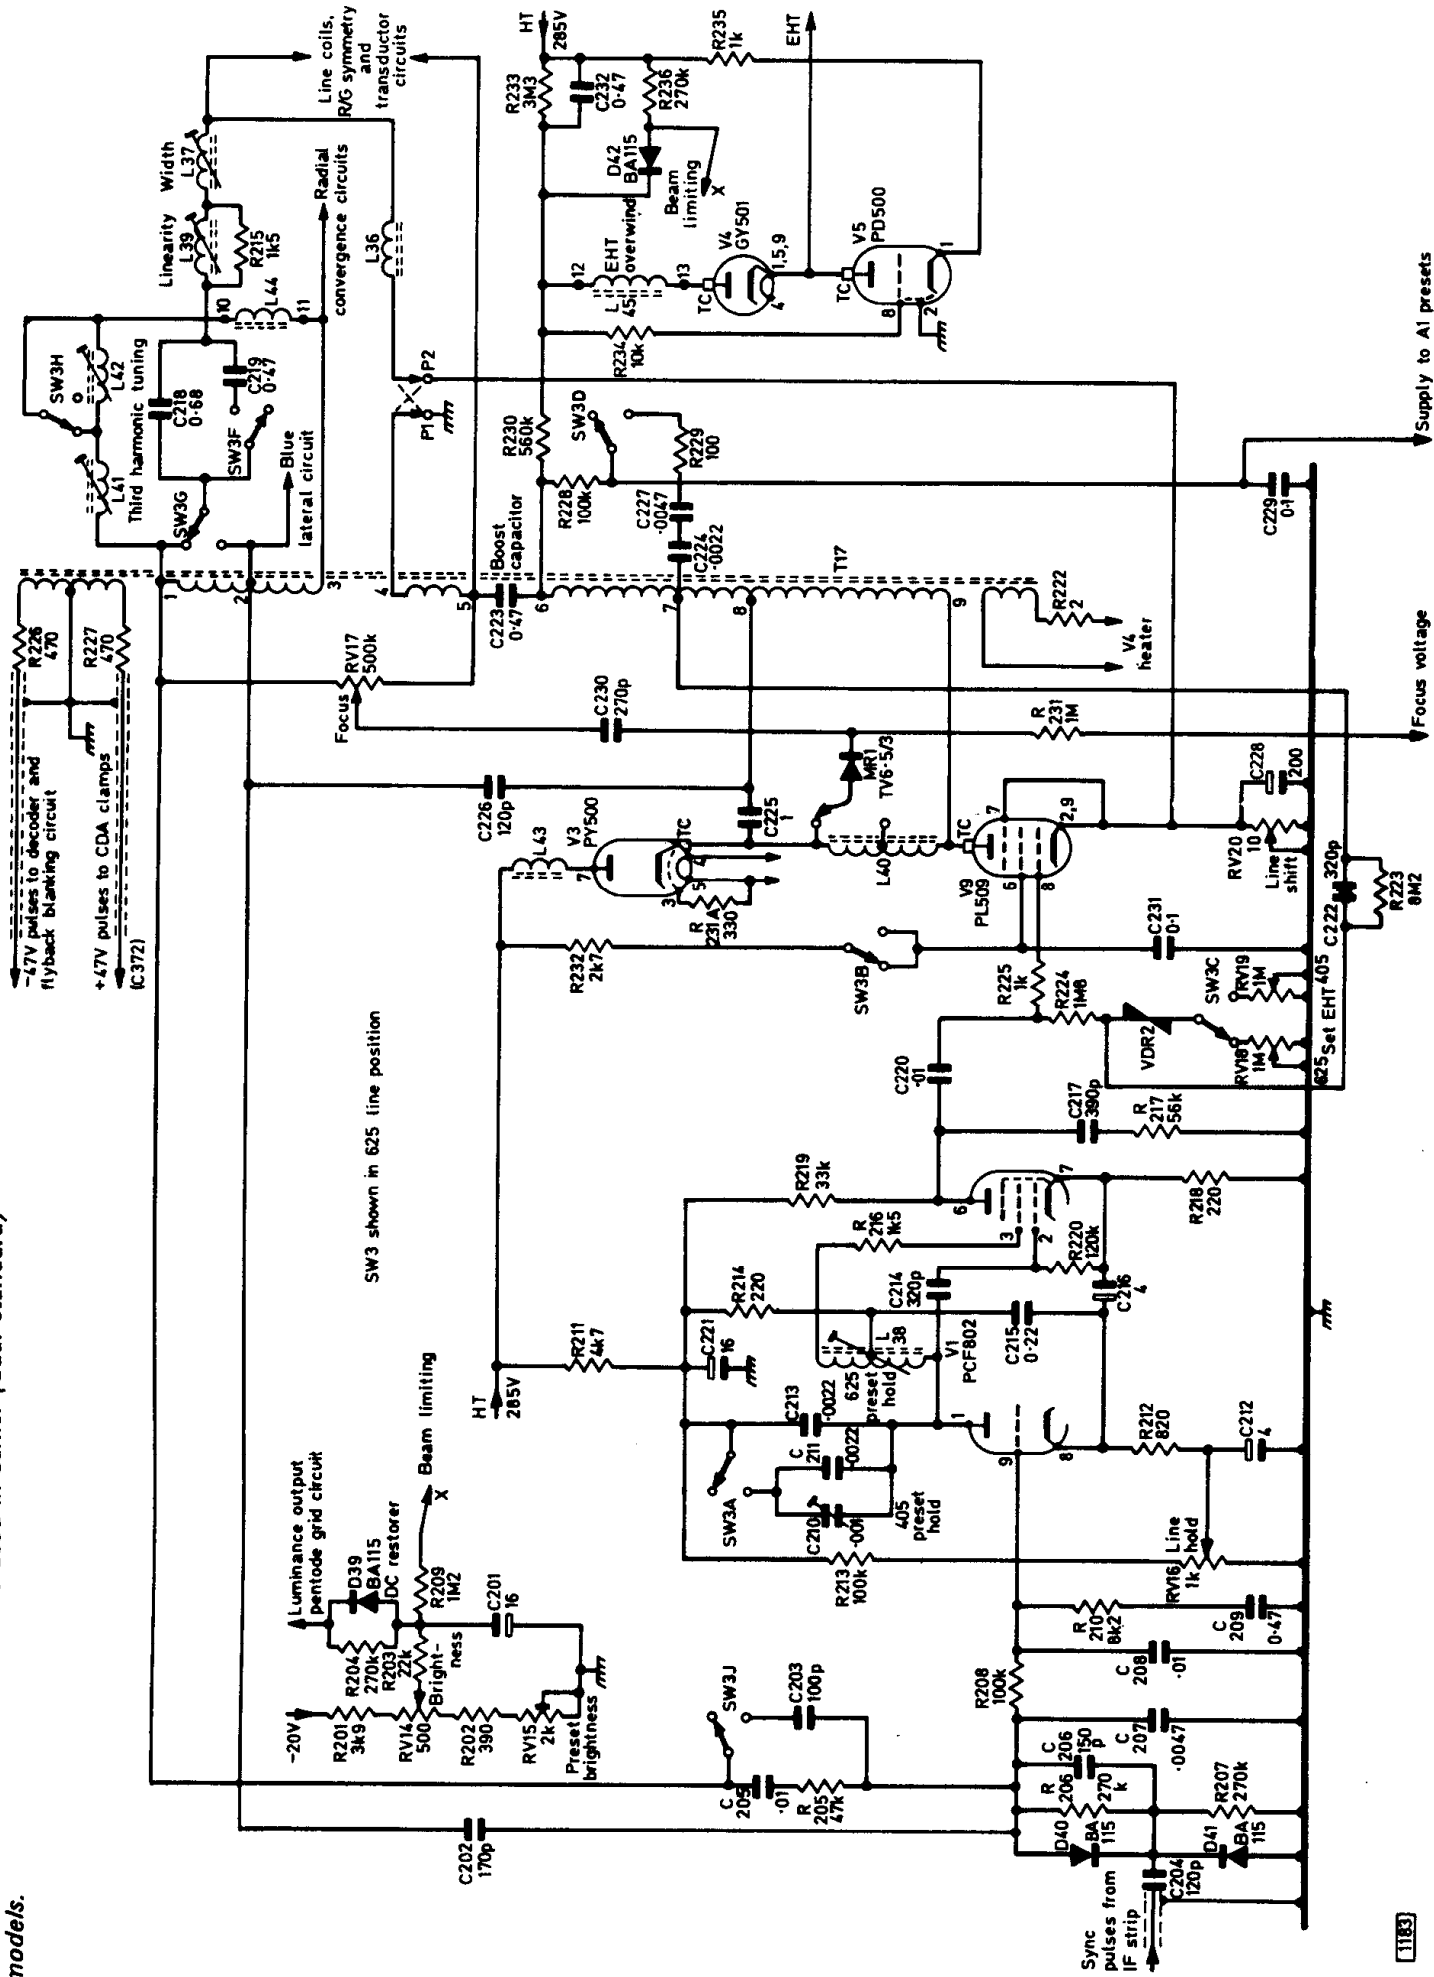
Fig. 1: Circuit of the line timebase used in earlier (dual-standard) models.

A common cause of no e.h.t. is an open-circuit line output valve screen grid feed resistor (R232, 2.7k Ω). You may find that this component is intact electrically but that it has parted company with the panel to which it should be wired. As switching is no longer necessary it can be wired directly from L43 to the PL509 base, leaving the associated decoupling capacitor C231 in its original position.

The line output stage can be killed or less seriously overloaded if C229 which smooths the feed from the boost rail to the c.r.t. first anode potentiometers is defective. If this is found to be the case the associated resistor R228 should also be checked.

In the event of weak line hold first try a new PCF802 line oscillator valve, then check the flywheel line sync discriminator diodes D40, D41 (type BA155 in later versions). Check C221 as mentioned last month. Another thing to check if necessary is the resistor (R205 47k Ω in Fig. 1) in the high-voltage reference pulse feedback path to the discriminator.

Fig. 1) are 3.3k Ω and 1 μ F: it is worth making this change in earlier chassis if the picture is bent over at the top.

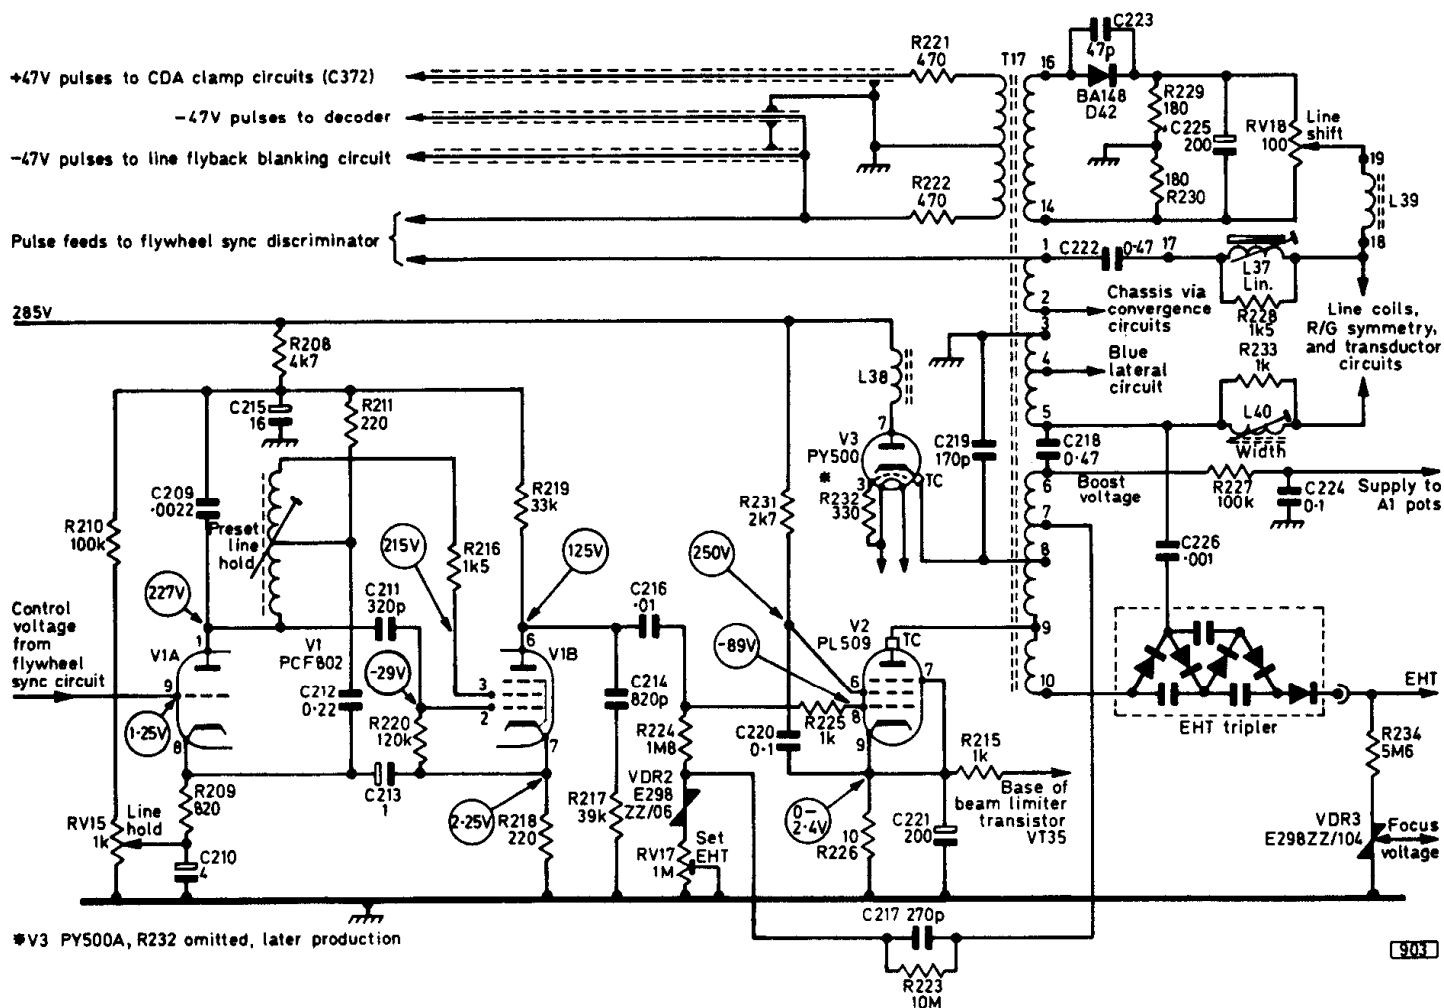
Fig. 2: Line oscillator and output stages used in single-standard chassis. In later production C219 is 180pF and is connected between tags 8 and 1 of T17; RV18 is centre-tapped and R229, R230 are omitted.

problem ourselves, of the fault "line shake" due to C211 and C212 (single-standard chassis component reference numbers) in the line oscillator circuit. It is recommended that these should be replaced using the best polystyrene or polyester types available.

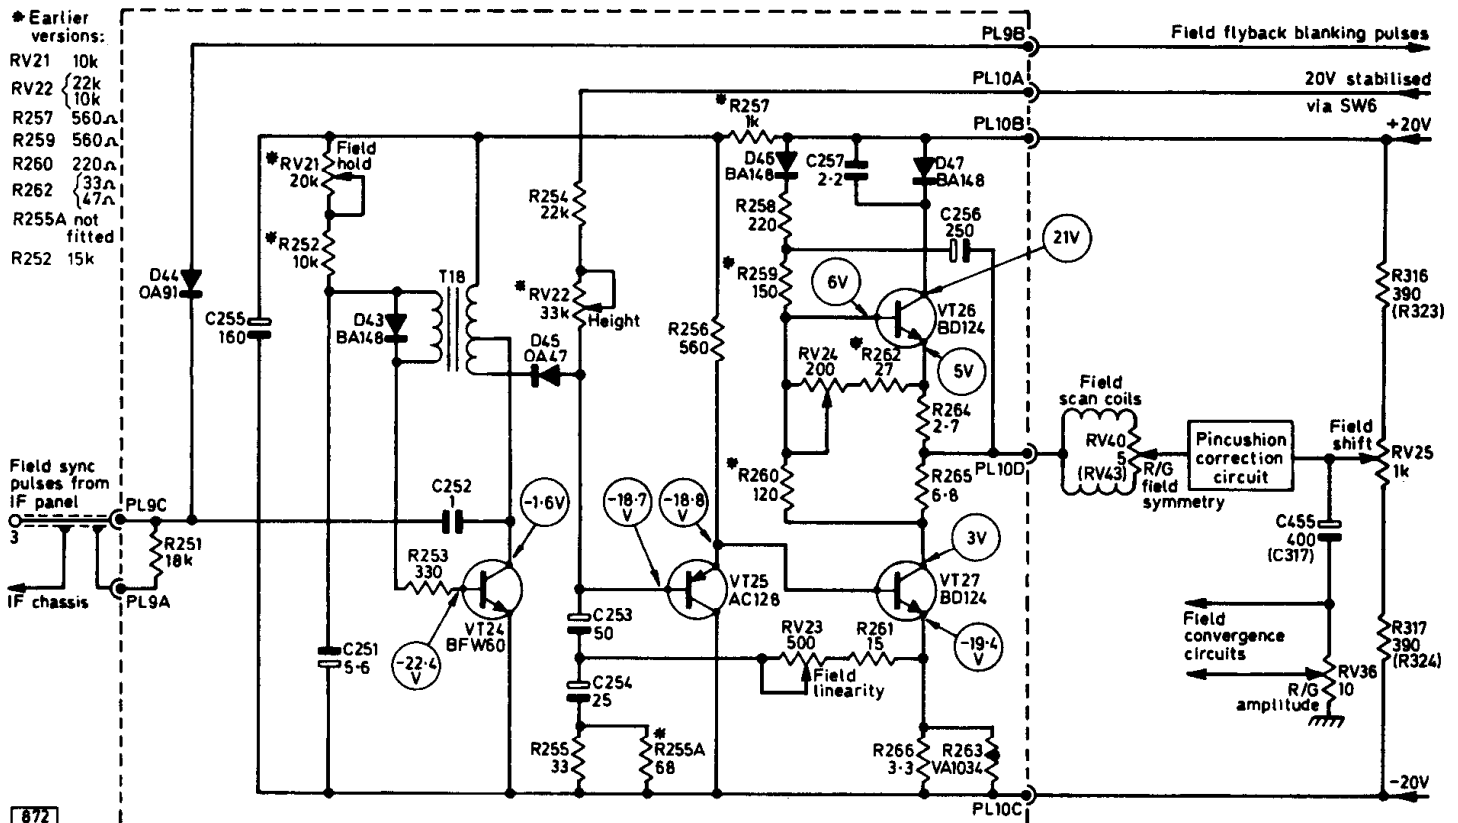
Fig. 4: The field timebase circuit, showing modifications. In the dual-standard version a coil (L49) was incorporated in series with the field shift control slider. Component reference numbers in brackets apply to the dual-standard chassis. For layout see page 261, April 1974.

The first set had a band of about four inches of scan across the lower half of the screen folded up. A meter check on the output transistors showed that they were sharing only 20V and that the 20V positive line was absent, so we said "Ah, must be the bloody edge connector". Having spent some time sorting out which contact was involved we then found the supply absent there as well. The dropper resistor down below was intact so we tediously followed the track up the panel until the voltage was suddenly lost. There visible only

height control was fluctuating. "Bloody zener" we wrongly diagnosed. In fact it turned out to be the 250µF electrolytic (C312) across the zener. It was well nigh open-circuit. When one ponders on this, the zener did do a pretty good job in keeping the voltage as steady as it was.

So there we are: the field timebase panel is more reliable than its power supply. What about the time when one of the output transistors went open-circuit, that wasn't the supply was it? No, but that was a long time ago, about the time when the 160µF smoothing capacitor C255 shorted and collapsed the field. So it doesn't matter what you say, there always seems to be something to jog your memory and prove you wrong. Field hold troubles can be caused by C255 drying up.

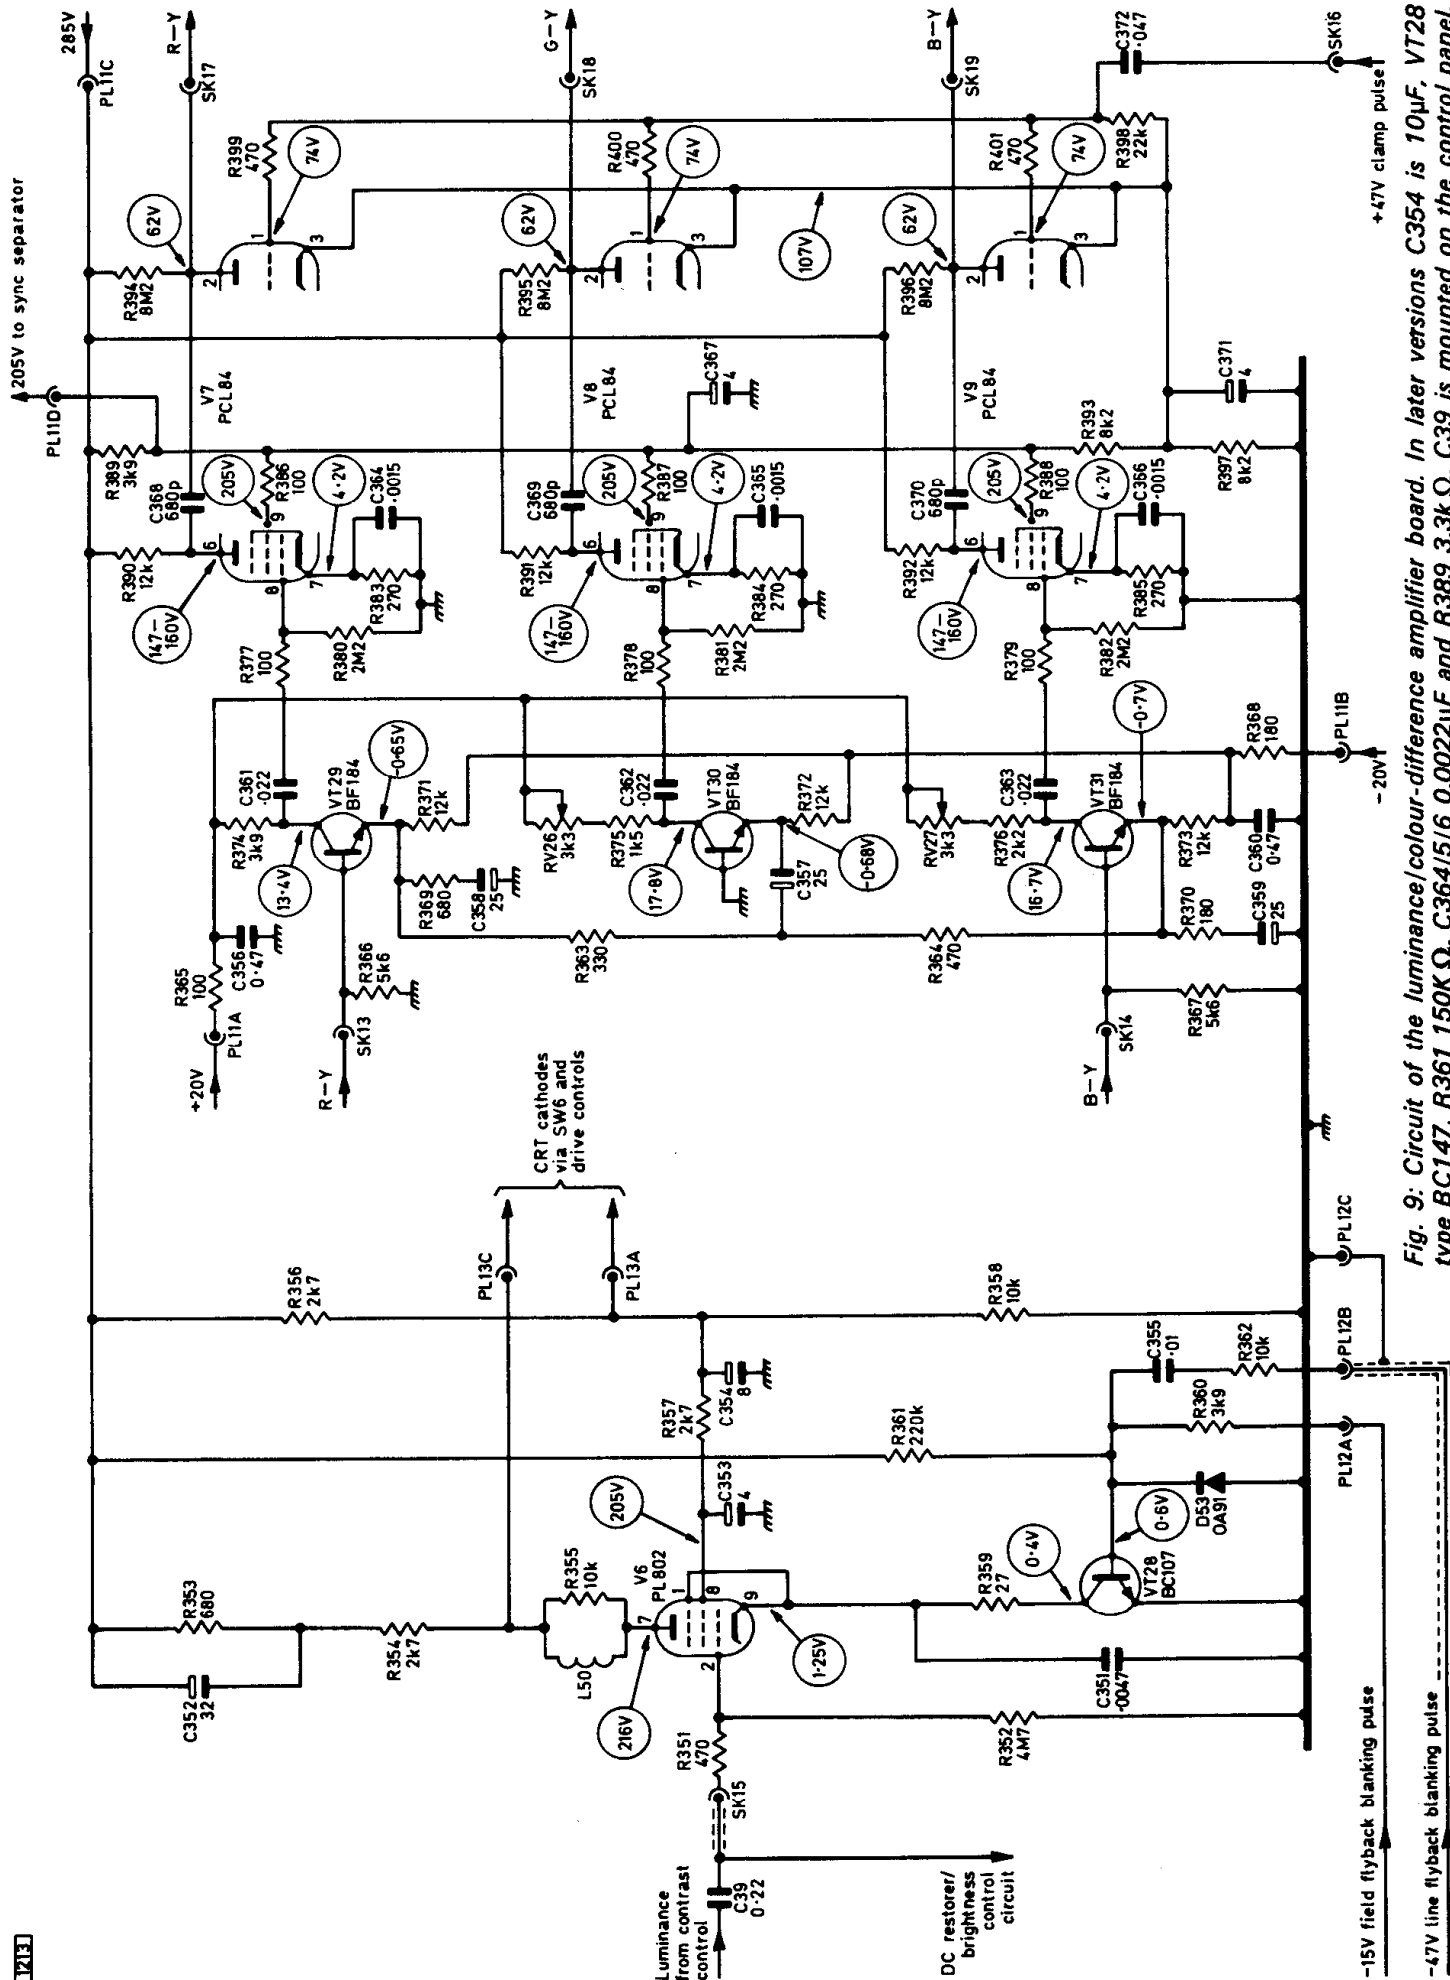
Fig. 9: Circuit of the luminance/color-difference amplifier board. In later versions C354 is 10µF, VT28 type BC147, R361 150kΩ, C364/5/6 0.0022µF and R389 3.3kΩ. C39 is mounted on the control panel.

Loss of sync along with loss of colour occurs when the 3.9k Ω wirewound resistor R389 on the right side of the luminance/colour-difference panel goes open-circuit. This resistor feeds the screen grids of the three PCL84 colour-difference output valves and as we have seen also provides the h.t. for the sync separator circuit. In later models fitted with a varicap tuner it was changed to 3.3k Ω and can spring open for no apparent cause, thereby causing loss of signals since the tuning voltage is derived from this line.

With a 285V supply line the anode voltage of the PL802 (pin 7) should be about 215V with about 1.25V on its cathode (pin 9) and 205V on its screen grid (pin 8). If the valve is not at fault and the screen grid voltage is low check the 4µF capacitor (C353) which decouples it. If the screen grid voltage is high check the PL802's cathode components which include VT28 and D53.

All this is fairly obvious. When on the other hand only one clamp varies, the colour of the picture will change. If for example the picture takes on a magenta hue it is likely that the c.r.t. green grid voltage is low and that R395 has gone high-resistance. If the green PCL84 loses emission on the other hand its anode voltage will rise producing excessive green.

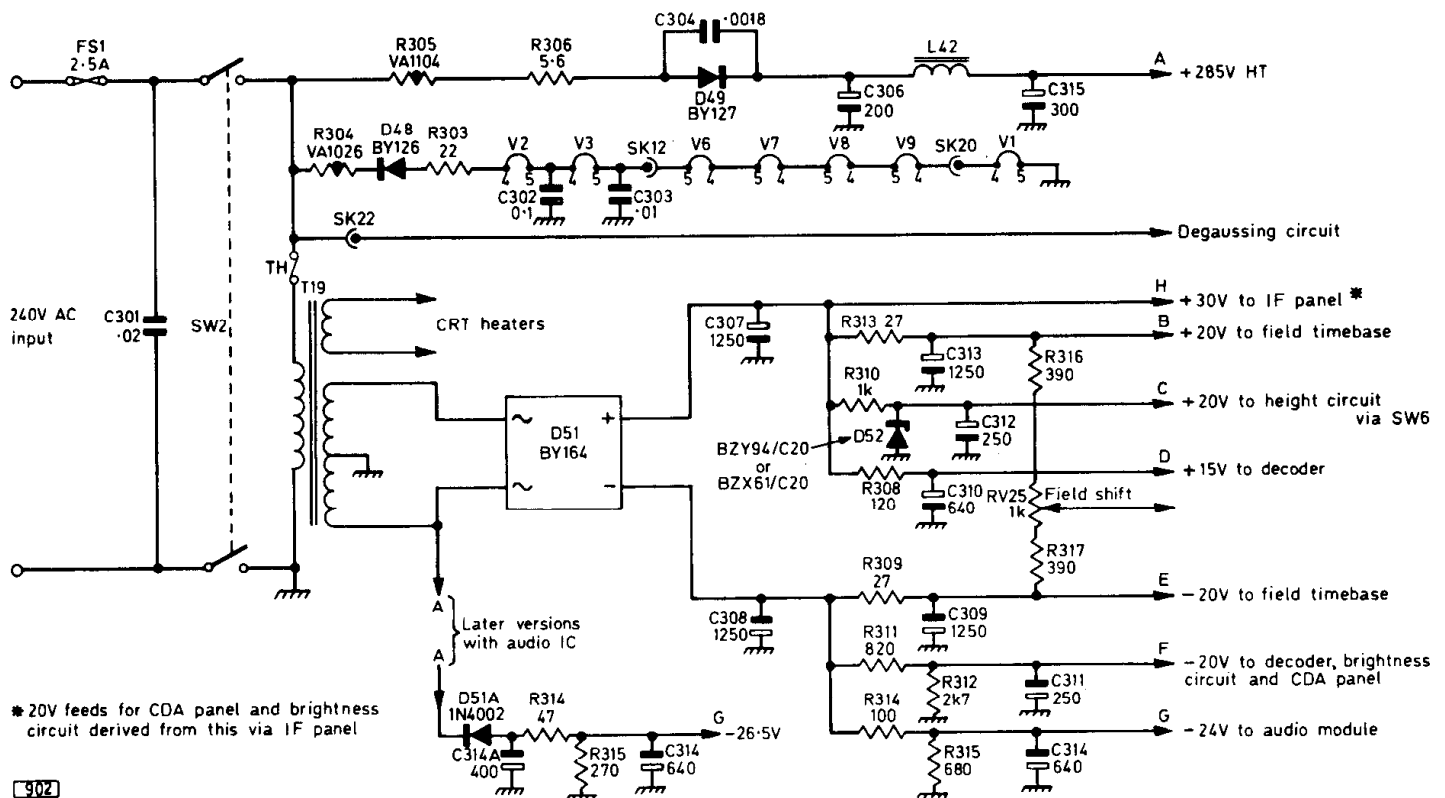
C313 (the 20V positive line smoother). Disconnecting the edge connector did not remove the short so we naturally took it that C313 was short-circuit. It wasn't. Looking closer at the edge of the panel, at the 20V take off point, we found that a lead protruded through and was long enough to have been bent down and soldered to the next contact down! It seemed that this had been done during production, had never been checked and had had the final inspection blue and white card attached, duly signed by two inspectors (well there were a couple of wiggly lines in the spaces where the signatures would normally be put).

Anyway we unsoldered the wire and cut it off short (as it should have been in the first place) and repaired the cut-out which is fitted on the transformer between the tags. The set then behaved itself, and the convergence wasn't far out. We then thought a bit more.
