SERVICING TELEVISION RECEIVERS

PHILIPS G6 CHASSIS

L. LAWRY-JOHNS

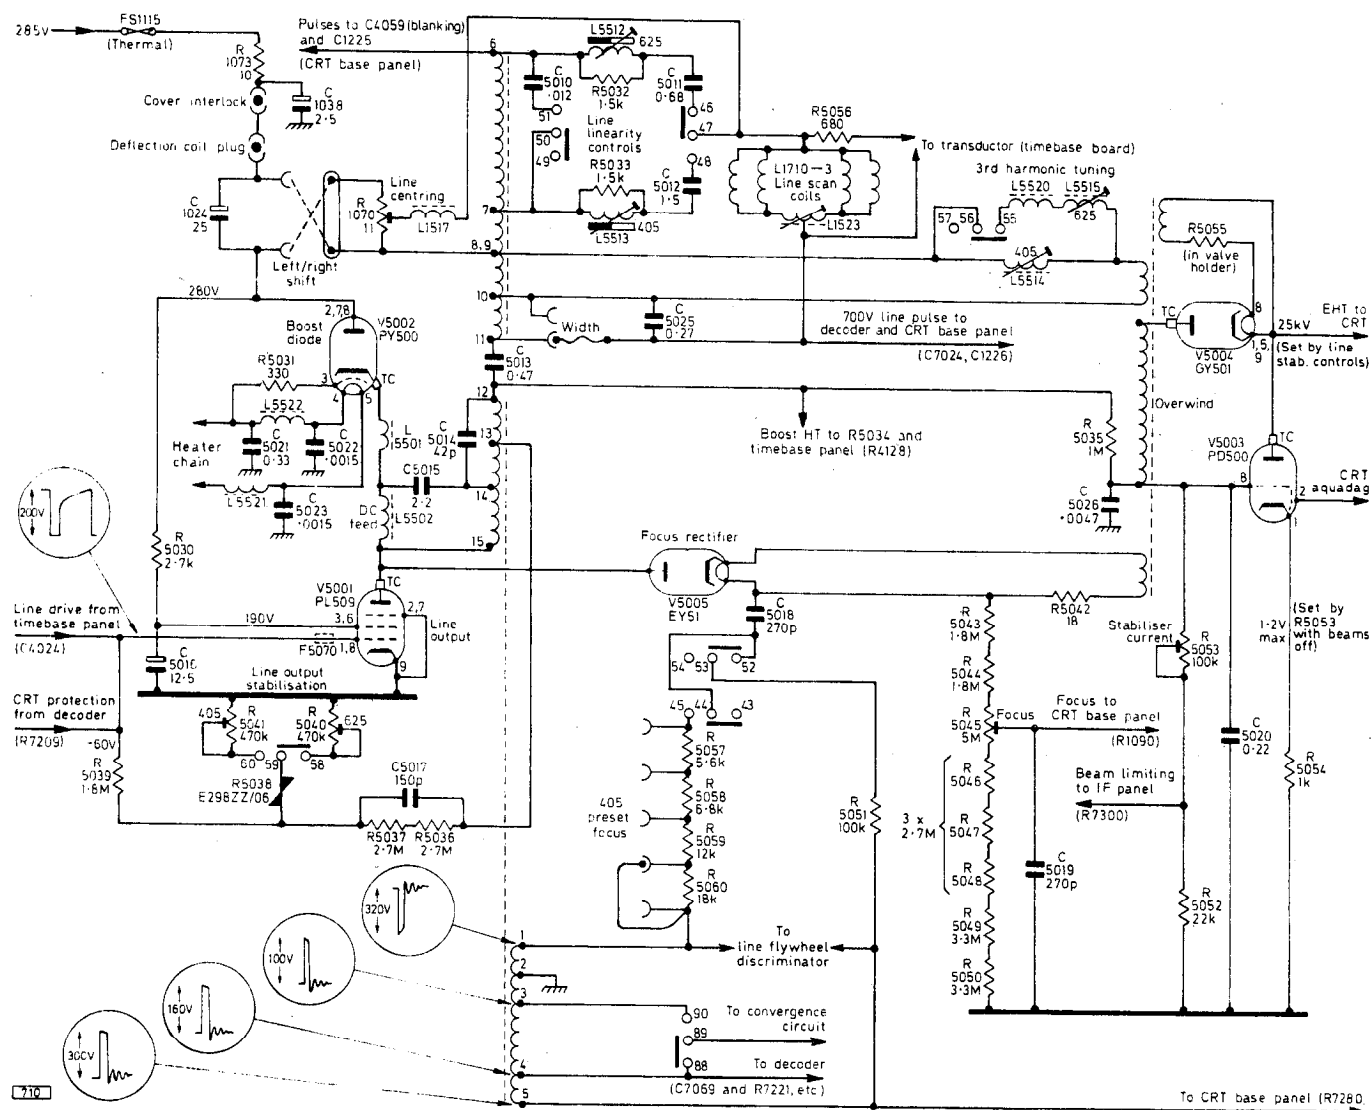
Fig. 1: Line output stage, e.h.t. and focus supply circuit. The system switch is shown in the 625-line position. R5040 and R5041 (line stabilisation controls) are 220k Ω in later versions. C5014 may be 100pF, 20pF or, in later production, omitted: where present it is a good idea to remove it. C1038 and C5026 were not fitted in early models. R1073/FS1115 and C1038 are on the lower chassis (power supply section). R4042 may be wired between V5005 heater and the junction C5018/R5043 and the heater winding on the line output transformer. R5037 and R5036 are 3.3M Ω on single-standard models.

dead although there is h.t. at the PL509 and PY500 top caps suspect the PL509's screen grid feed resistor (R5030, 2.7k Ω) which can go open-circuit at odd times.

Non-operation of the line output stage can also be the result of a shorted boost line capacitor (C5013, 0.47 μ F). As this is returned to the h.t. line there is no overheating when it shorts. Another cause of no e.h.t. is when the d.c. feed coil (L5502) to the anode of the PL509 is defective.

When the valves are not responsible for lack of width, resistors R5036 and R5037 should be checked as they can change value. R5039 is also suspect. Capacitor C5017 can cause fluctuating width and this can be misleading as it tends to suggest poor e.h.t. regulation.

The 1k Ω resistor R5054 is the one on top of the e.h.t. compartment. A meter connected across it will indicate the current drawn by the PD500. The correct reading is 1.2V with the beam switches off. R5053 is set to produce this 1.2V and correct beam limiter operating conditions (the earthy end of R5053 connects to R5052 and also goes back to the i.f. panel where it is connected via R7300 to the beam limiter control R7301). By beam switches we mean the A1 (or G2) switches on the convergence panel. If R5053 is not set correctly the stabilisation won't work properly, with a dull picture, ballooning on advancing the brightness control, etc. The beam limiting system operates via the a.g.c. circuit.

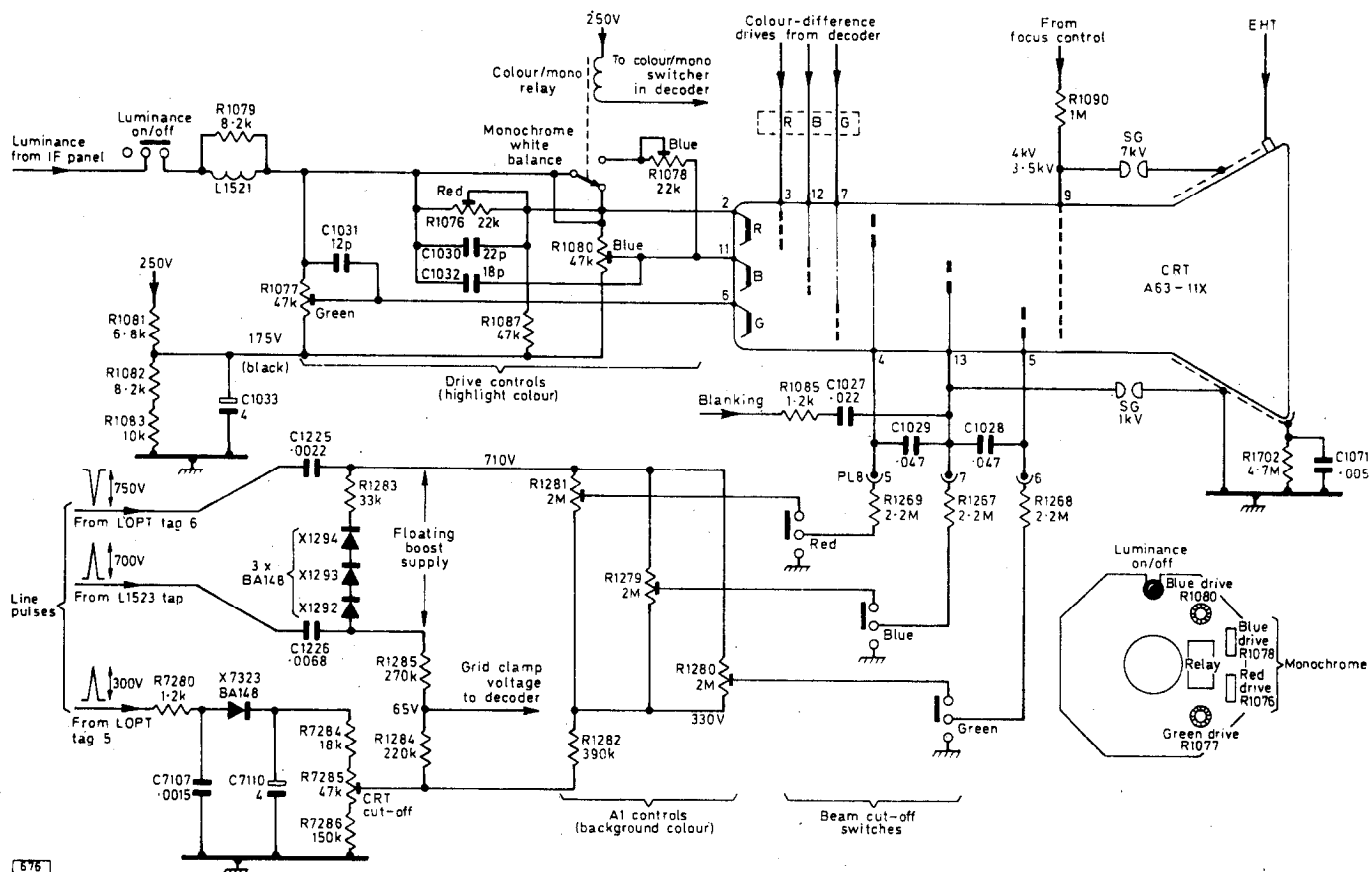
Fig. 2: C.R.T. supply and drive circuits. The first anode presets and switches are mounted on the convergence box. The colour/monochrome relay switch is shown in the colour (relay energised) state – R1076 is shorted out and R1078 is open-circuit in this condition: on monochrome R1076 is brought into circuit to reduce the red drive while R1078 provides increased blue drive. This arrangement was fitted in early production only. In later versions R1282 is 220kΩ, R1284 180kΩ and R7284 is deleted.

there are times when the picture size is right and does not vary. This could well indicate that all is not well around the focus network. Some 4.5kV is required at pin 9 of the c.r.t. base for sharp focus. This is the pin which has the insulation around it to prevent eager little fingers getting burnt.

In these receivers the focus potential is not derived from the e.h.t. system. A separate focus rectifier (EY51) is employed, its anode being connected to the PL509 anode contact on the line output transformer. From its cathode a chain of high-value resistors eventually connects to chassis. The focus control is the third resistor from the cathode. Obviously then if one of the first two resistors changes value, going high, the focus potential available will fall below that required. Focus control adjustment will "take up the slack" at first but the time will arrive for a check on the resistor chain to reveal which of the resistors has departed from the ranks of the righteous. Decomposition of the resistors can occur which can make the focus fluctuate above or below the norm. The control itself is not above suspicion but seems to survive pretty well. If, as happens, one of the resistors on the earthy side of the control goes open-circuit the focus will be poor and adjusting the control will have no effect.

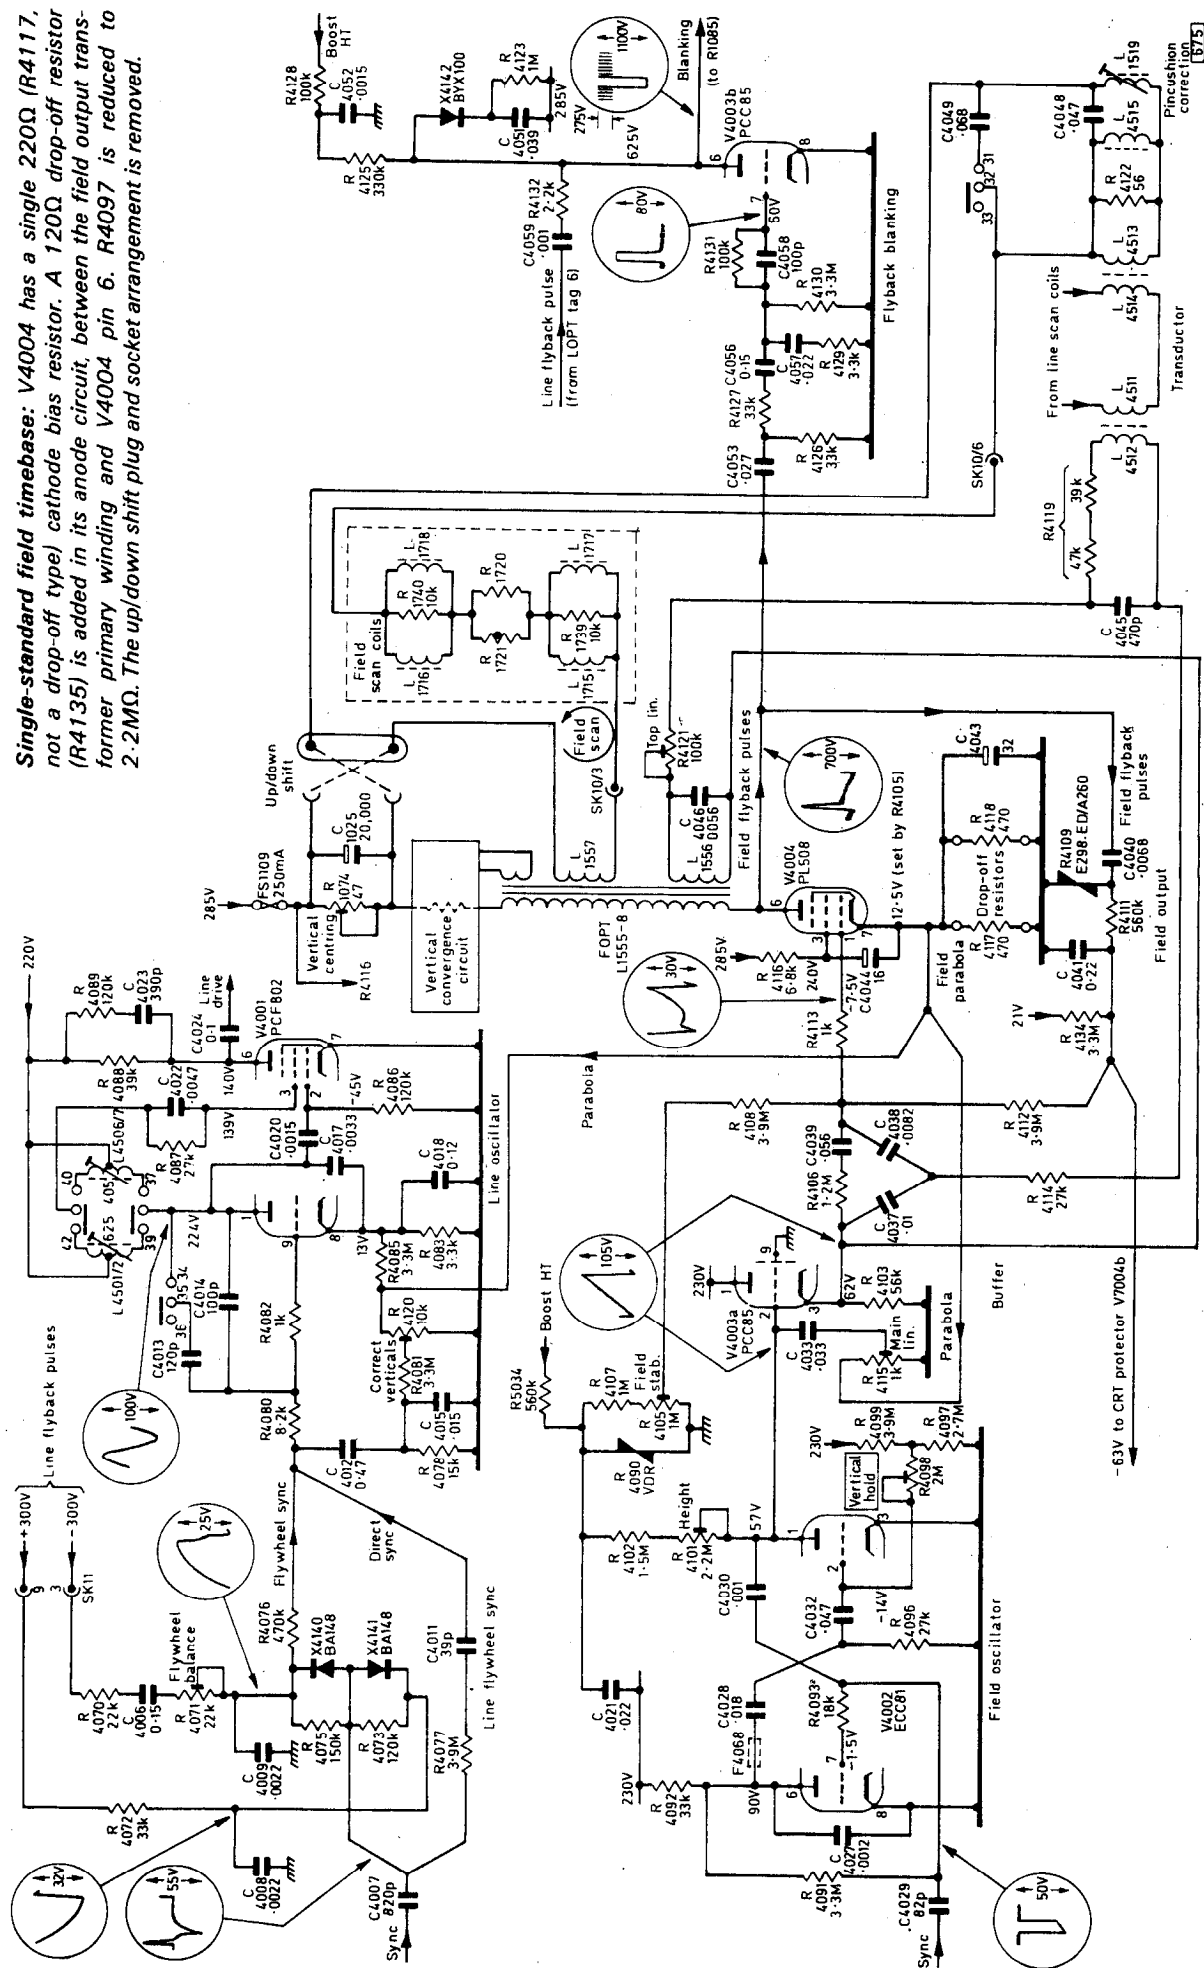
Fig. 3: Circuit diagram of the timebase printed panel, with the 405/625 line switching shown in the 625-line position. In later versions R4075 is 130kΩ and R4134 and the c.r.t. protection circuit are deleted.

When the field hold control has to be adjusted in the same direction until it reaches the end of its travel, resistor R4099 will probably be at fault (going high) but the ECC81 should nevertheless be the first suspect.

common in valve line output stages, and a field output stabilising control (R4105) is provided. Now the trouble with this is that it can be wrongly set without any apparent field scan non-linearity yet nevertheless leaving the PL508 with incorrect bias. Whenever any work is carried out in the field circuit therefore it is necessary to adjust the control – for a voltage of 12.5V at the cathode of the PL508. It should not be assumed from this that the valve is without the normal cathode resistor(s). From the cathode to chassis there are usually two cathode bias resistors, of 470Ω each. There are also two controls, one of 1kΩ (R4115) and one of 10kΩ (R4120). If the PL508 develops internal leakage between its cathode and grid the resultant heavy cathode current can overheat the 470Ω resistors so that one or both drop off their tags. If both drop off the 1kΩ control is left and develops a high voltage across it. This overstrains the decoupling electrolytic C4043 which can pop off and make a mess. Thus one thing leads to another and the drill is to fit a new PL508 and, having replaced the capacitor and resistors, set up the stabilising control R4105 as outlined above.

Bottom compression can be caused by the cathode electrolytic C4043 or the screen decoupler C4044 drying up. Whilst the former is a natural suspect the latter is often overlooked, as are the h.t. electrolytics, when compression of the lower part of the raster is being investigated. Note that the two cathode bias resistors of 470Ω each were later replaced by one 220Ω resistor (R4117).

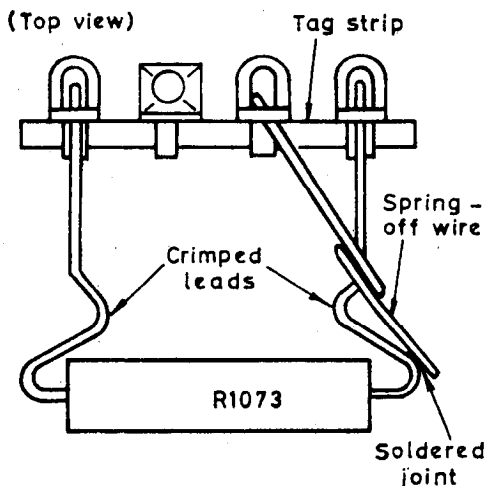
The other trouble spot has already been mentioned. This is the 10 Ω resistor on the left side supplying the line output stage. Whilst it can go open-circuit on its own account, more often it parts company with its mounting springs due to overheating. This of course directs attention to the right side line output stage.

Fig. 9: The spring-resistor assembly R1073/FS1115 which is mounted on a tagstrip near the mains transformer and is included to protect the valves in the line output stage in the event of certain fault conditions. To reconnect, the spring-off wire must be soldered to the outside of the bend in the resistor's leadout wire, using ordinary 60/40 resin-cored solder. If it is necessary to replace either the resistor or the spring-off wire, the new parts must be carefully fitted as shown above. Slip the bent end of the spring-off through the second tag from one end of the strip, then turn it approximately 45° to the strip before soldering it to the outside of the crimped part of the resistor's leadout wire.

After a few checks we found that resistor R1073 was off its spring mount and that this had been caused by a defective PY500. We fitted a nice new PY500 plus a PL509 for good

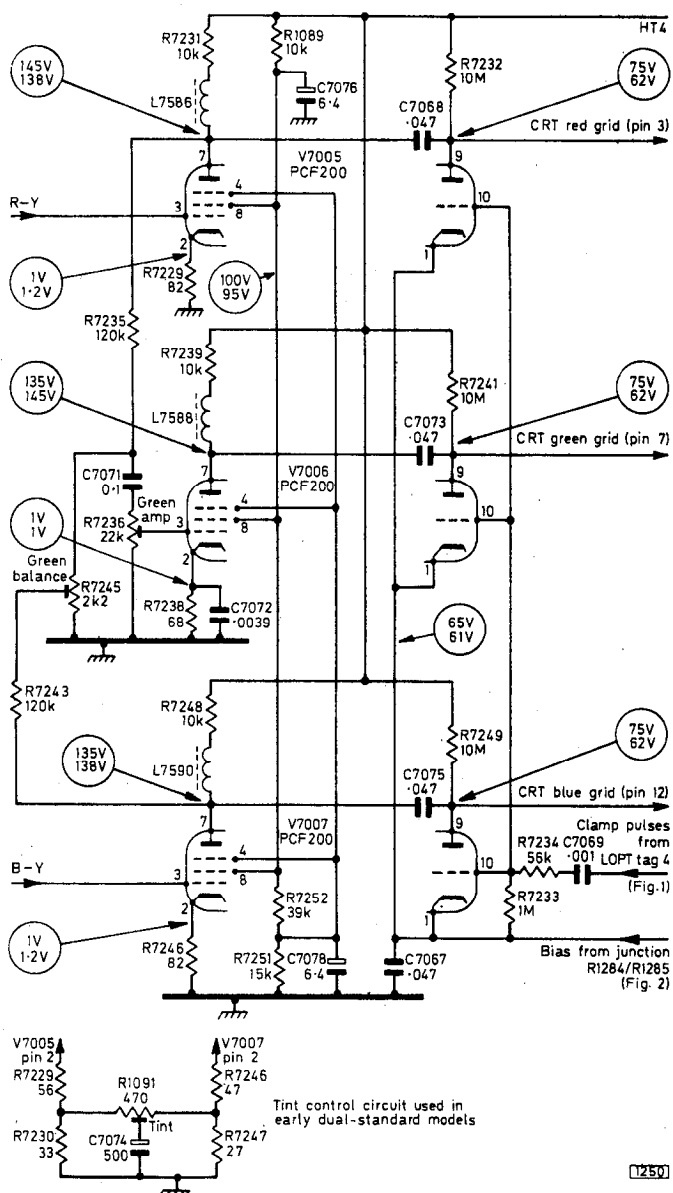
Occasionally one encounters intermittent colour faults due to the coupling capacitors in these stages.

Fig. 10: The colour-difference output stage/clamp circuits. The upper voltages shown apply to the dual-standard chassis (measured on 625 lines), the lower voltages to the single-standard chassis.

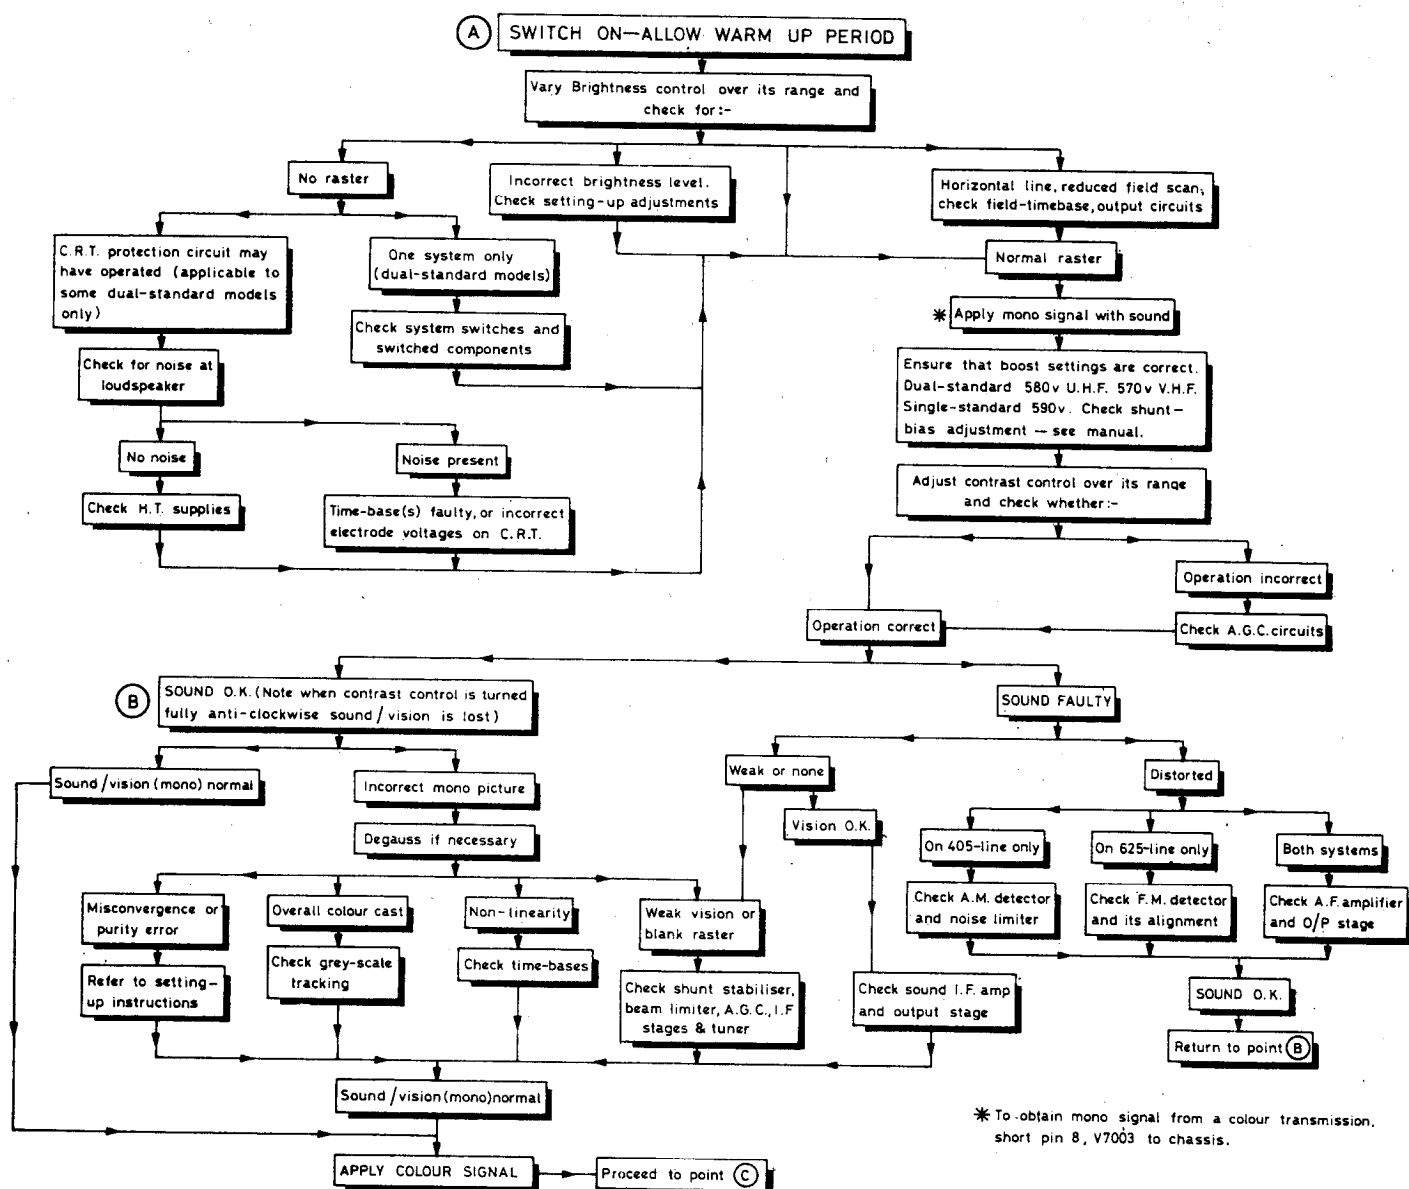
G6 Fault Location Guide

In the event of suspected trouble in the decoder the Philips G6 *Fault Location Guide* can be consulted. This will unerringly lead to the stage where the fault is, all that then remains to do being to check a limited number of components to ascertain which is causing the trouble. We have used this plan for some years and find it invaluable from every point of view, not the least of which being that it saves the writer thinking too hard, something he doesn't do very often.
