Servicing Telpro Colour Receivers

Barry F. Pamplin

TELPRO colour TV sets, marketed under the Carnival emblem, were manufactured at Kearsley, Lancs., initially by the Telpro company, a subsidiary of the rental firm Telefusion Ltd., and later, when the factory changed hands, by ITT Ltd. There were three models, the 20in. Model C501, the 22in. Model C561 and the 26in. Model C671.

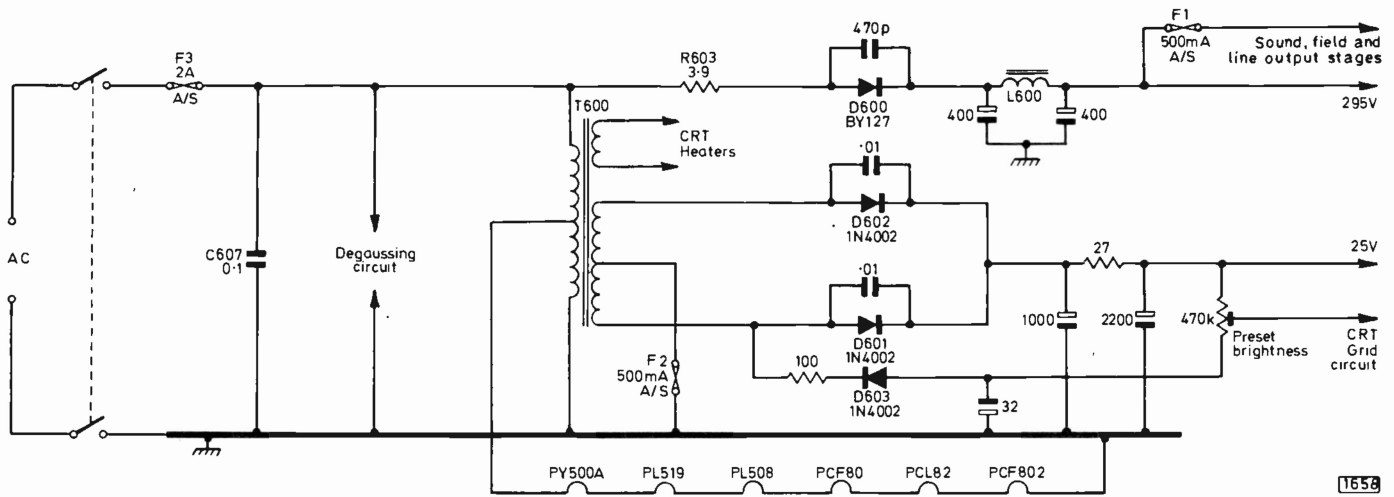
Fig. 1: Circuit diagram of the power supplies.

The tendency exhibited by the Decca chassis for intermittent fuse blowing occurs with equal regularity in the Telpro sets. The 500mA h.t. line fuse F1, which is mounted on the power supply/sound panel, is frequently ruptured by flashovers in the PL519, the PY500 and the c.r.t. The understandable tendency simply to fit a "fatter" fuse should be resisted. Nine times out of ten one gets away with it, but in the tenth case the line output transformer really does get alight with expensive damage to the adjacent cable forms.

Rupturing of the 2A mains fuse F3 is nearly always caused by the h.t. rectifier diode D600 (BY127) being damaged by transients created by the on/off switch. Very often its series 3.9 Ω resistor R603 goes open-circuit as well. On unmodified sets this failure happens very frequently: the way to prevent recalls is to fit a VA1005 thermistor in series with the resistor.

The most satisfactory solution to the problem is to

remove the fuse altogether and to replace it with a fusible 10 Ω resistor rated at about 5W. This will open up in the event of a "solid" fault occurring, but the thermal inertia will avoid spurious failure due to flashovers and the like.

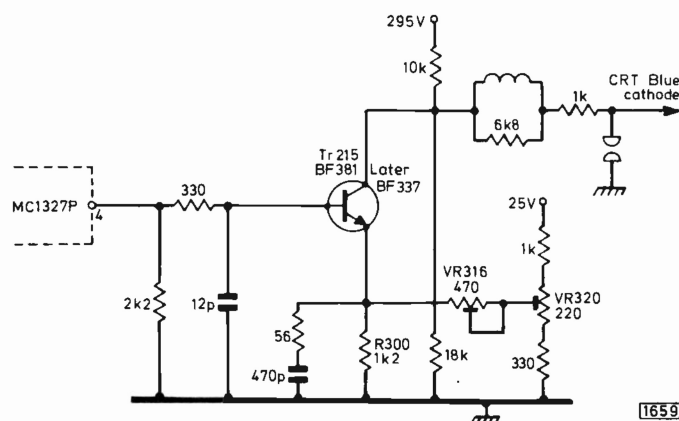
Fig. 2: One of the RGB output stages.

Loss or excess of one colour is usually due to one of the two small preset controls associated with each output transistor becoming defective. The effect is usually intermittent, and when tracking it down it's important to get the viewer to observe what happens to the monochrome picture when the fault occurs. If the viewer tells you that the picture keeps flicking to purple, for example, then the remedy is to change the two presets associated with the green channel.

Early production panels had output transistors with flat heatsinks. These are not reliable and should be replaced with BF337s with circular corrugated heatsinks.
