Servicing the Rank A823 Colour Chassis

Part 1

R. W. Thomson

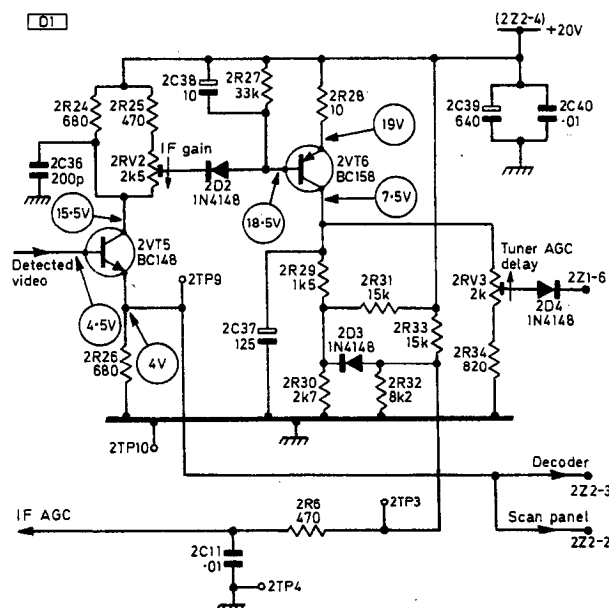
Fig. 1: The luminance emitter-follower and a.g.c. circuits. The 20V supply to the i.f. strip comes in via plug/socket 222-4. 2Z1-6 feeds an a.g.c. bias to the tuner unit. The collector voltage of 2VT5 depends on the setting of 2RV2 while the collector voltage of 2VT6 depends on the setting of 2RV3. Later 2R30 1kΩ, 2R31 6.8kΩ, 2R34 1.5kΩ.

Faults are not common on the A809 i.f. panel. There are some regulars however. Poor field sync for example is commonly due to a dud 2C37 in the a.g.c. circuit. The same capacitor can be responsible for a.g.c. flutter, this time due to excessive capacitance: reduce its value from 125μF to 25μF. Low gain but with clean pictures and good sound and 2.2V a.g.c. bias at 2TP3 is due to 2C13 being defective: this 0.01μF decoupling capacitor is in the collector circuit of the first i.f. stage, in can J. The a.g.c. reservoir capacitor 2C38 can dry up to cause overloading (negative picture). The latter fault can also be caused by 2VT6 of course.

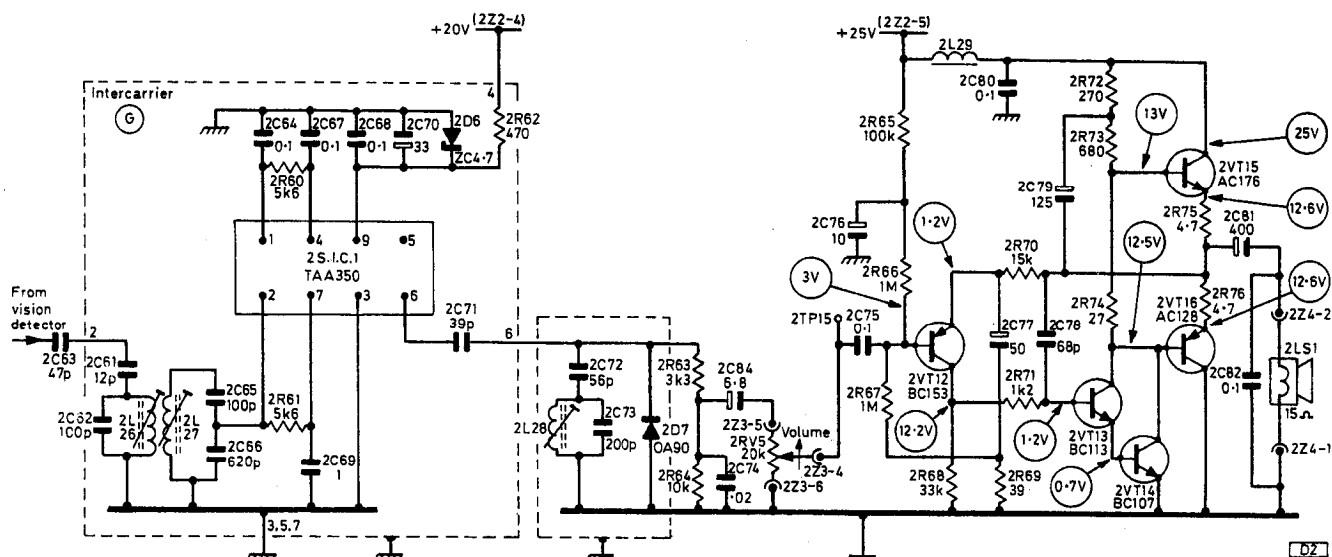
Fig. 2: The sound circuits. In later versions 2D6 was omitted and 2R62 increased to 680Ω. 2C65 changed to 120pF.

No sound with loud hum is usually either the audio output transistors 2VT15/16 (which can also be responsible for low, distorted sound) or a dud TAA350 i.c. Less common causes of no sound are the driver transistors 2VT13/14, the slope detector diode 2D7 or the electrolytic coupler 2C84. The TAA350 can also be responsible for buzz and distorted sound.

Severe crackling on sound is nearly always due to 2C64/67/68/69 on the A809 panel, but it should be borne in mind that as the type of capacitor used in these positions is of the semiconductor (barrier-layer) type, resistance tests are not conclusive, replacement being the only reliable method of testing.

If instability occurs after replacement, fit a 1μF electrolytic in place of the existing 2C69. This should have a minimum working rating of 30V. On later receivers, 2C64/67/68 were all changed to 0.05μF.

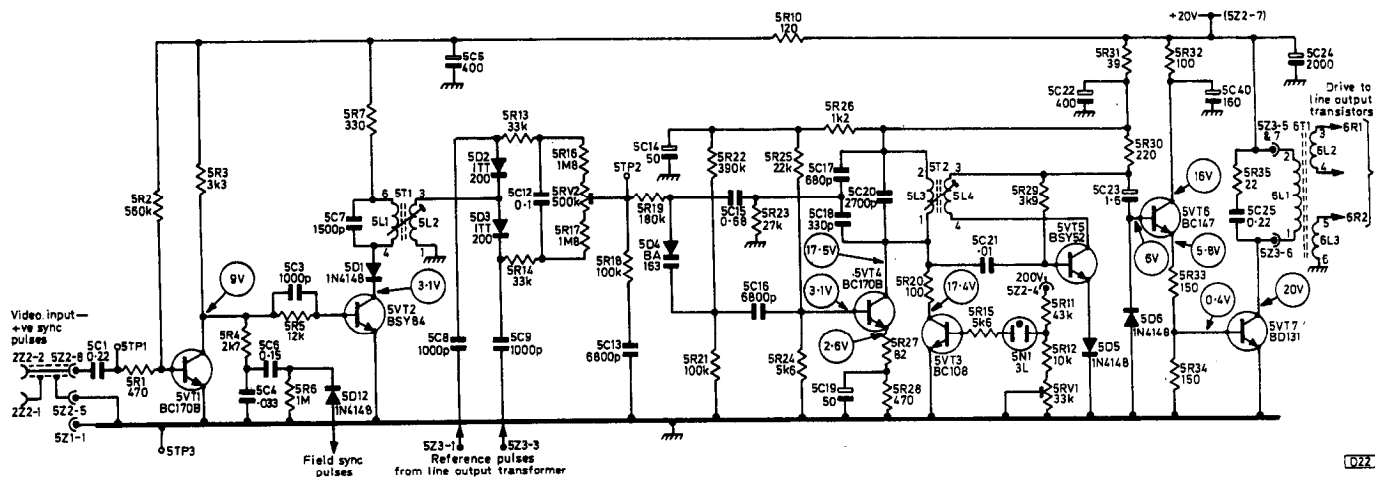
The capacitors in this area can be troublesome. 5C14, 5C20, 5C21 and 5C23 have all been found responsible for no e.h.t. Intermittent loss of e.h.t. has been traced to 5C7, 5C17 and 5C18 – also 5D6, which can be checked with freezer. Loss of line sync can be caused by 5C14, 5C20 (also check whether it's dry-jointed), 5C21 and 5C23; also the flywheel sync discriminator diodes, usually 5D2. Intermittent loss of sync can be 5C17/18 or the line oscillator coil (5T2) former warping. Intermittent line jitter can be 5C17/18 again. Finally 5C22 can be responsible for bent verticals, maybe intermittent.

Fig. 4: Sync separator and line generator circuits. See Fig. 7 for modifications. 5TP4 (not shown) is a chassis connection.

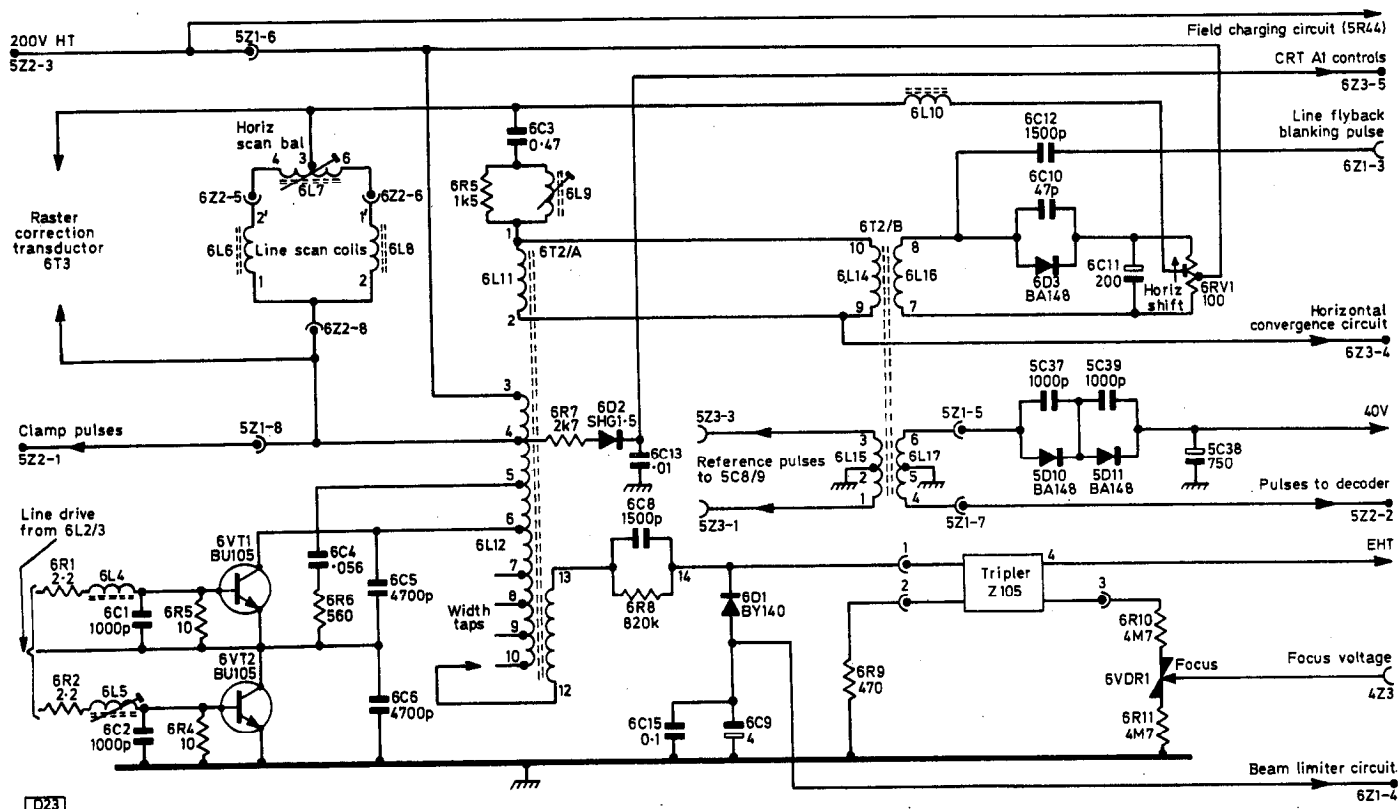
Fig. 5: Line output stage circuit. See Fig. 7 for modifications.

In addition to the line output transistors going short-circuit, several other components in the line output stage can cause the h.t. fuse 8F3 to blow. One is the tuning capacitors (6C5/6) previously mentioned, another is the c.r.t. first anode supply rectifier 6D2 and/or its reservoir capacitor 6C13 (in either case 6R7 will probably be burnt). Other causes are the horizontal shift circuit rectifier diode 6D3 and its reservoir capacitor 6C11, the scan-correction capacitor 6C3, shorting turns in the pincushion distortion correction transducer 6T3 (which may smoke!), and, not so common, short-circuit scan coils.

The old fault of striations across the screen is due to the usual cause — the linearity coil damping resistor, in this case 6R5. The striations are usually down the left-hand side of the screen only.

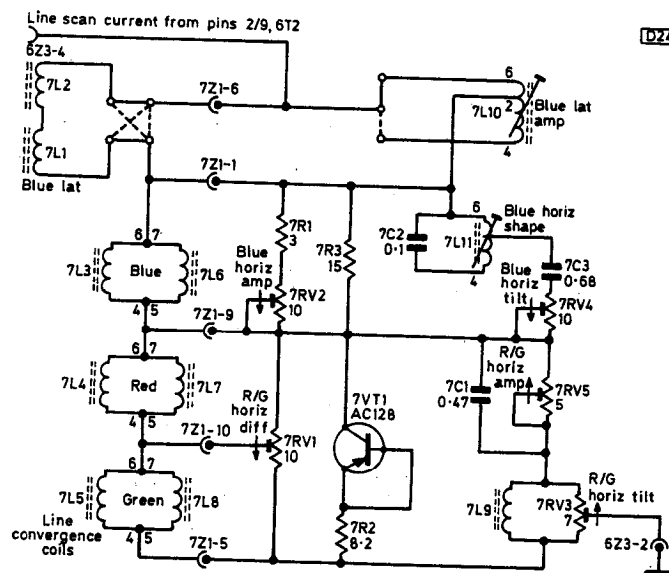
Fig. 6: Horizontal convergence circuit.

A not uncommon fault is a narrow picture (may be about 2in. wide), with smoke from the convergence board. The cause is the R/G horizontal tilt control 7RV3 on this board burning up — the line scan current returns to chassis via this control.

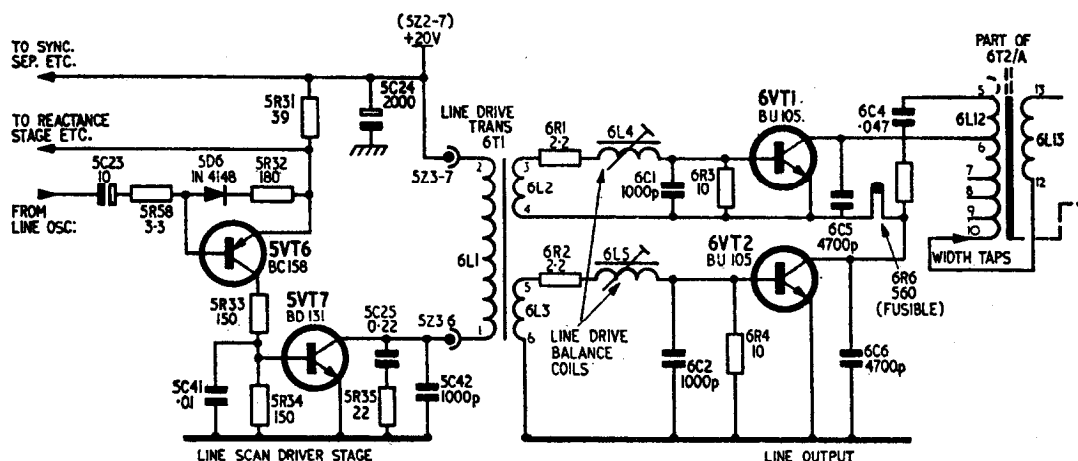
Fig. 7: Line driver and output stage modifications. In addition, 5R20 replaced by a 1N4148 diode, 5C43 (390pF) added from 5VT1 base to chassis, 6C9 changed to 5µF and 6D1 to type BY182, and 6L25 added between 6L17 pin 6 and 5Z1-5.

- (1) Switch off, remove fuse 8F1 and fit an additional 390k Ω resistor in parallel with 8R9.
- (2) Switch on and reduce the h.t. to approximately 100V by means of 8RV1.
- (3) Switch off, replace 8F1 and set the cores of 6L4 and 6L5 to be flush with the top ends of their formers. Connect a meter on the 250V a.c. range across 6R6.
- (4) Switch on and rotate the core of 6L5 clockwise, by no more than three turns, for minimum reading on the meter (after three turns the reading will not change due to the coil inductance being at maximum). If the adjustment results in an increased reading on the meter, return the core to the flush position and then rotate the core of 6L4 inwards. When the minimum reading has been obtained with either

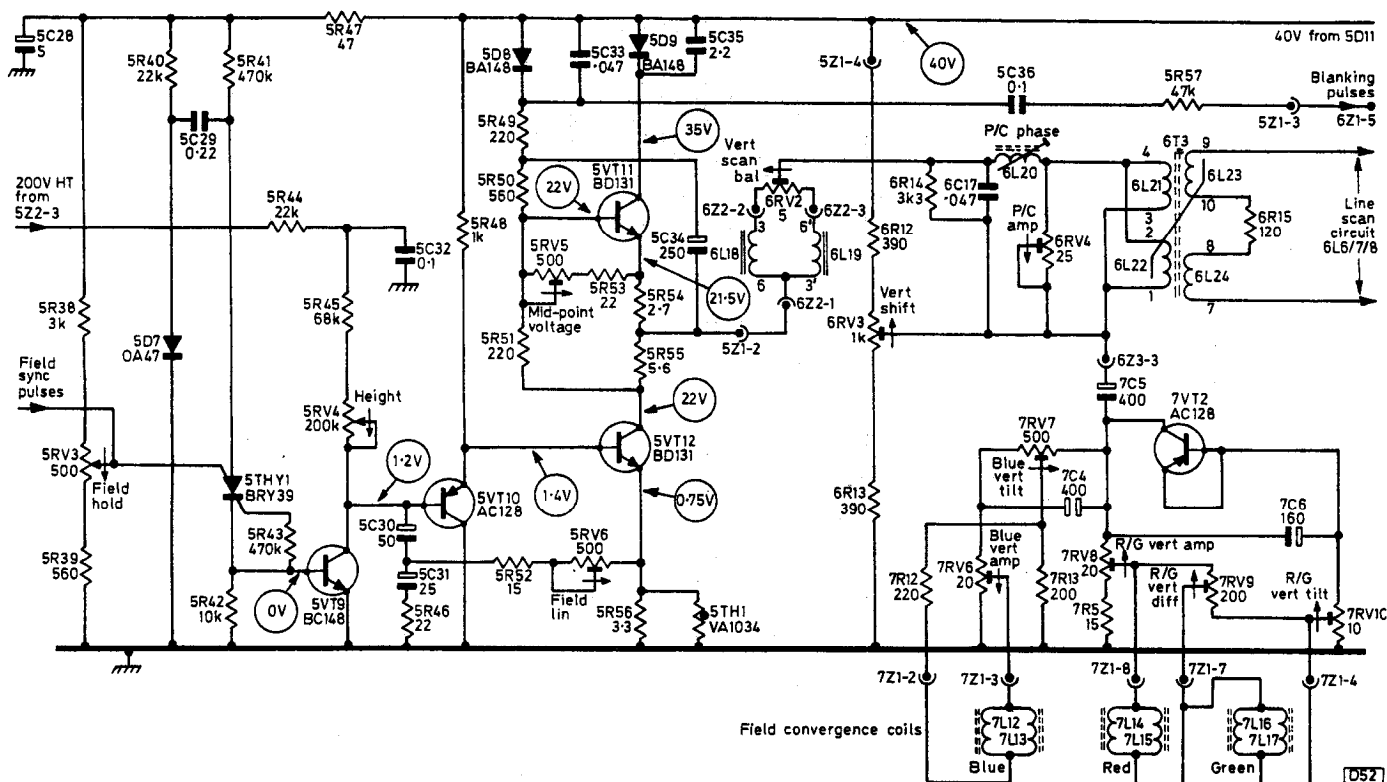
Most troubles in the field timebase are caused by the same few components. Field bounce, judder, poor lock and/or height fluctuations are nearly always eradicated if the field charging capacitors 5C30/31 and the output bootstrap capacitor 5C34 are replaced as a matter of course, although judder can be due to faults in the power supplies (see later). As mentioned in the first part, 2C37 on the i.f. panel can be responsible for poor locking: another possibility here is 5C5 (400 μ F) which decouples the supply to the sync separator. Field collapse is usually due to the BD131 transistors in the output stage, though absence of the 40V supply is occasionally responsible. Intermittent loss of field scan can generally be eliminated by resoldering the connections to 6L20 or replacing 6RV4 – these components are in the pincushion distortion correction circuit on the scan control panel.

Lack of height can be due to leakage in 5VT10/11/12, 6RV4 having a defective track, 5C30/31 drying up or, occasionally, the scan coils. Check that the 40V line is not low. Another fault which has been traced to the scan coils is very intermittent (every few hours) field bounce.

Fig. 8: The field timebase, vertical convergence and pincushion distortion correction circuits. Modifications: 5R46 later 18Ω, 6C18 0.1μF added between 6Z2-1 and chassis, 5D13 1N4148 added between the base and emitter of 5VT10, with its cathode to 5VT10's emitter, 5VT11/12 later changed to type 2N5496. See also Fig. 11.

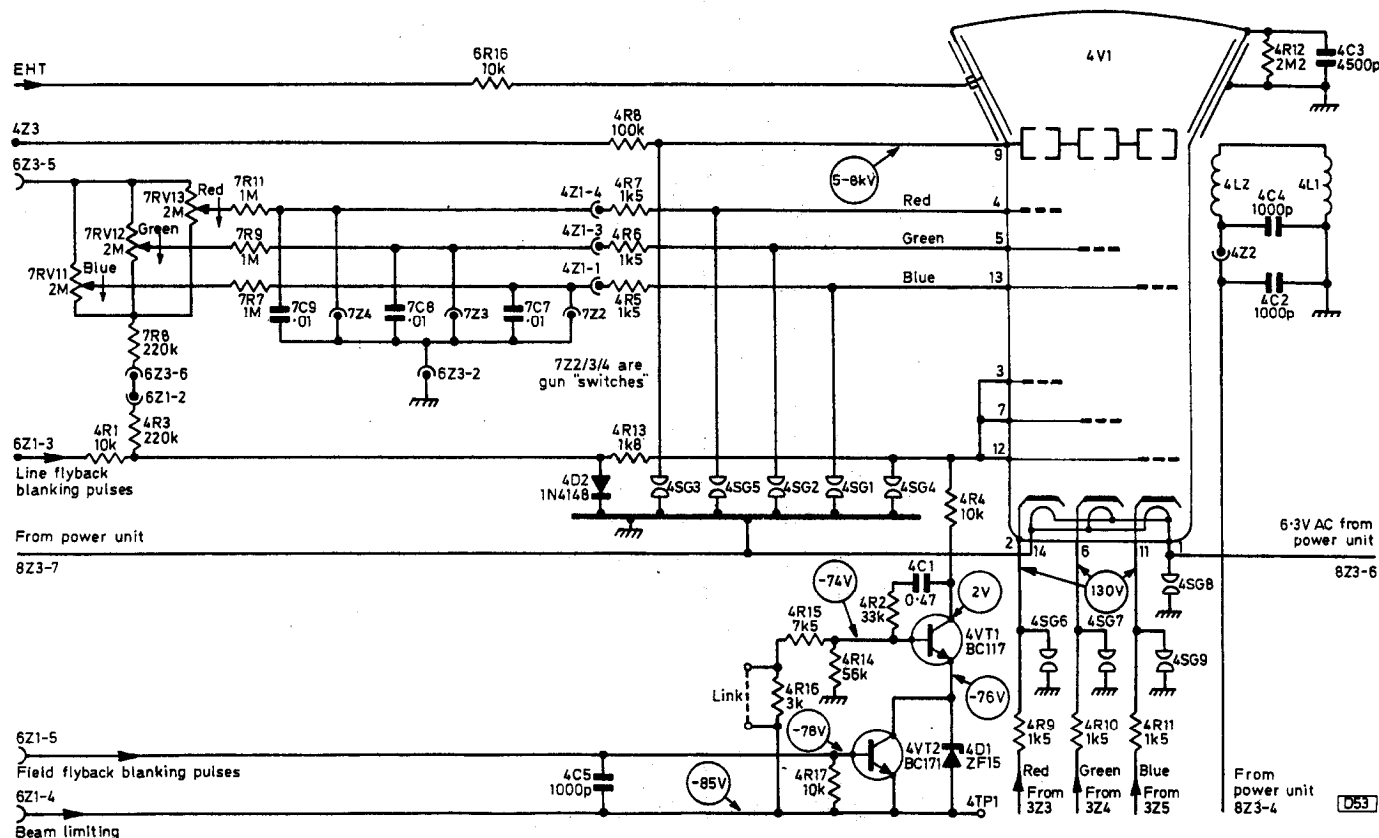
Fig. 9: C.R.T. circuitry.

base panel. They are concerned with beam limiting and field flyback blanking, and can become defective due to tube flashovers. The effect produced is flyback lines (of course) and sometimes a dull picture. 4R3 on the tube base panel goes high in value, with the result excessive brightness and poor grey scale since the first anode supplies become

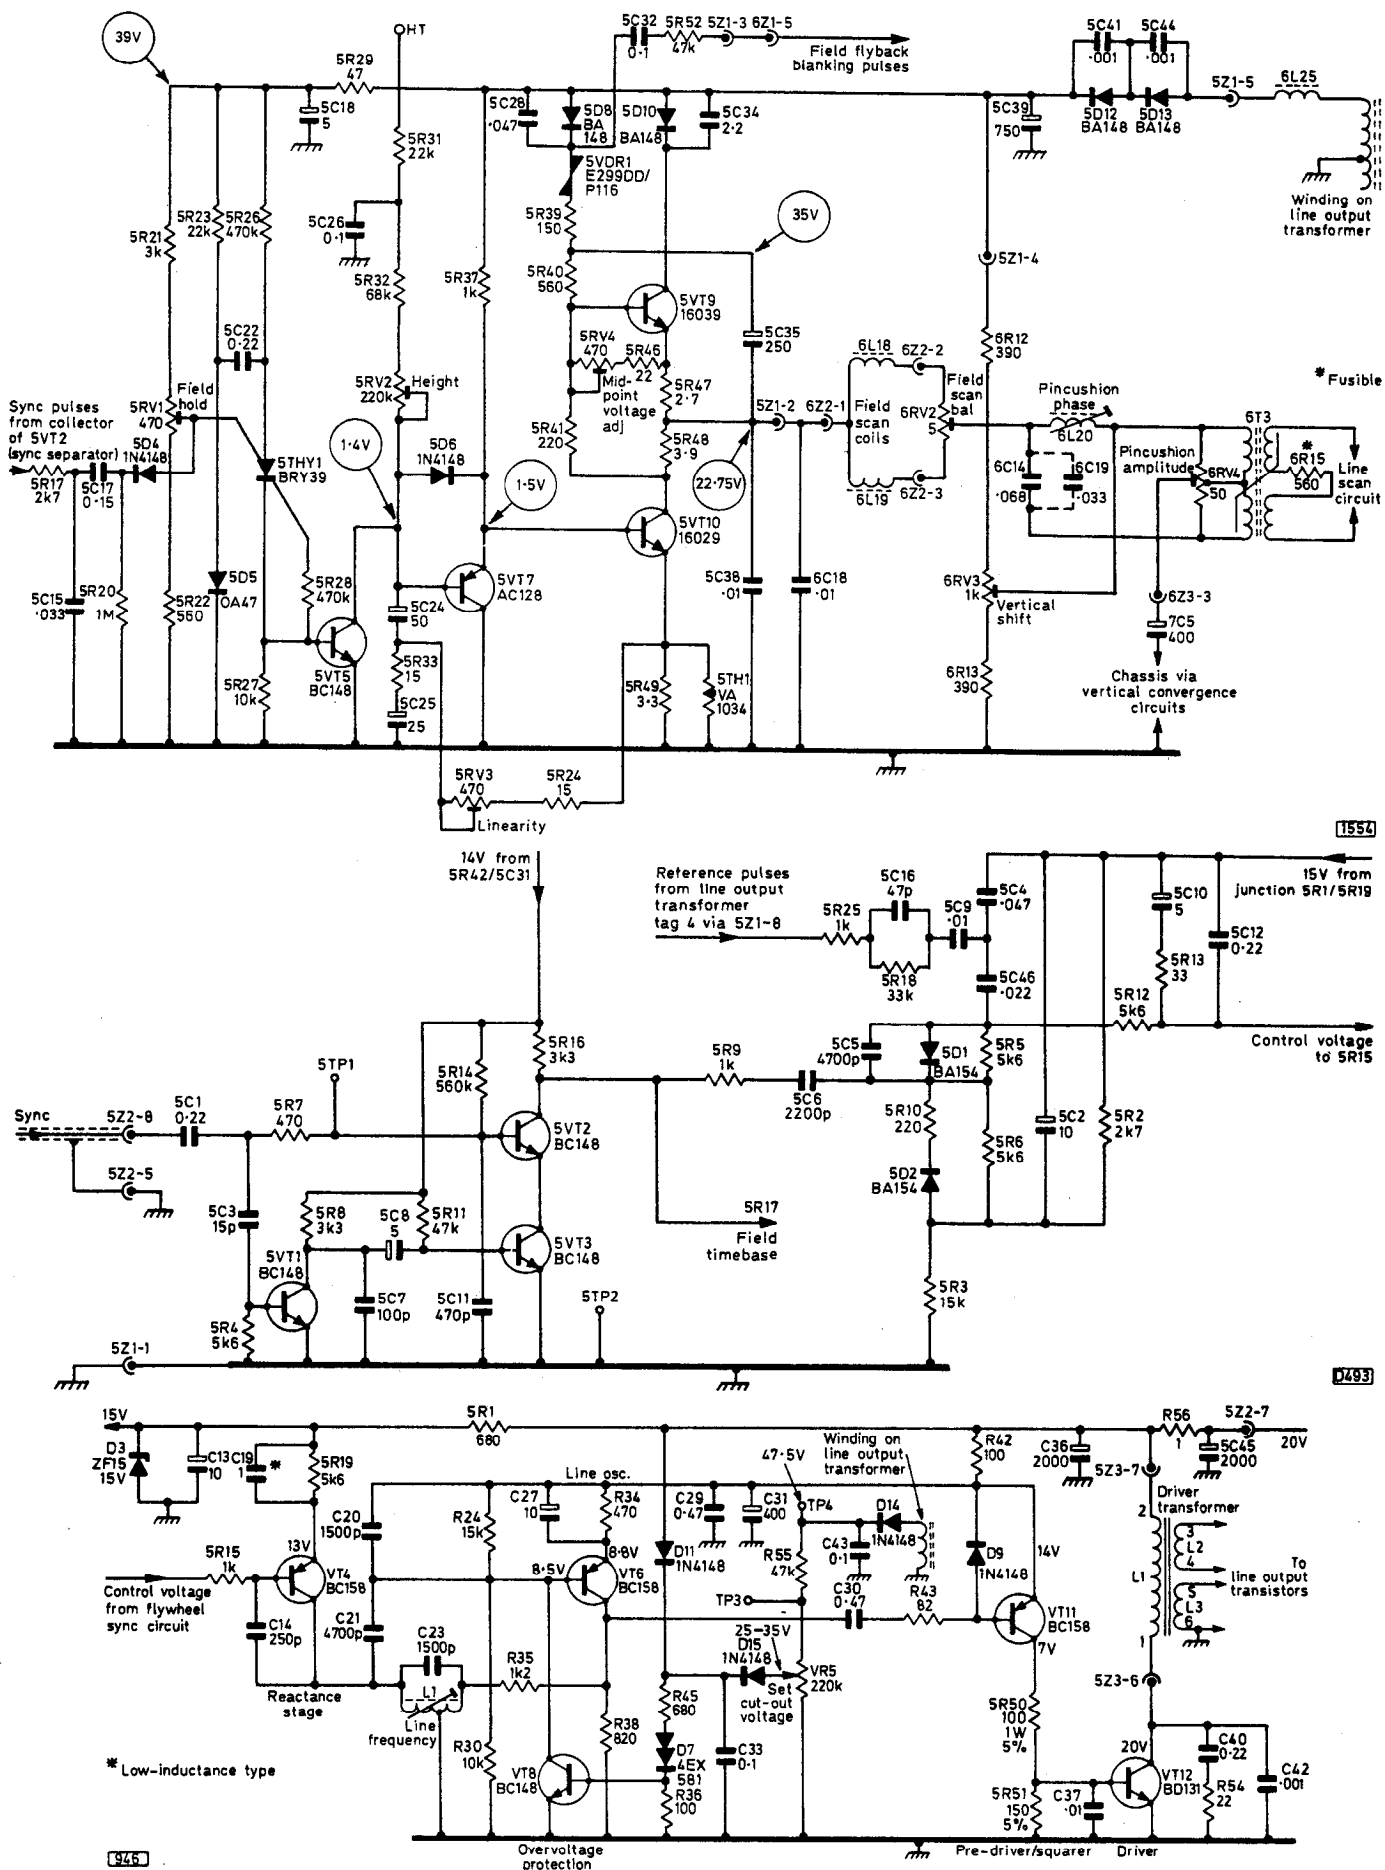
One of the most common faults is simply field collapse, due to a defective field output transistor (5VT9/10). Another common cause of this fault is failure of 5D12, 5D13 or 5C39, as a result of which there is no 40V supply to the field timebase. If these points are in order, it's worth checking the field scan balance control 6RV2 on the scan control panel, since this may have developed a dud spot. Another fairly common fault on this panel is intermittent loss of field scan due to a faulty connection at the base of the pincushion phase coil 6L20. Returning to the scan drive panel, a less common cause of field collapse is either 5D8 or 5D10 going open-circuit. If it's necessary to replace any of the diodes mentioned so far (5D8/10/12/13) it's better to use a BY206. Another possibility is a defunct field oscillator – the silicon controlled switch 5THY1. In this event however there will probably be a burn-up in the output stage. Note that voltage readings should not be taken around 5THY1 since this will stop the oscillator with the result just mentioned. So beware! If you suspect field oscillator failure, check the voltage at the emitter of the driver transistor 5VT7 – you should find about 1.4V here. It may be necessary to replace 5R47 and/or 5R48.

On the line timebase side, probably the most common fault is no e.h.t. due to the line driver transistor 5VT12 going short-circuit. In this event the 2A fuse 8F1 will blow of course. 5VT12 has also been known to go short-circuit collector-to-base, producing the same symptom (no e.h.t.) with damage to its base resistor 5R51. In the event of 5VT12 failing again a few days later, check the driver transformer damping components 5C40/5R54. The capacitor sometimes goes open-circuit, while the wirewound resistor may well be dry-jointed (it gets very hot). Two capacitors in this area can be responsible for no line drive – sometimes intermittent – the electrolytic decoupler 5C31 and 5C42.

Fig. 1: The circuitry on the Rank Z504 scan drive panel. Top, field timebase circuit – plus some of the external circuitry. Centre, the sync separator and flywheel line sync circuits. 5R7 later changed to 560Ω, with 5VT1/3 and associated components deleted. Bottom, the line generator and driver circuits.
