Servicing the Baird 700 Chassis

E. Trundle

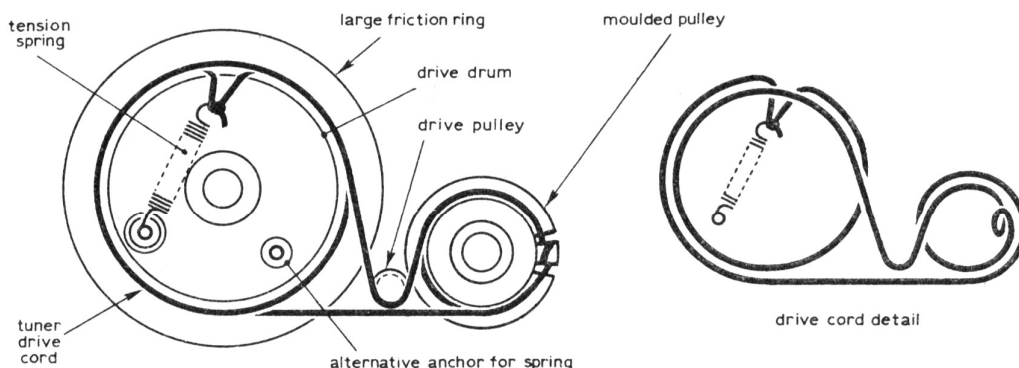
Fig. 1: The u.h.f. tuning drive cord system.

drives the tuner shaft tends to perish and develop a permanent dent, causing loss of drive – this situation is often precipitated by cleaning the customer controls above with lubricant or switch cleaner, which percolates down into the works. The large plastic drive drum contains a pin – the anchor for the cord tensioning spring – and this often snaps off. Finally, the brass bush tends to undo its securing nut, whereupon the whole assembly falls to pieces – misery indeed. These troubles usually involve restringing the drive cord – no mean task – as shown in Fig. 1.

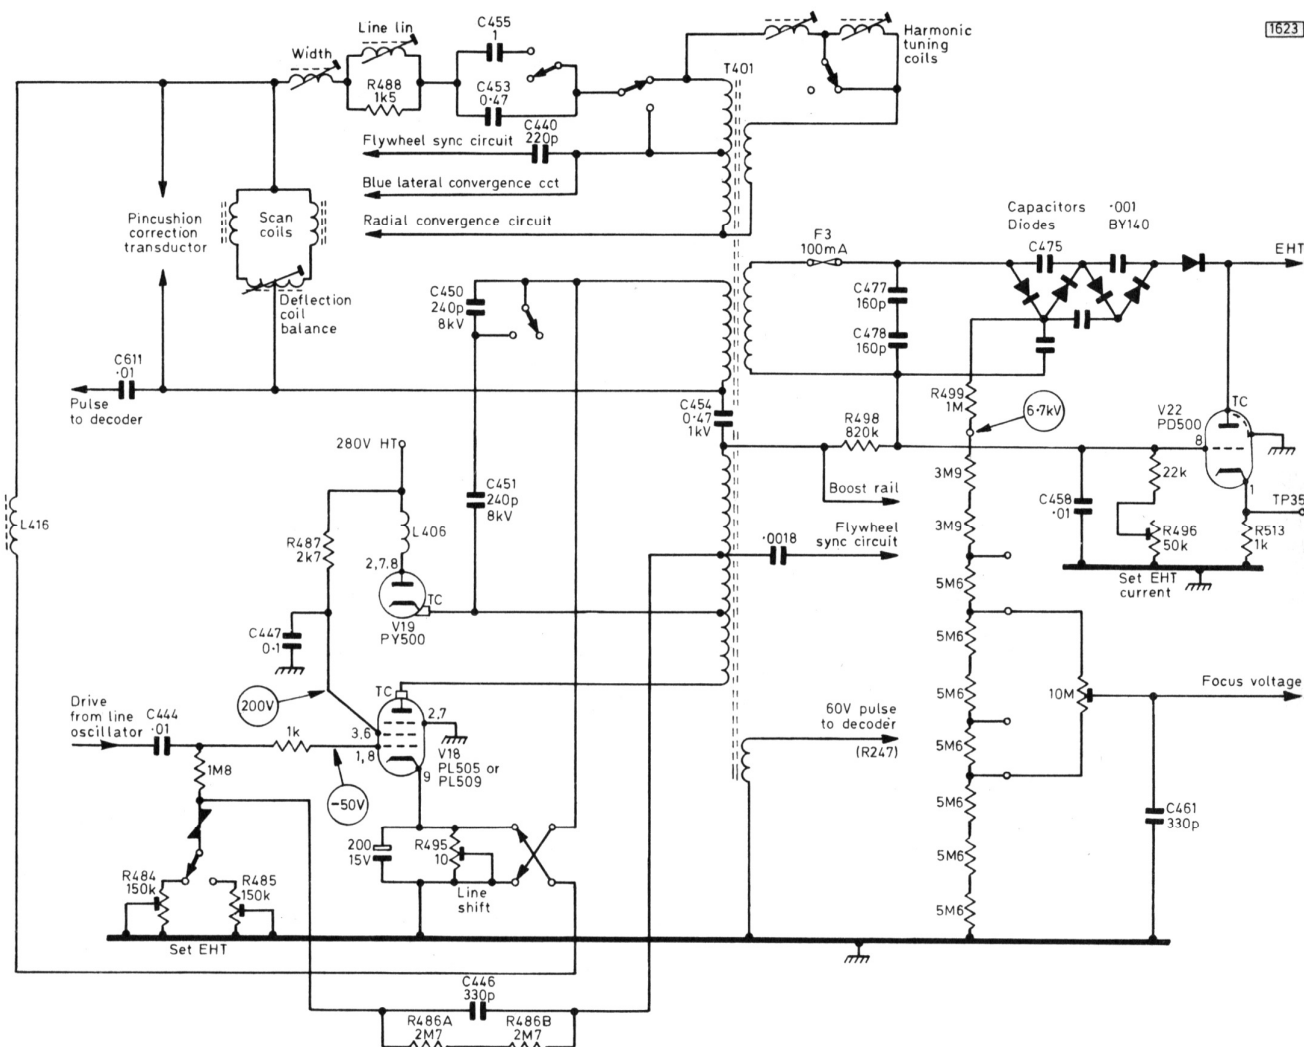
Fig. 5: Circuit of the line output stage.

Low width is a common trouble on this chassis and predictably the fault is generally due to the high-value resistors in the width stabilising circuit. R486A and R486B are each 2.7M Ω and tend to go high. Accessibility in the area of these components is poor, and we find it easier to remove the chassis from the cabinet for this and similar operations. The set e.h.t. potentiometer R484 sometimes curls up, making adjustment difficult. The line output stage circuit is shown in Fig. 5.

On the other side of the line output transformer, which itself is quite dependable, several weak spots exist. We'll kick off at the e.h.t. tripler, a strange device built up of separate rectifiers and capacitors. The 100mA e.h.t. feed fuse F3 will often be found open-circuit when problems develop in the tripler department, and the presence of this fuse probably accounts for the longevity of the transformer itself. Just out of sight under the paxolin lip of the tripler assembly lurk two tubular pulse capacitors, C477 and C478, both 160pF. These are wont to burn to a crisp, and are the most common cause of fuse failure. The value of these capacitors is quite critical for correct transformer tuning and width/e.h.t. ratio, and 160pF capacitors can be hard to come by. We suggest as a replacement 150pF and 180pF in series, both of the 12kV disc type.

The first capacitor of the tripler proper, C475 (0.001 μ F), is also prone to trouble, the snag here being that in spite of violent internal arcing and overheating it usually looks quite innocent! If F3 is blown and C477/478 are ok, most often this capacitor is responsible. When working on these high-voltage components, make the solder joints nicely rounded to avoid corona discharge.

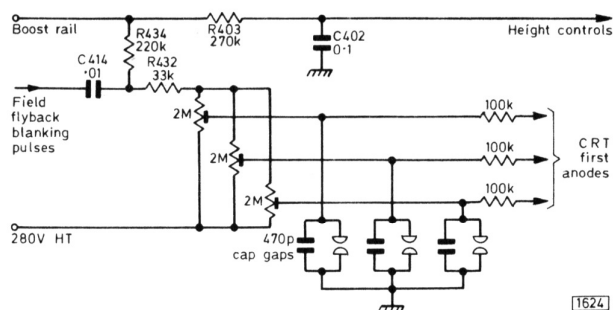
Fig. 6: The c.r.t. first anode circuit.

member of the chassis. Open the door/coder and all will be revealed! Similar symptoms (but the smoke smells different) are caused by a short in C402 cooking R403 (see Fig. 6). These components decouple the boost feed to the field charging circuit and sit on the left side of the timebase panel. The cathode capacitor (C420, 500 μ F) for the PL508 output pentode lives on the convergence board. This component is often dry-jointed to its panel, leading to field jitter at the bottom of the picture. Jitter of the whole picture should lead to a check of the M3 sync filter diode D30. This can also be the cause of complete loss of field sync. The triode section of a PCF80 acts as field oscillator (with the PL508), the pentode section of this valve being the sync separator.

The c.r.t. first anodes are fed from 2M Ω potentiometers which are connected between the boost and the h.t. lines (see Fig. 6). No picture (or sometimes a very dim one) is the

result when C414, which feeds field flyback blanking pulses to the A1 control network, goes leaky or short-circuit – R434 often burns as a result. In a few early receivers R432 was not present and a slight shading effect occurred, the left side of the screen being brighter than the right side.

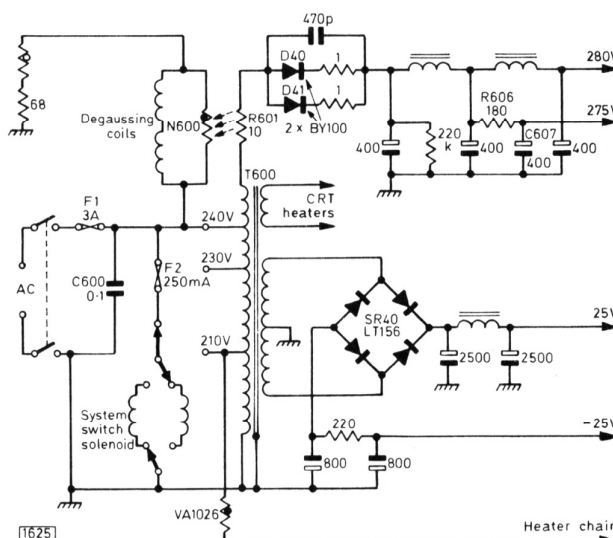
Fig. 7: The power supply circuit.

The power supply circuitry (Fig. 7) is nothing if not robust – no Syclops nonsense here! No results and a shattered fuse is often due to a faulty mains buffer/filter capacitor C600 or, less commonly, a short-circuit h.t. rectifier diode D40 or D41. No results and an intact fuse usually means that the rotary mains on-off switch has failed. A picture which gradually decays away with defocussing and white clipping should lead to a check of the c.r.t. heater connections on the mains transformer, where dry-joints can occur.
