# Servicing the Philips G9 Chassis

Mike Phelan

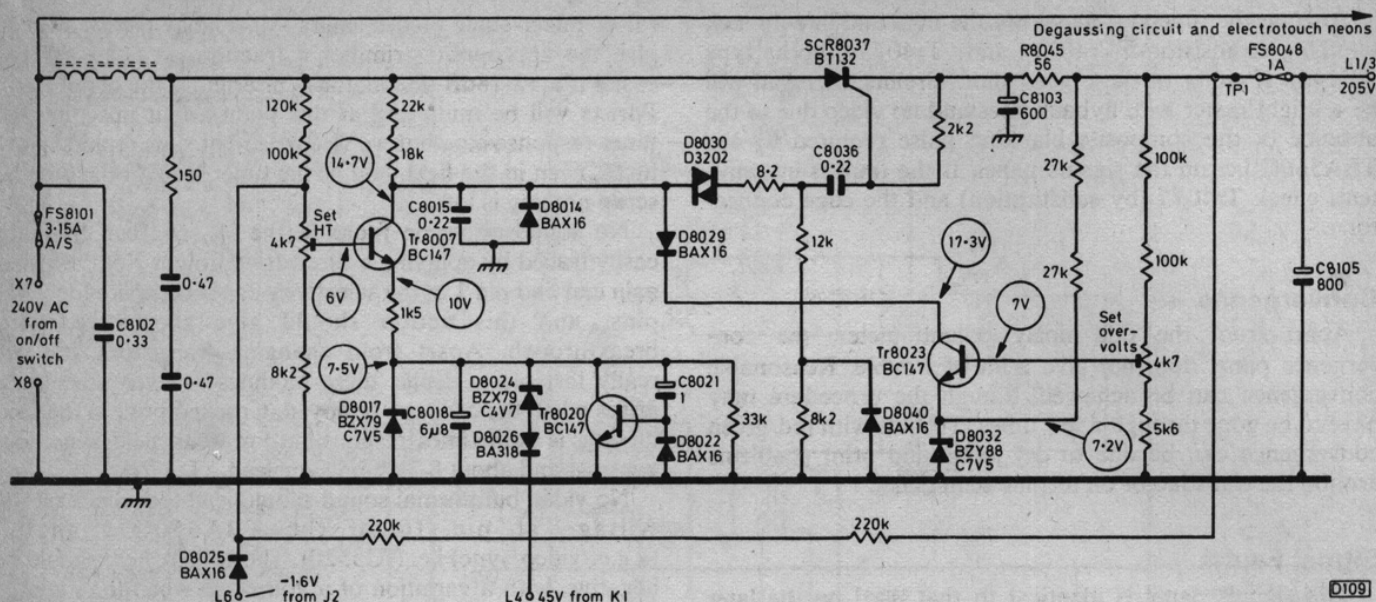
Fig. 1: Mains input and h.t. supply circuitry, Philips G9 chassis.

If the 3.15A anti-surge mains fuse FS8101 has gone open-circuit, check the thyristor for leakage, although mains fuses on this set do sometimes blow for no apparent reason.

If the mains fuse is intact but there's no h.t. at TP1, check the 56Ω power resistor R8045 for being open-circuit as a first step, though it's fairly unlikely to be at fault on this chassis. The next thing to do is to remove the 1A h.t. fuse FS8048 and disconnect D8025. If the h.t. (approximately 205V) returns at TP1, check D8025 and D5134 for leakage – the latter is the 51V zener diode on the line scan panel. This is one of those cases where it's more likely that the fault is in the trip circuit rather than something causing the trip to operate. If neither is faulty however check our friend C5138. Incidentally the 45V line is shown as 42.8V at the emitter of the line output transistor in the circuit diagram in the official manual: in practice the voltage is usually about 48-50V.

Returning to the power supply, if there's no life with D8025 disconnected, disconnect D8024 and check it for being short-circuit – if it is, check C5138 (again!). If there's still no h.t., check the thyristor (SCR8037, type BT132) for being open-circuit, then the control circuit. The over-voltage circuit can be isolated by disconnecting D8029. The two prime suspects in the G9 chassis are zener diode D8017 and clamp diode D8014.

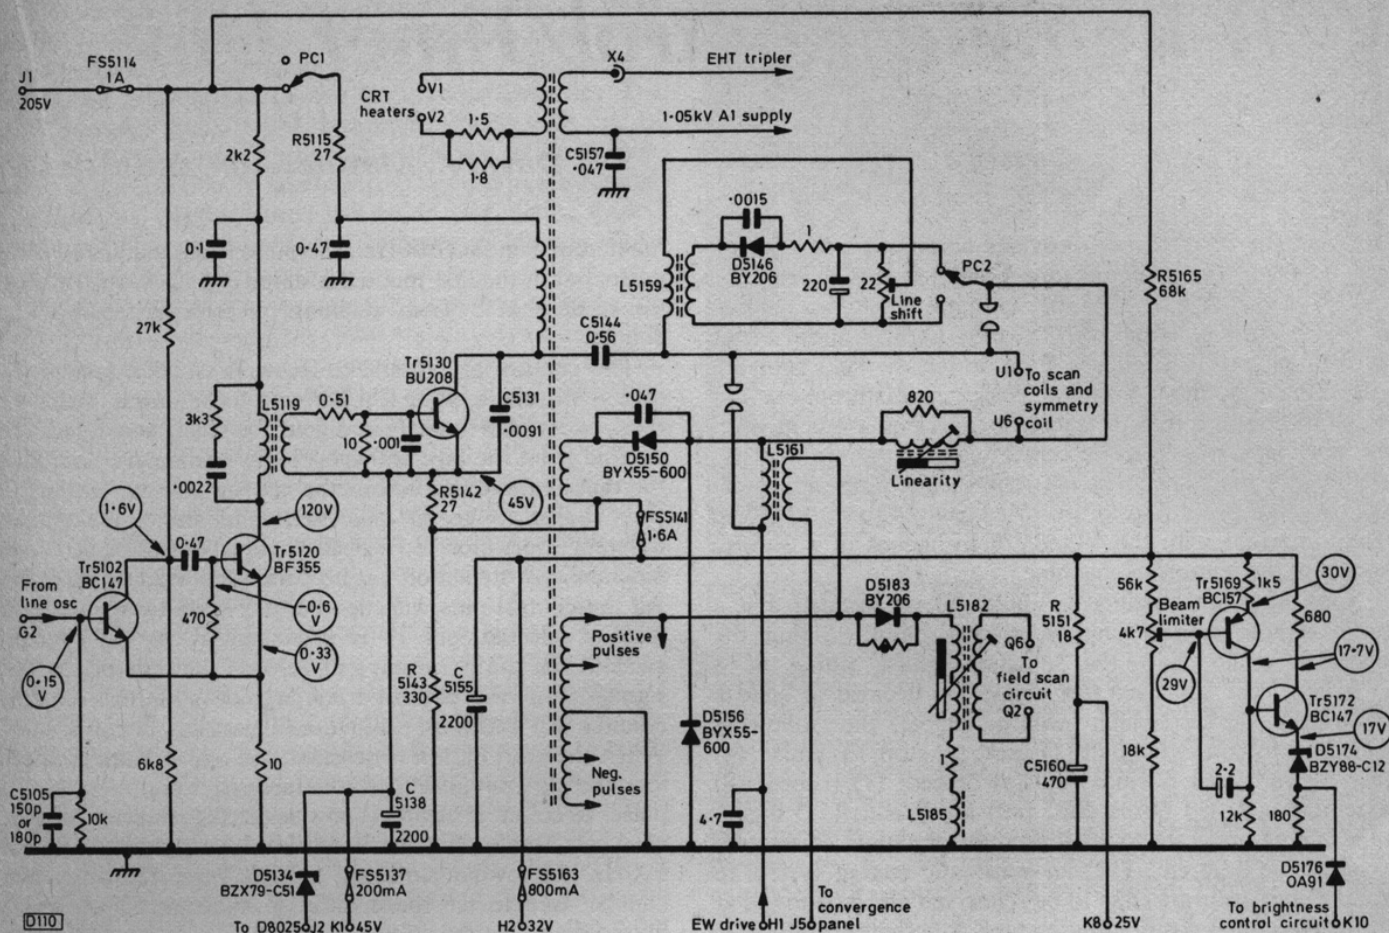
If the h.t. is about half the value it should be, this means that no l.t. is being produced, due to a line timebase fault or FS8048 being open-circuit. If this fuse (or maybe FS5114 on the line scan panel) has blown, check the BU208, the flyback tuning capacitor C5131 (0.0091μF) and the tripler for shorts and examine the line output transformer closely for burn marks.

Another common fault, which is sometimes intermittent, occurs when either of the BYX55-600 diodes D5150/D5156 in the EW modulator circuit goes open-circuit. The l.t. rails fall, giving a 4in. field scan and no video.

The beam limiter circuit (Tr5169/Tr5172 etc.) seems to be more reliable than its counterpart in the G8 chassis, though the 12V zener diode D5174 fails on occasion. When it goes open-circuit, there's no brightness – this can be intermittent.

If the picture looks as if the tube is flat and the width alters with the brightness, examine the EW modulator transformer L5161 at the top of the line scan panel for dry-joints. The shift transformer L5159 also suffers from this problem.

Fig. 2: Circuitry on the line scan panel. C5105 was added to prevent line jitter.
