SERVICING TELEVISION RECEIVERS

THORN 1400 CHASSIS

L. LAWRY-JOHNS

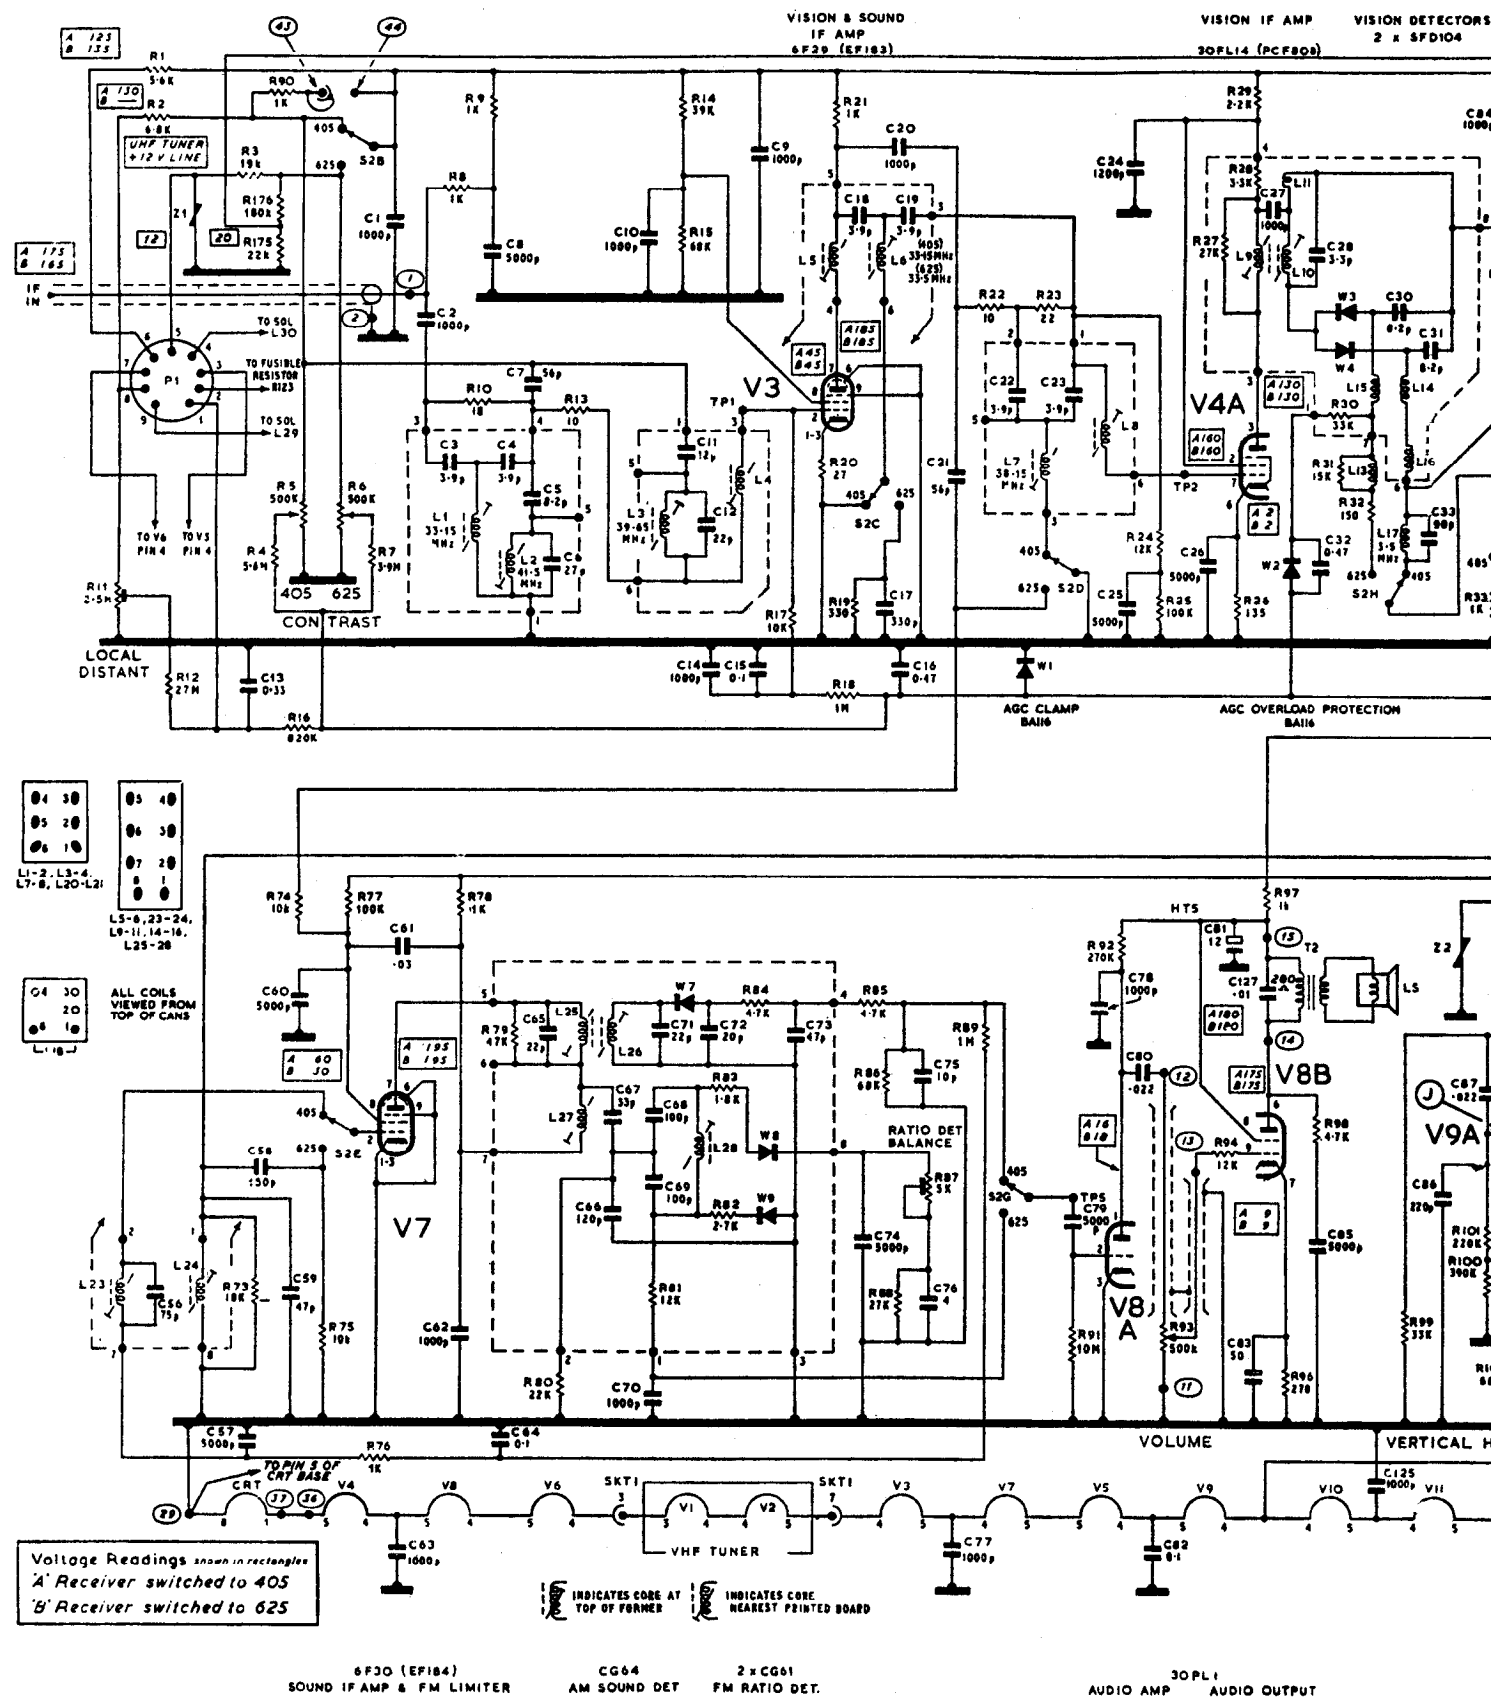
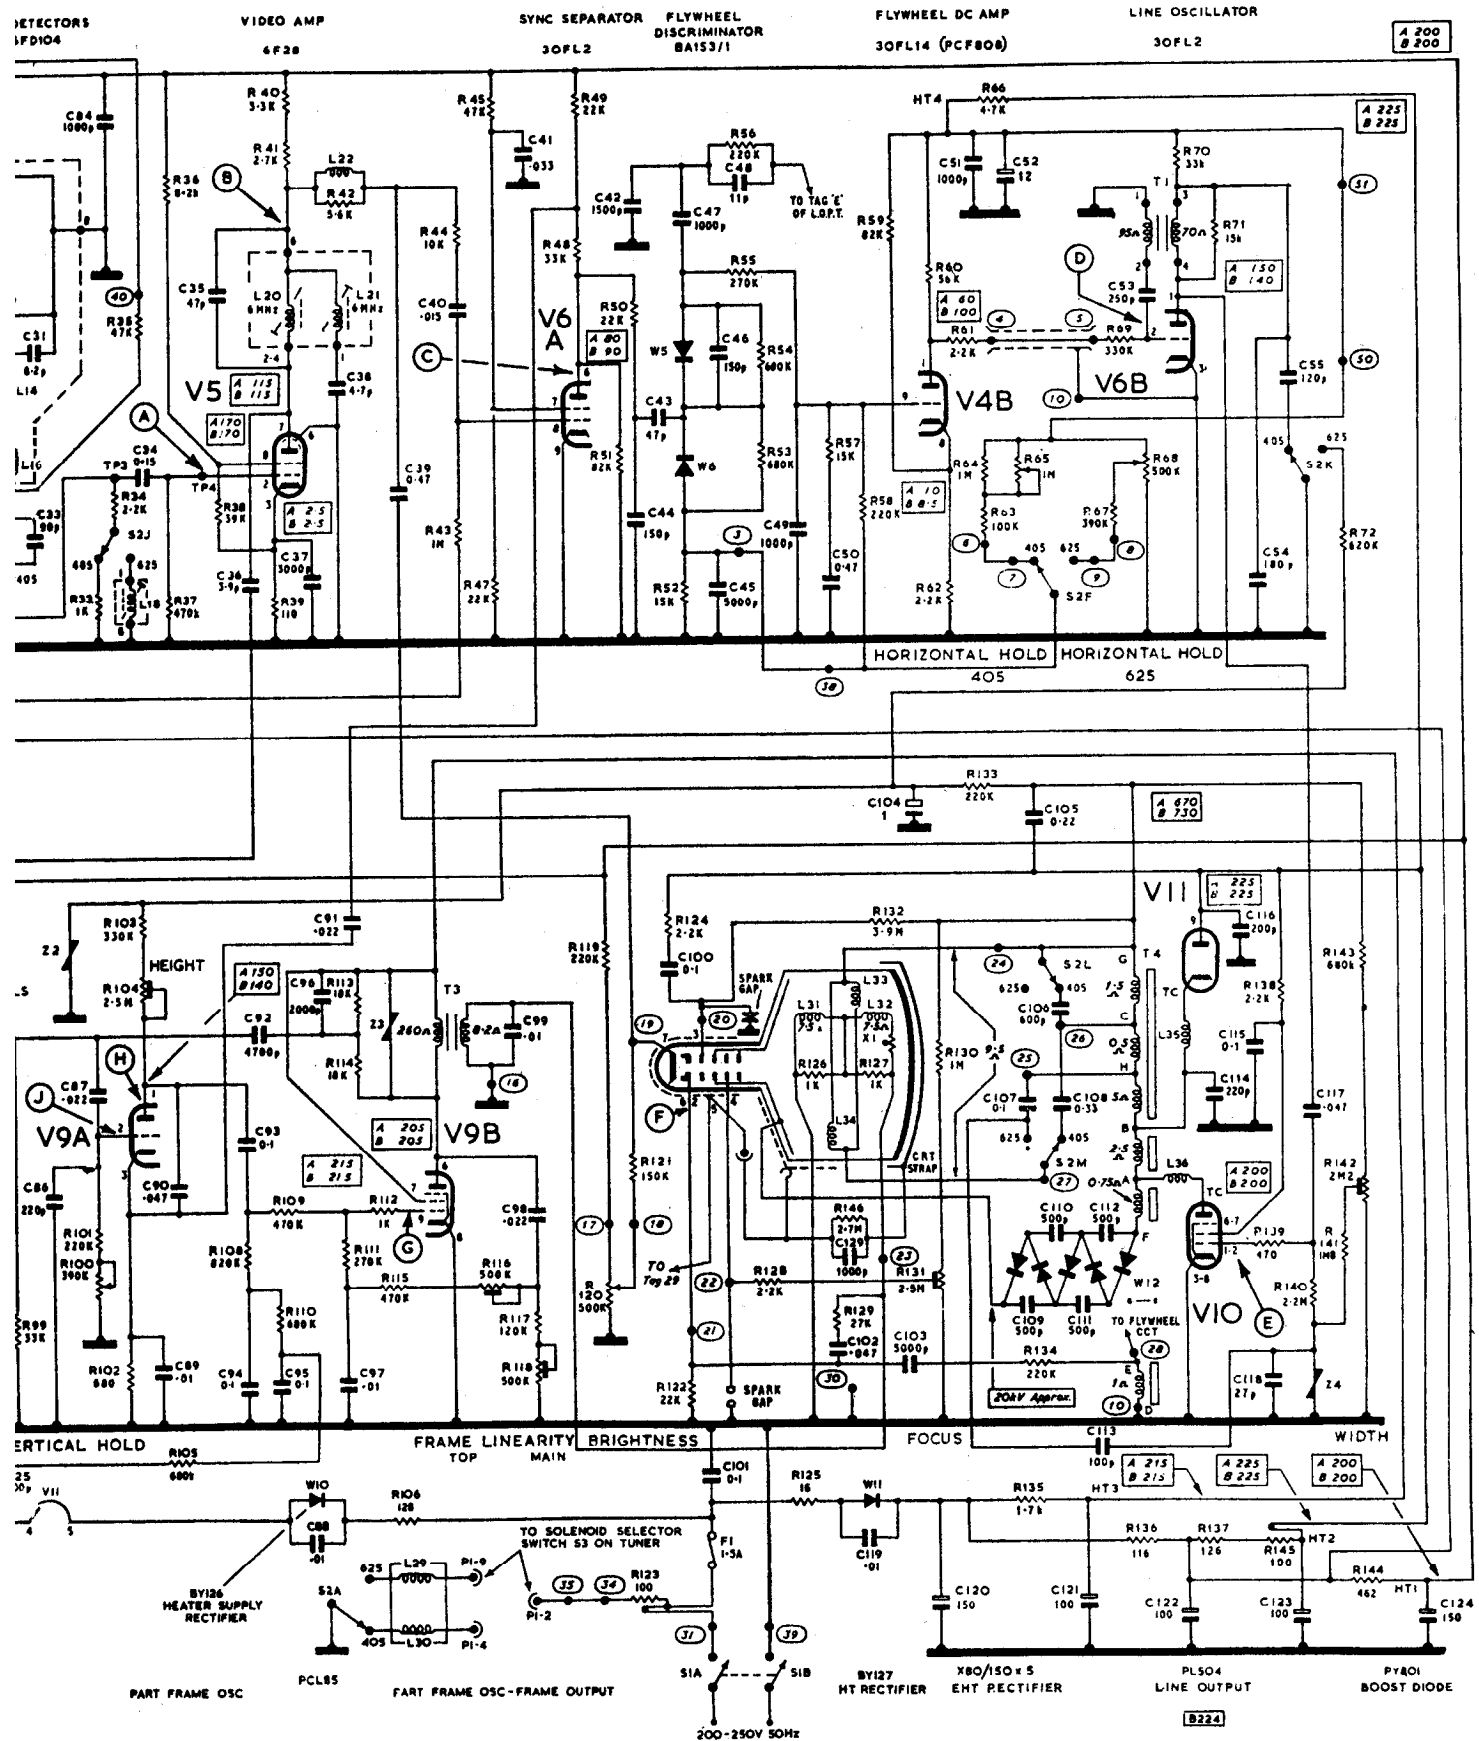
Fig. 1: Circuit diagram of the Thorn 1400 dual-standard chassis -

Now to get down to the annoying vision buzz. Generally no amount of tuning the coil cores (mainly L27-28) or setting the rejector potentiometer R87 will completely remove the buzz and one is left with the task of going through the whole of the vision i.f. alignment procedure or looking for an alternative. There is an alternative, and this consists of making some very small alterations to the circuitry.

The first job is easy and simply consists of changing the video stage screen grid feed resistor from 3k Ω to 8.2k Ω or thereabouts. The resistor is R36, connected to pin 8 of the 6F28. The next is a little more involved and requires the addition of two small resistors, one of 22k Ω , the other 180k Ω (both $\frac{1}{4}$ W). These are shown in our circuit diagram (Fig. 1, schedule E receivers) as R175 and R176 to the

junction of which R35 is returned. In earlier models R35 was returned to the junction of R3, Z1. This modification divorces the detector from the 12V u.h.f. tuner supply. Finally, make sure that R74 and R75 are both 10kΩ. Then adjust L27 and R87 for optimum results.
