# SERVICING television receivers

## BRC 1500 CHASSIS

**Ferguson** Models 3800, 3801 3802 and 3803.  
**HMV** Models 2800, 2801, 2802, 2803 and 2804.  
**Marconiphone** Models 4800, 4801 and 4803.  
**Ultra** Models 6800, 6801 and 6803.

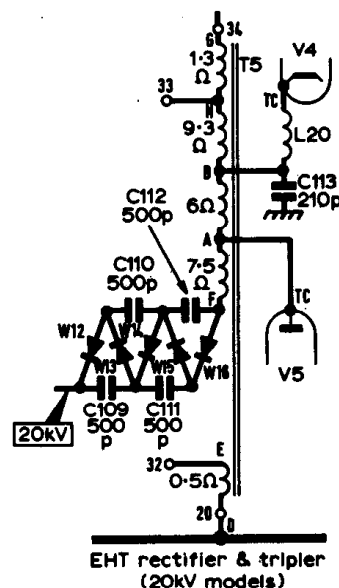
*Fig. 1: E.H.T. circuit used in models operating with an e.h.t. of 20kV. The main circuit (Fig. 3) shows the e.h.t. doubler system used in models operating with an e.h.t. of 15-25kV. Voltages shown on the main circuit (Fig. 3) are given as a guide—variations between 10% and 20% do not necessarily indicate a fault. They were measured on a 15kV model with 240V a.c. mains input, no signal and all controls set for normal operation using (except for the e.h.t.) an Avo Model 8. T1 anode winding 70 $\Omega$ , grid winding 95 $\Omega$  d.c. resistance.*

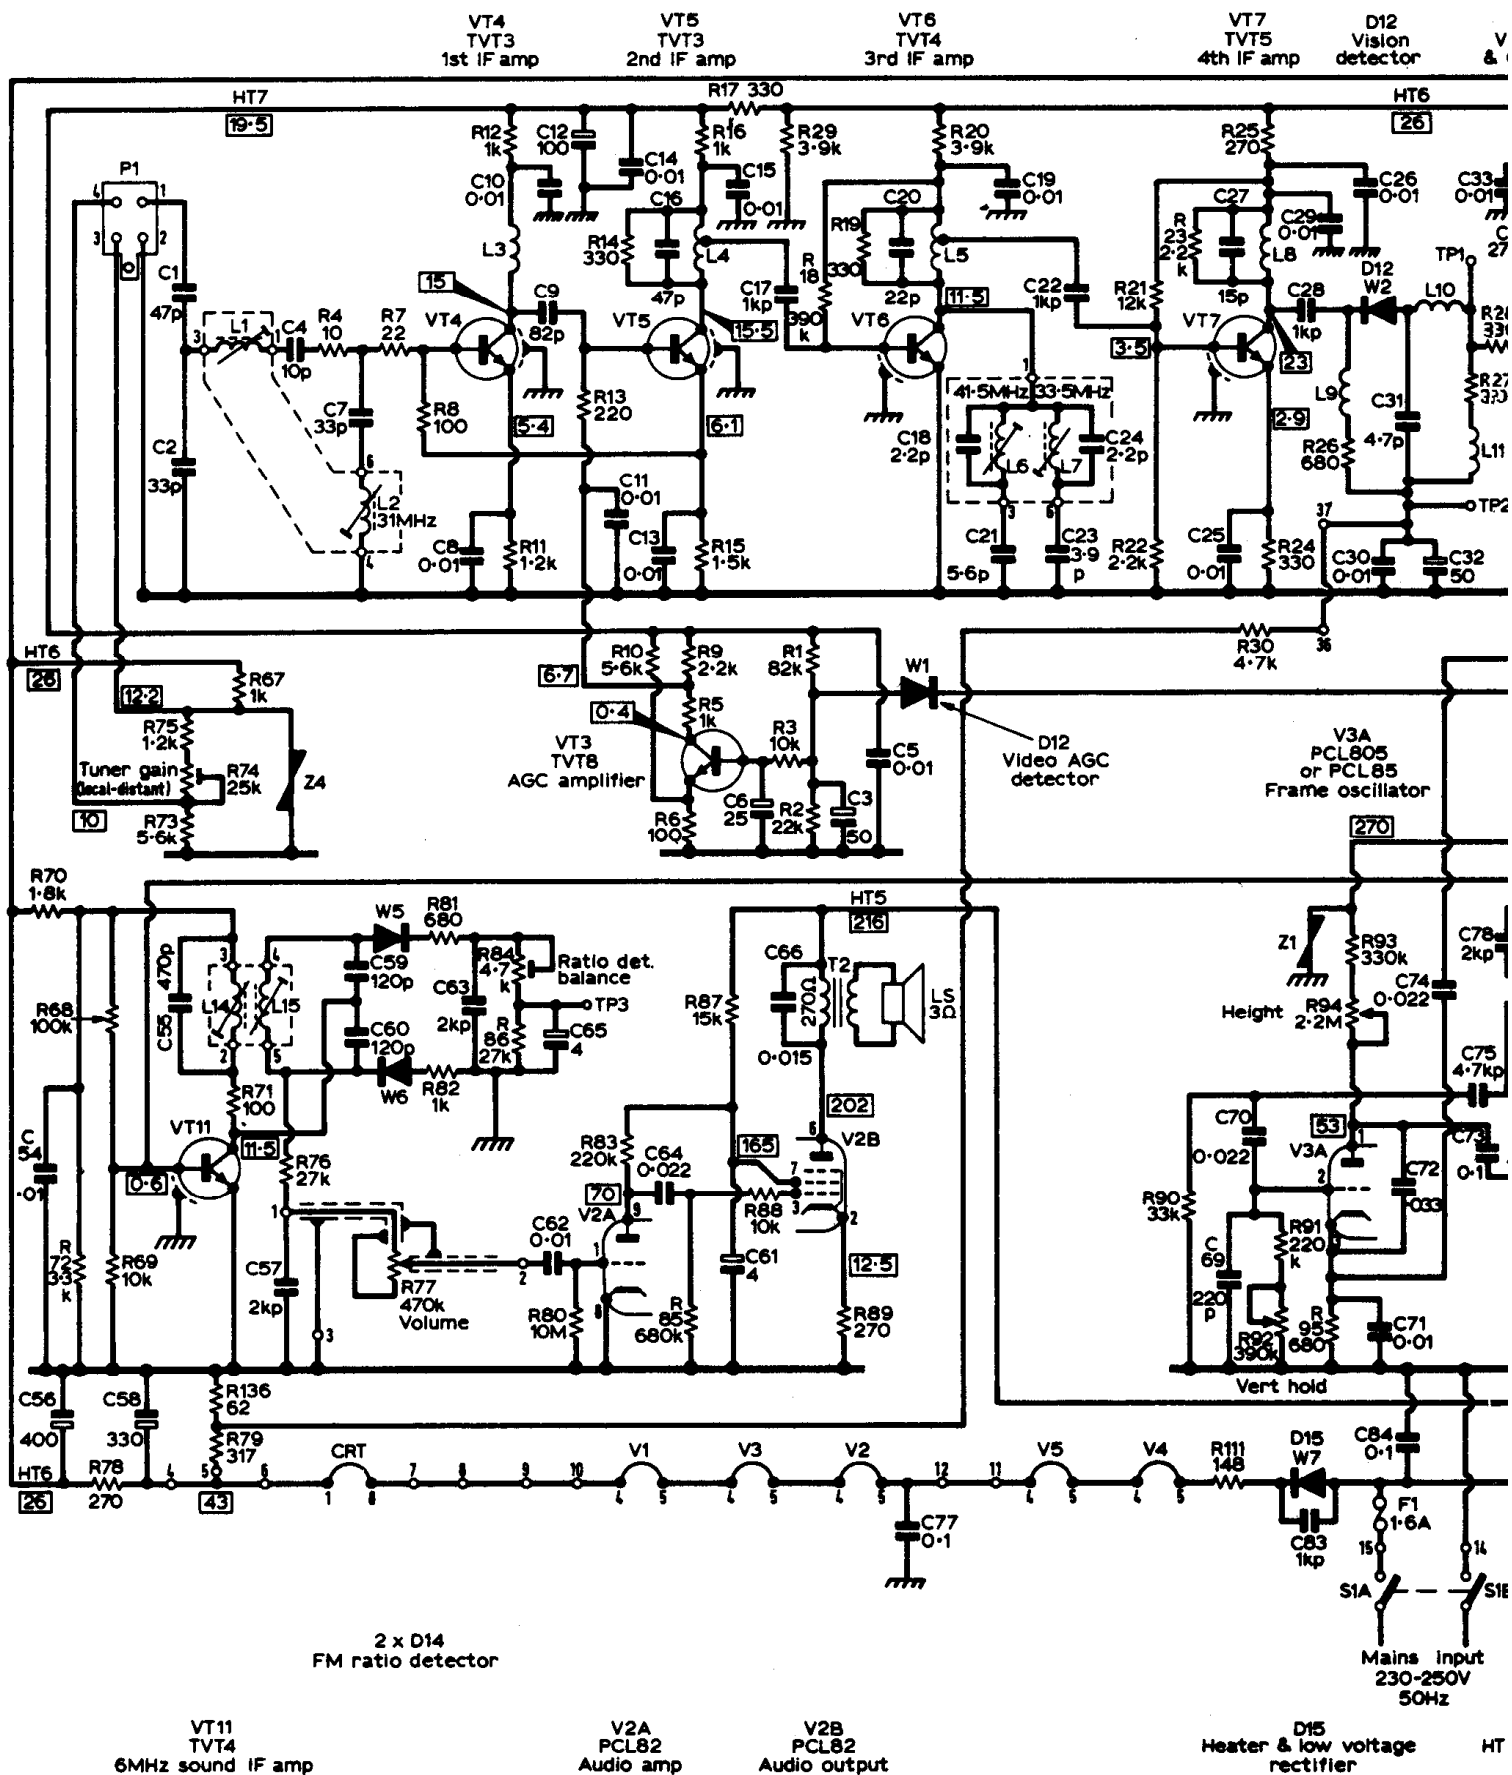
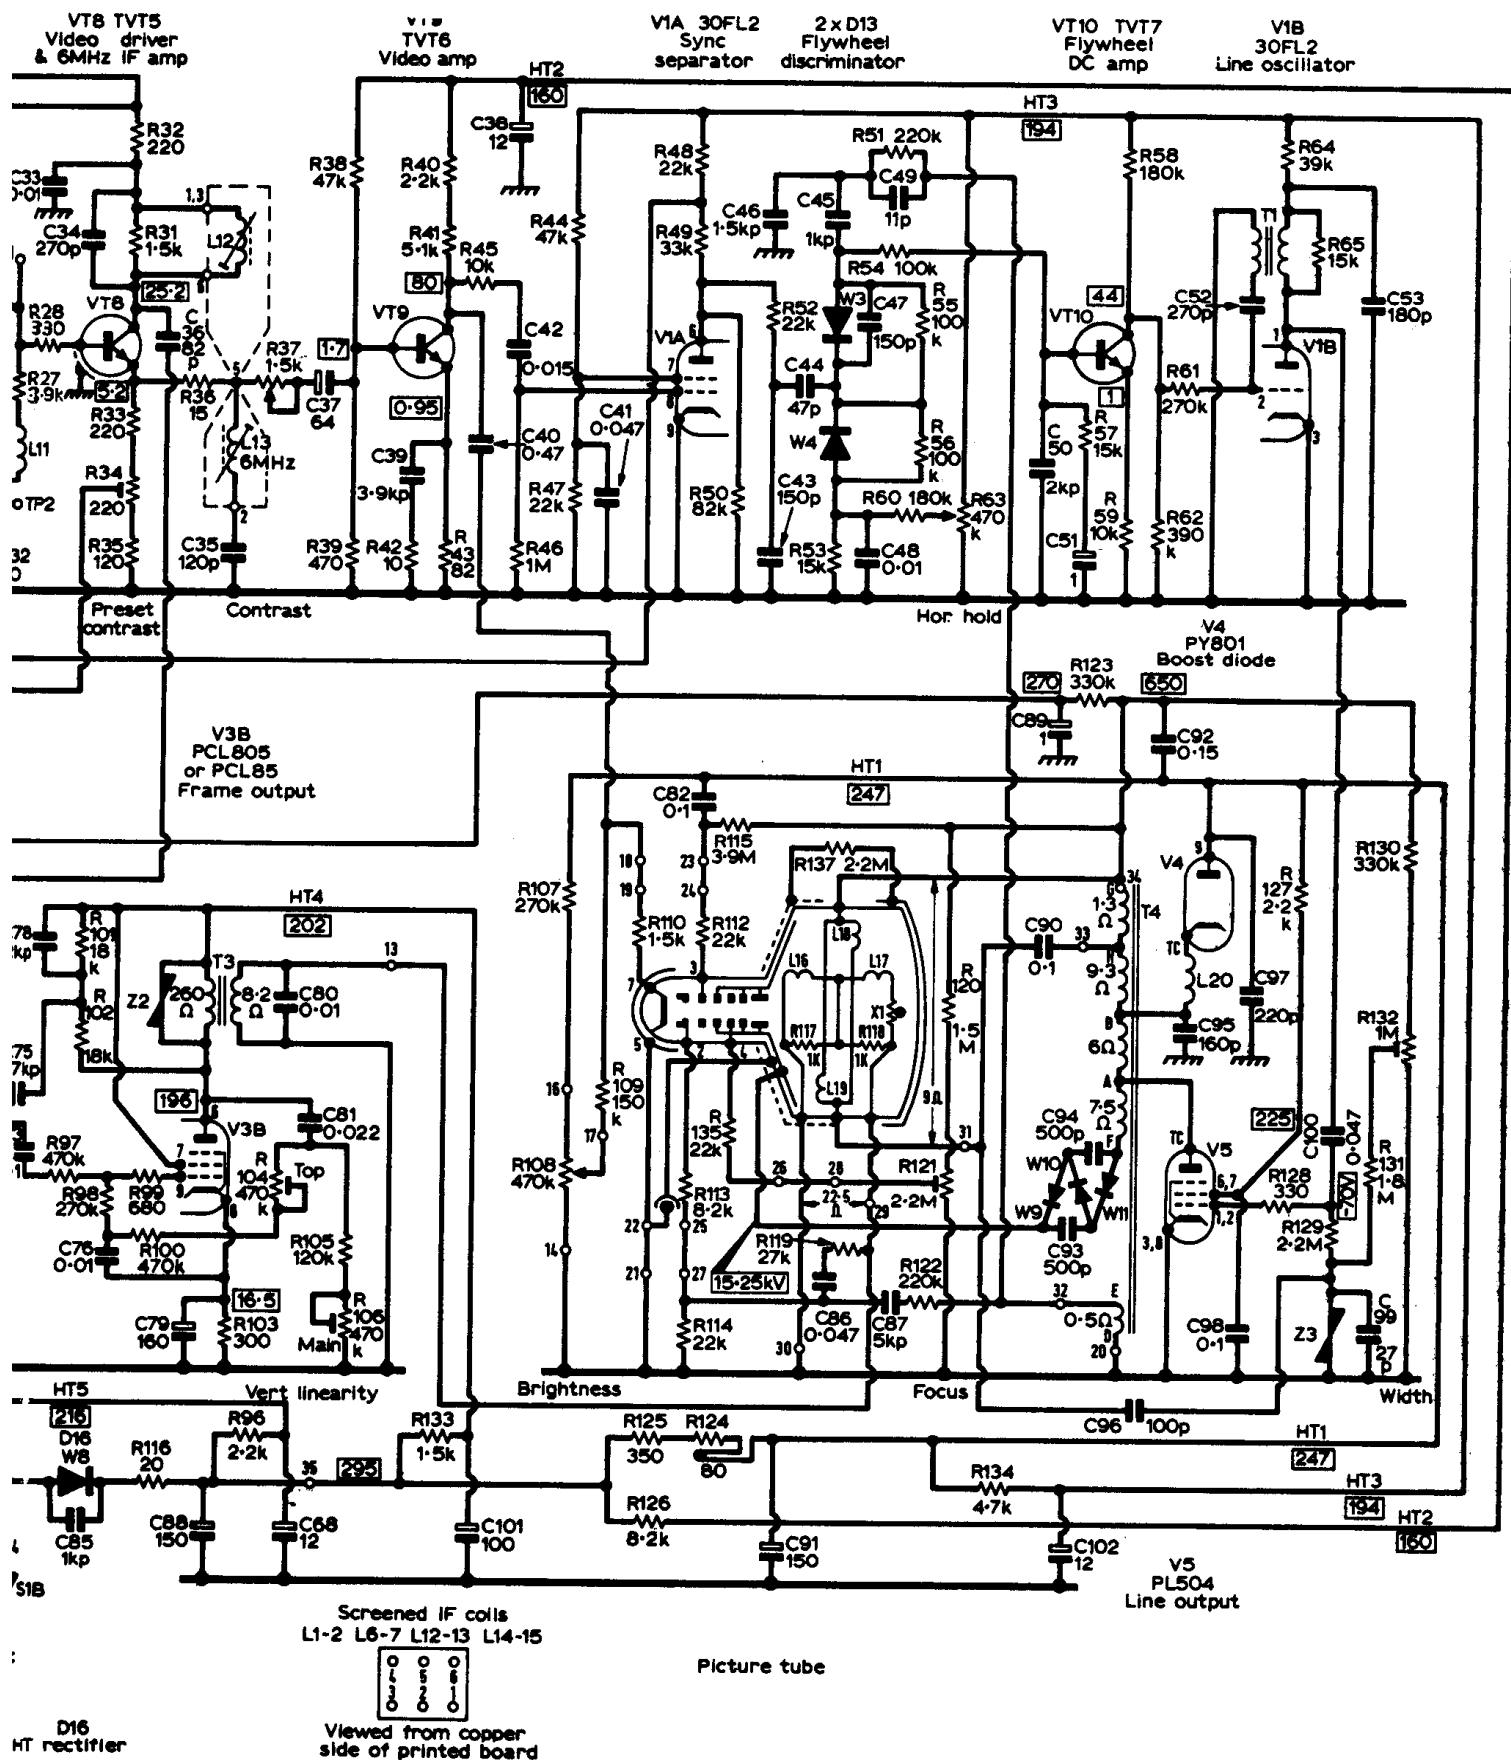
Fig. 3: Circuit diagram, BRC 1500 single-standard chassis.

Poor sync is one complaint which will be met on practically every set. The symptoms are that the contrast and sound are good but the picture cannot be held. In nine cases out of ten the trouble is due to R44 going high-resistance. It is a small 47k $\Omega$  resistor feeding the screen of the sync separator (30FL2): since it is in series with a 22k $\Omega$  resistor across the h.t.

Having said that nine times out of ten R44 is responsible for poor sync we will now mention the tenth time! This turned out to be C42, the  $0.015\mu\text{F}$  sync coupling capacitor. We are finding more and more capacitors faulty due to a fracture inside the moulding. Moving them will sometimes reveal which is at fault. Whether the defect is due to manufacture or to stress imposed by mounting on the panel is a matter for others to decide but it is a fact that component failure is far more common now than of yesteryear (yes Grandad, remember factor R?).

It is mainly the smaller electrolytics which are giving trouble. We have already mentioned C37 in the video circuit which tends to go open-circuit. Far more regularly however it is C79 which fails. This is the  $160\mu\text{F}$  cathode decoupling capacitor of the field output valve (PCL85). It will go open-circuit sud-

the rectifier D8 to the various h.t. smoothing elements —R96, R125, R126 and R133. It is R116 (20Ω) which is most likely to be found at fault. It is well worth-

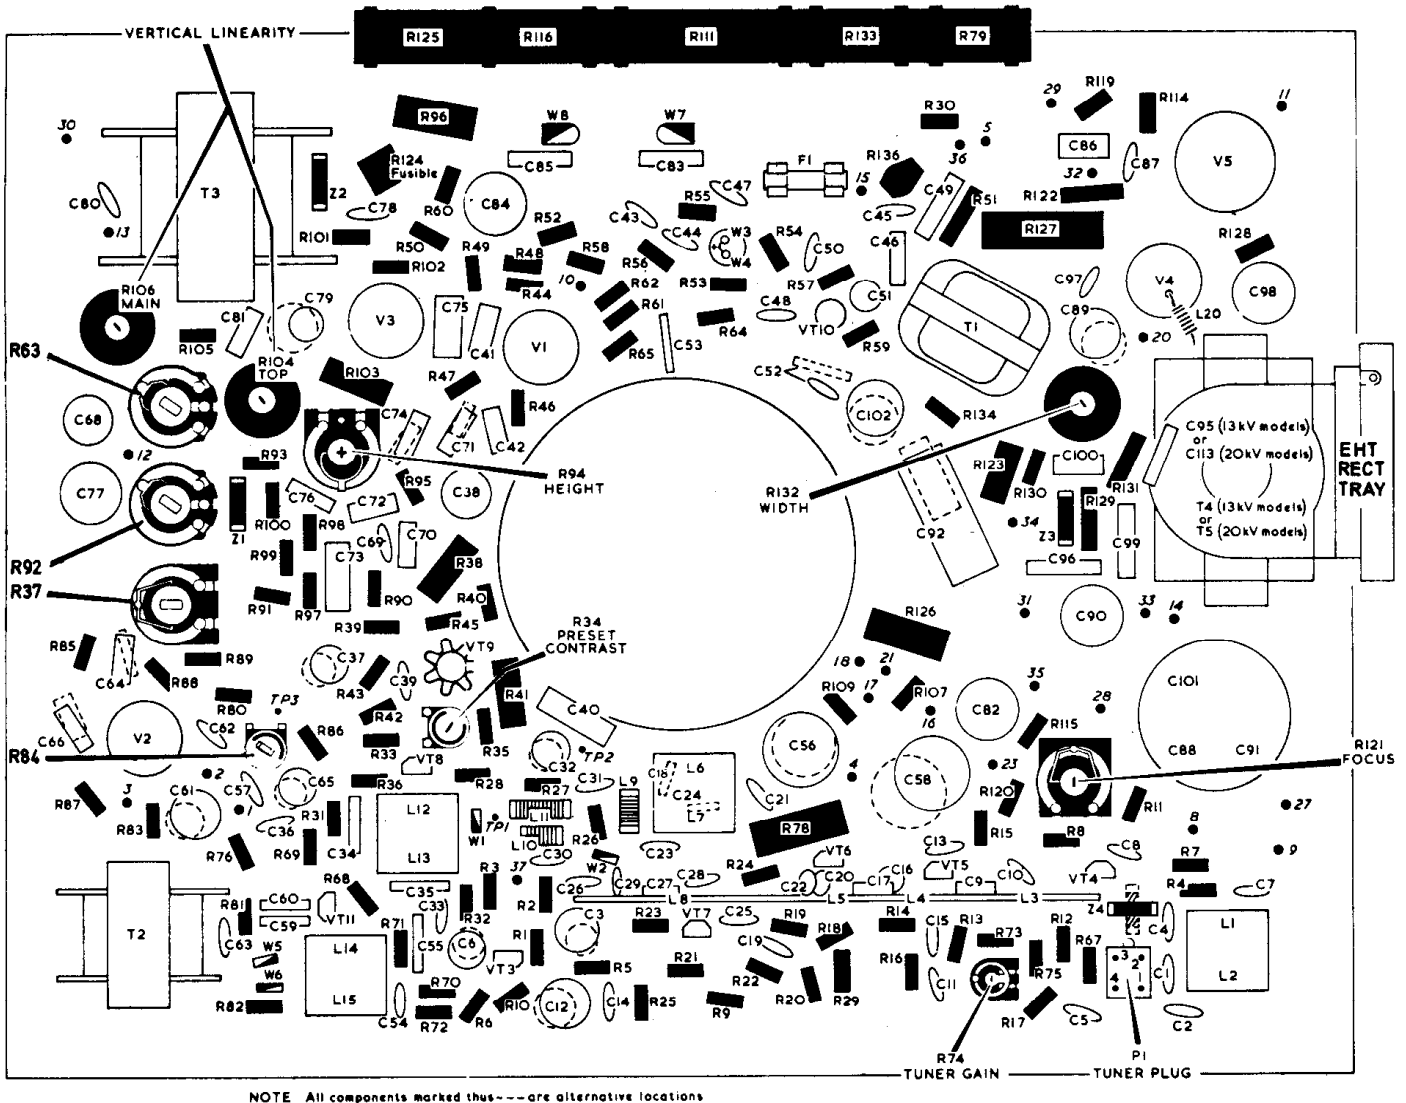
Fig. 4: Component layout on the main chassis assembly.

When a particular section of the receiver fails, for example the sound output or the field timebase, our instinct is to note that the other stages are working and therefore to assume that the h.t. supply is in order. Over the last few years however it has become necessary for the h.t. supply to be more elaborately smoothed and decoupled. Each section of a set tends therefore to have its own supply line and thus smoothing resistor which can fail or be made to fail. In this chassis for example overheating in the line output stage could well be caused by R134 failing, a white line across the screen by R133, no sound by R96 and

so on. Each h.t. feed line should be checked first therefore if the relevant section suddenly becomes inoperative. Kids' stuff? Of course it is, but who hasn't been red faced at some time or the other by not following simple basic routines.
