SERVICING television receivers

THORN 850 CHASSIS

THORN 850 CHASSIS—cont.

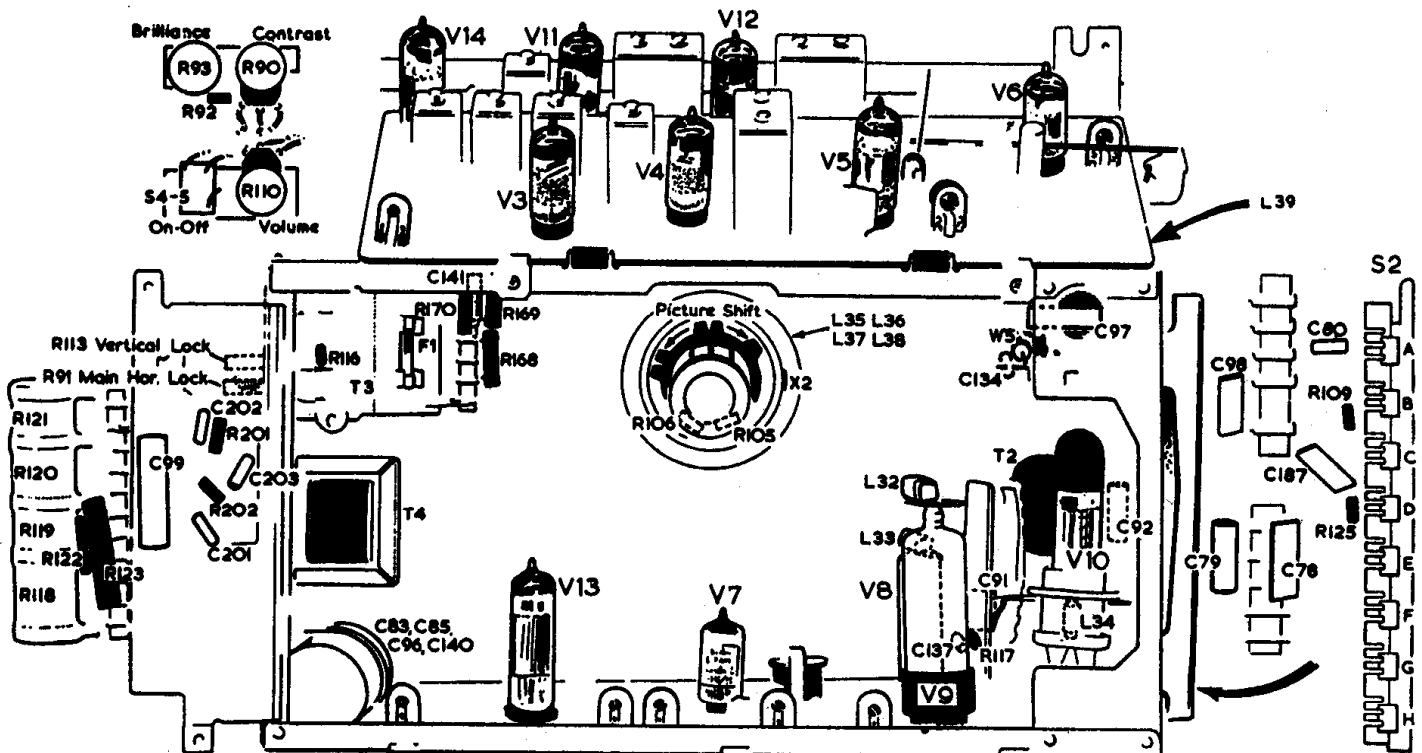
Probably the most common fault on this series is failure of one or more sections of the mains

dropper. On most models this large wire-wound resistor, with its severalappings, is mounted vertically on the left side of the chassis. On some models however it is mounted horizontally at the rear centre. When the symptoms are no mains supply to the valve heaters or to the h.t. rectifier although the supply is at both sides of the fuseholder it is a matter of moments to check along the tags of the dropper with a neon tester or a.c. voltmeter to find where the supply is present and where it is not.

Fig. 1: Rear chassis view. In some versions the mains dropper R118-R121 is mounted horizontally at the rear centre.

Apart from valve failure the other troubles seem to be confined to resistors changing value—check R206 and R209—and shorted lead-through capacitors. This latter condition causes the h.t. feed resistors (R169 or R170) to cook up—these resistors are mounted to the right of the fuse F1 as shown on the rear view diagram.

Having located the faulty section the repairer must then decide whether to replace the whole dropper or wire a replacement section across the faulty one. The faulty section should never be shorted out as this will reduce the reliability of the receiver and shorten its working life. The life and reliability of any receiver are largely determined by the setting of the mains voltage adjustment when the set is first installed, and the tappings should always be set as high as the set will satisfactorily operate. An underrun receiver is always more reliable than one which is overrun by the voltage setting being too low (which is the same as a section of the dropper being linked across).

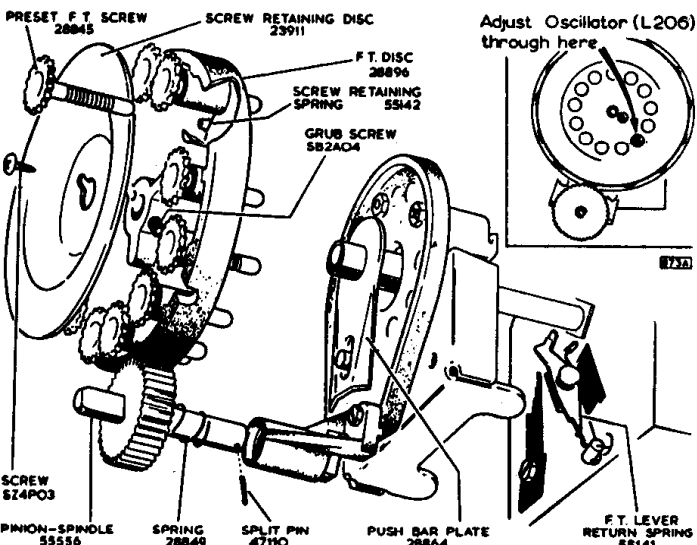
Other than this the most common trouble is associated with the fine-tuner sprocket disc at the rear. The disc becomes loose on its spindle which prevents the sprockets exerting the correct pressure on the fine-tuning plate. The fine-tuner knob at the rear therefore becomes ineffective. The disc is

Fig. 3: Preset fine tuning mechanism. On some models manual fine tuning is used.

secured on the shaft by a grub screw. This can only be tightened effectively with an Allen key (¼ in.). Using a small screwdriver will spoil the screw and will not effect a positive grip.

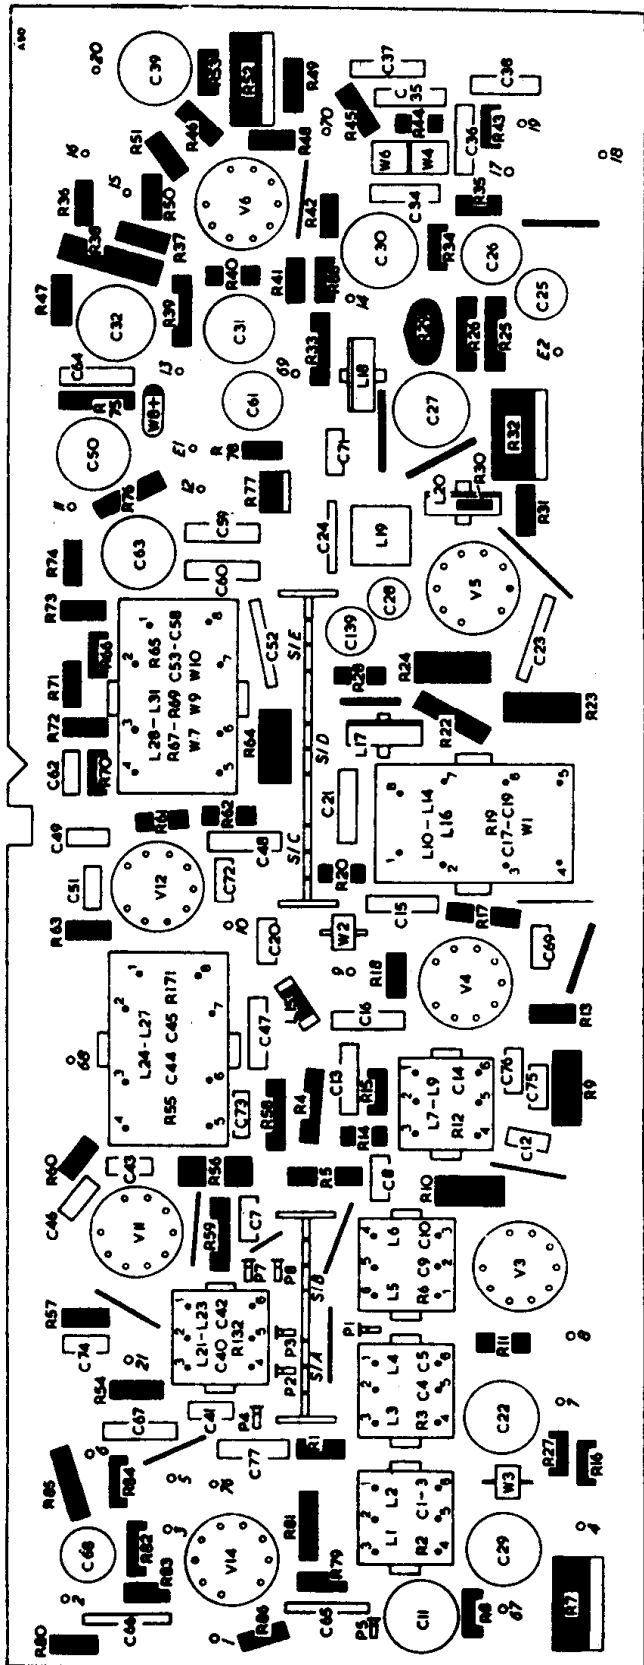
Fig. 6: Layout of the i.f. printed board. The tag connection numbers (italics) correspond to those given in the circuit diagram.

If the fine tuning range is insufficient to tune a particular channel, adjust the oscillator core as follows: Set the fine tuning control to the middle of its range—on receivers fitted with a preset fine tuning mechanism turn the control to bring the cogged wheel of the preset fine tuning screw to mid-position. With the volume control at minimum inject the sound carrier frequency of the appropriate channel at the aerial socket. Adjust the signal input for an adequate deflection on a video output meter (e.g. Avo Model 8 on its 100V d.c. range) then adjust L206 (for access see Fig. 2) using a fully insulated trimming tool for minimum video output. The video output meter should be connected across R29, its positive lead being taken to tag 18 and its negative lead via a 22kΩ resistor to L18 and via an 800pF capacitor to tag E1. The positions of these connections are shown in Fig. 6.
