Servicing the Rank A823 Colour Chassis

Part 1

R. W. Thomson

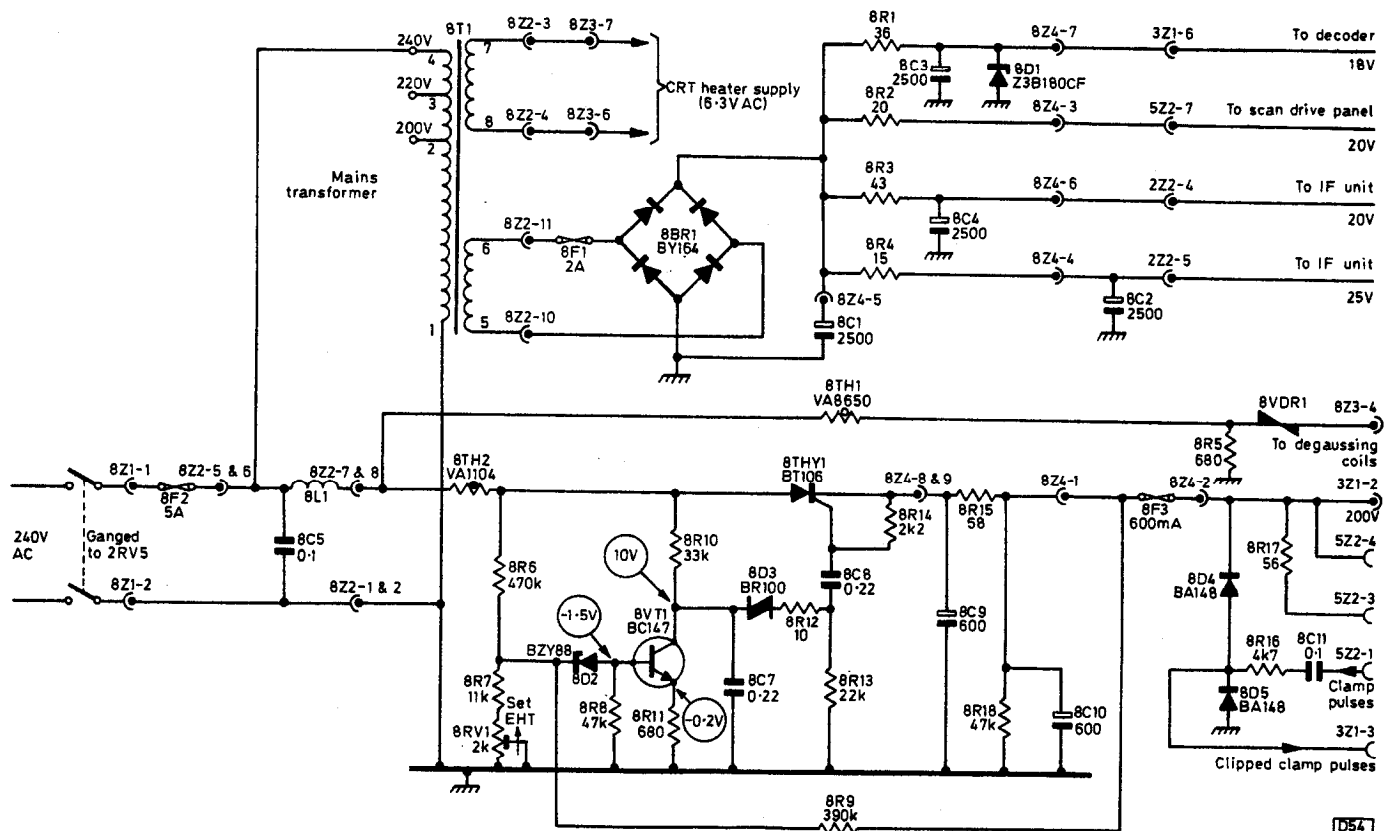
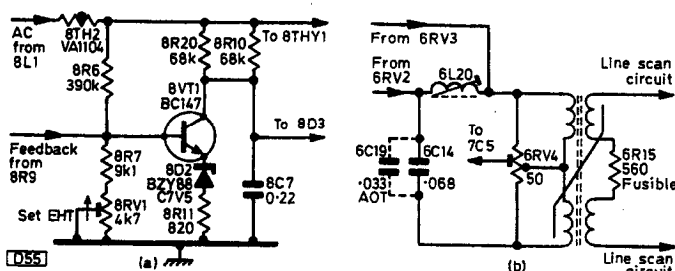
Mains fuse 8F2 blown, c.r.t. heaters not alight, due to 8THY1 being short-circuit. In this event check the condition of 8TH2. If 8THY1 is in order, check 8C5.

C.R.T. heaters alight, sound present but no raster, with the h.t. fuse 8F3 blown, check 6C3. If o.k., check 6C13 and 6R7 — if 6R7 is burnt, either 6C13 or 6D2 is short-circuit. If the same symptoms are present but 8F3 is o.k., check for voltage at either side of the fuse. If present, check at 8R17 which may be open-circuit or the wiring desoldered. If everything is in order here, check 6R9. If this has burnt up the e.h.t. tripler is short-circuit. If 6R9 is intact, check for

approximately 500V at pins 4, 5 and 13 of the c.r.t. If missing, either the tripler is open-circuit or the BD131 line driver transistor has died. It usually goes short-circuit, blowing the l.t. fuse 8F1, but sometimes goes open-circuit. As previously mentioned, check 5C25 and 5R35 if it has failed.

Short 8THY1 life (sometimes very short, milliseconds!) can usually be traced to an intermittent or complete short in 8C9/10.
