Servicing the Baird 700 Chassis

E. Trundle

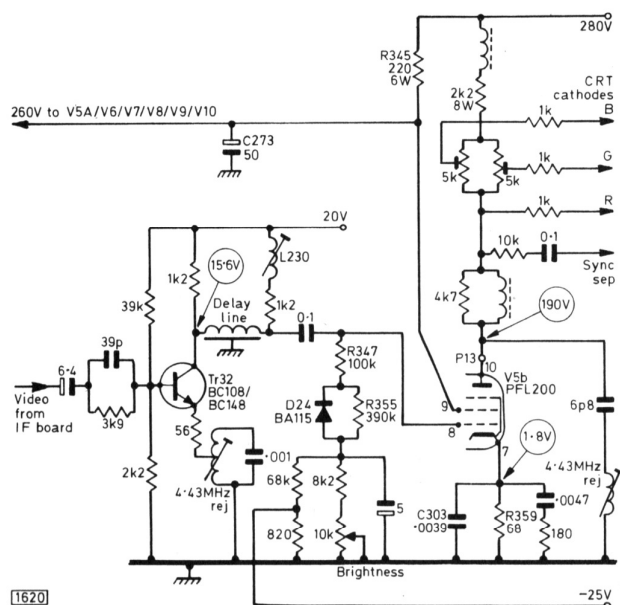
(luminance output section) of anode potential, and the brightly-glowing screen grid will destroy the valve after a very short time.

The PFL200 is the *bête noir* of this chassis, both halves contributing their quota of troubles. At this point we are concerned with the "b" (luminance) half of the valve, whose internal electrodes seem to have a magnetic attraction for each other. The first victim of this is usually the 68 Ω cathode bias resistor R359 (see Fig. 2) which goes out in a blaze of glory, often followed by C303 developing a leak or short. R345 is next in line, and can almost disintegrate. The PFL200 is thus the instigator of burn holes in the printed circuit panel in the area of its associated resistors.
