SERVICING television receivers

THORN 850 CHASSIS

THORN 850 CHASSIS—cont.

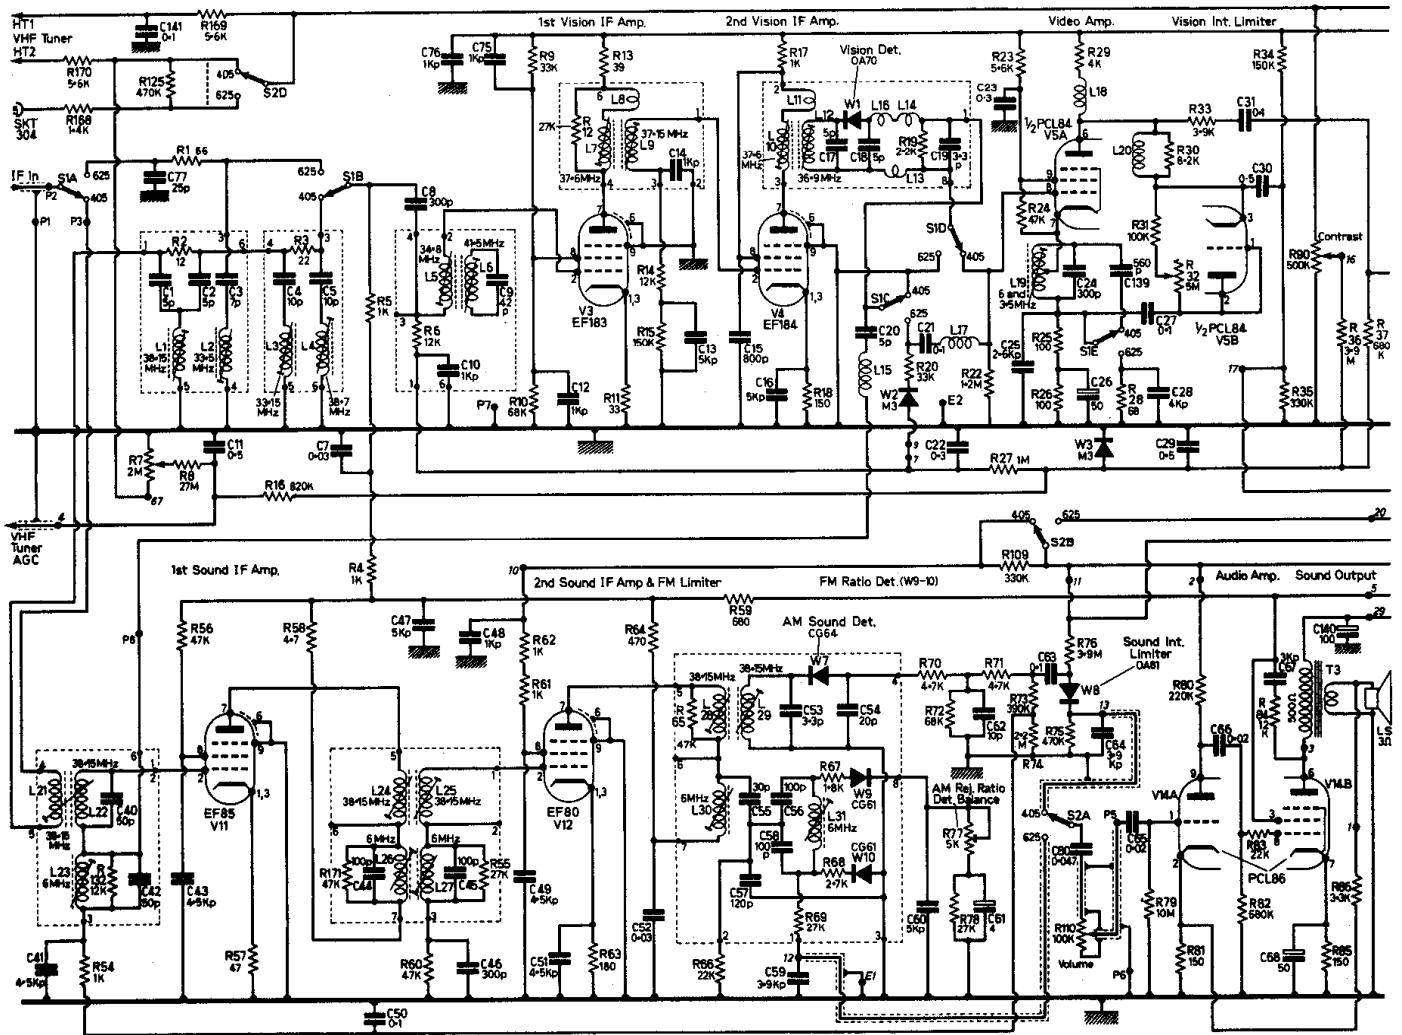
Fig. 4: Circuit diagram of the

The video amplifier is a PCL84 (V5). This valve sometimes gives trouble leading to loss of vision signals. Probably the most serious effect is when the valve develops a screen-to-grid short. When this happens not only do the associated resistors cook up but the vision detector diode is usually ruined by the excessive current flow. This of course is W1 (OA70) inside the oblong can to the left of the PCL84.

Quite often however the valve is blameless and resistors change value on their own account, particularly R24 (47kΩ).

Weak sync may be caused by C26 losing capacitance (50μF) or R24 changing value, whilst on 625 the field sync can often be improved by changing C23 from 0.03μF to 200pF.

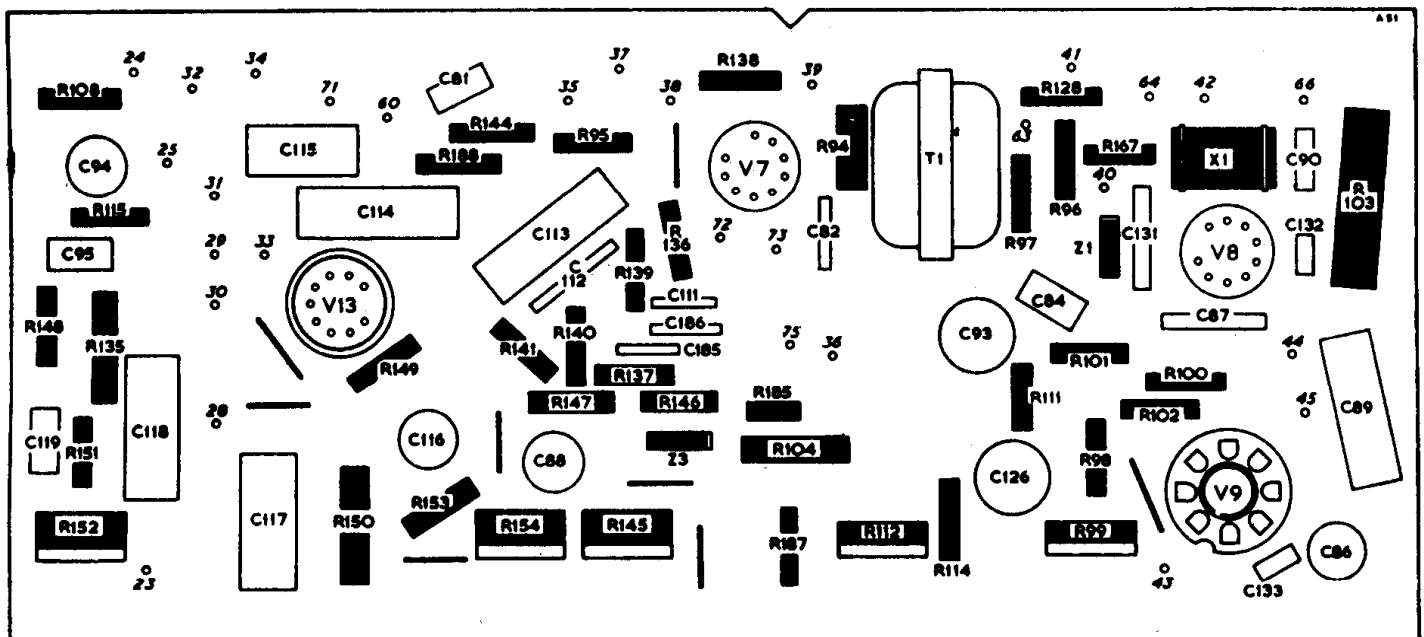
Fig. 5: Layout of the timebase printed board, component side. Figures in italics are tag connections.

If there is no picture at all, with no line whistle on 405 and the EY86 not lighting up, check the above valves, then the boost capacitor C89 0.1μF and the screen feed resistor R103 (1.5kΩ). This latter component is often damaged by a faulty PL36. A check on the boost capacitor can be made by removing the top cap of the PY81. If this restores some degree of line operation the boost capacitor is shorted.

If the line hold control is at one end of its travel check V7. R94 and C82. If these are in order check
