Servicing TELEVISION Receivers

No. 148 - THORN 900 CHASSIS

No. 149 - THORN 900 CHASSIS *continued*

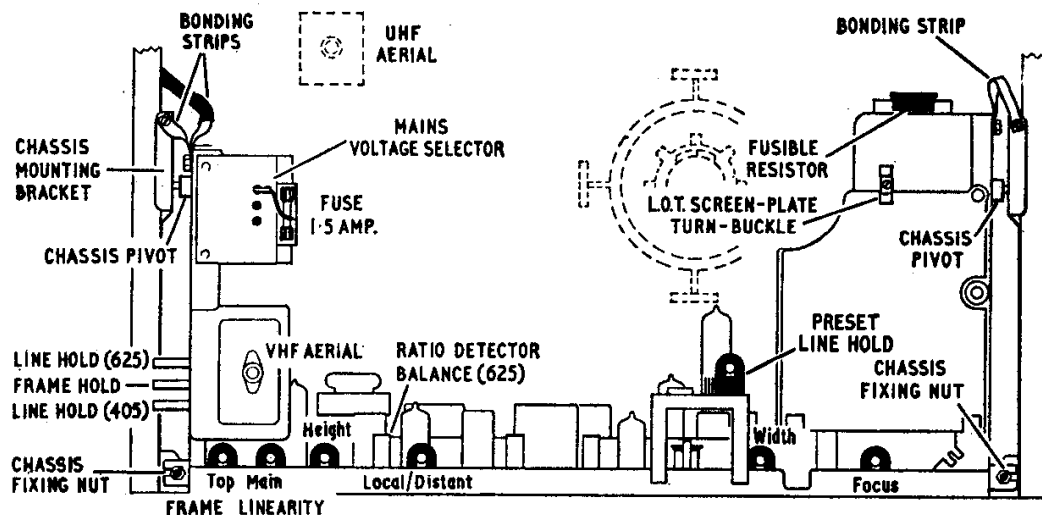
Fig. 1: Preset adjustments, Flywheel unit with preset line hold on fringe models only.

Some models use a flywheel sync unit which is a small assembly on the right side using an EF80 valve and a couple of diodes in one envelope (W401 and W402, type FSY11A), with the preset line hold control R413 prominently mounted.

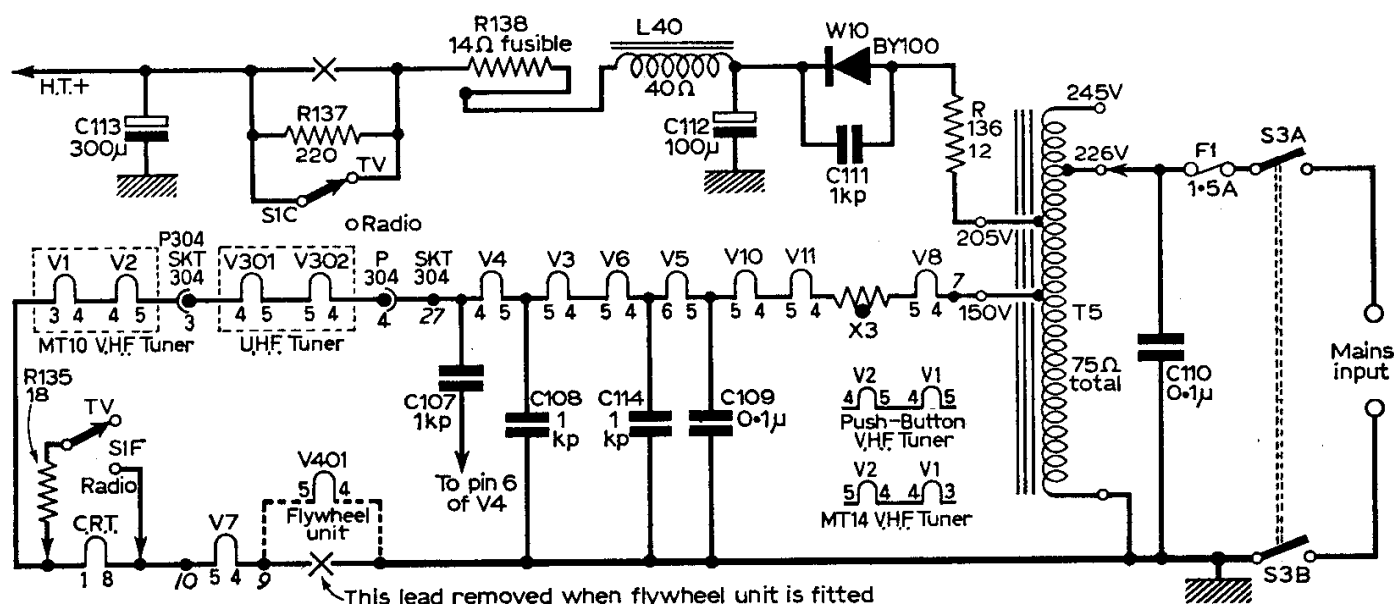
Fig. 10: H.T. supply and heater chain circuits.

One fairly common fault in the heater line which can be nasty if it continues over any period of time is excessive heater current resulting in all the valves and the tube heater being overrun. If the valve heaters appear to glow brighter than normal either put a meter in series with the heater chain which should show 300mA or a little under,

or check the voltage at autotransformer T5 150V tap (or tag 7 on the panel). The voltage should not exceed 150V at normal running. If the voltage is higher with the mains tapping set correctly change the transformer. This develops shorted turns and causes overrunning. This fault can cause premature valve and tube failure.
